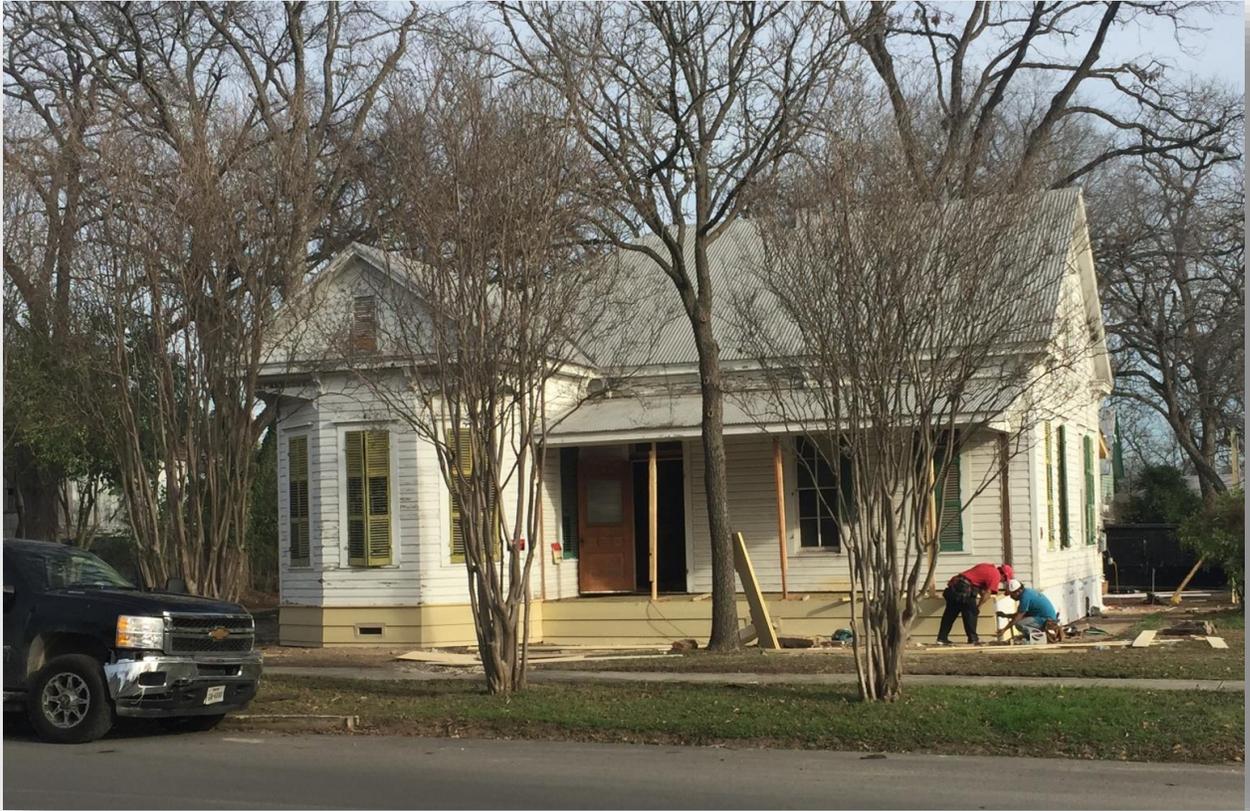
Photograph of subject structure before/during rehabilitation, camera facing northeast

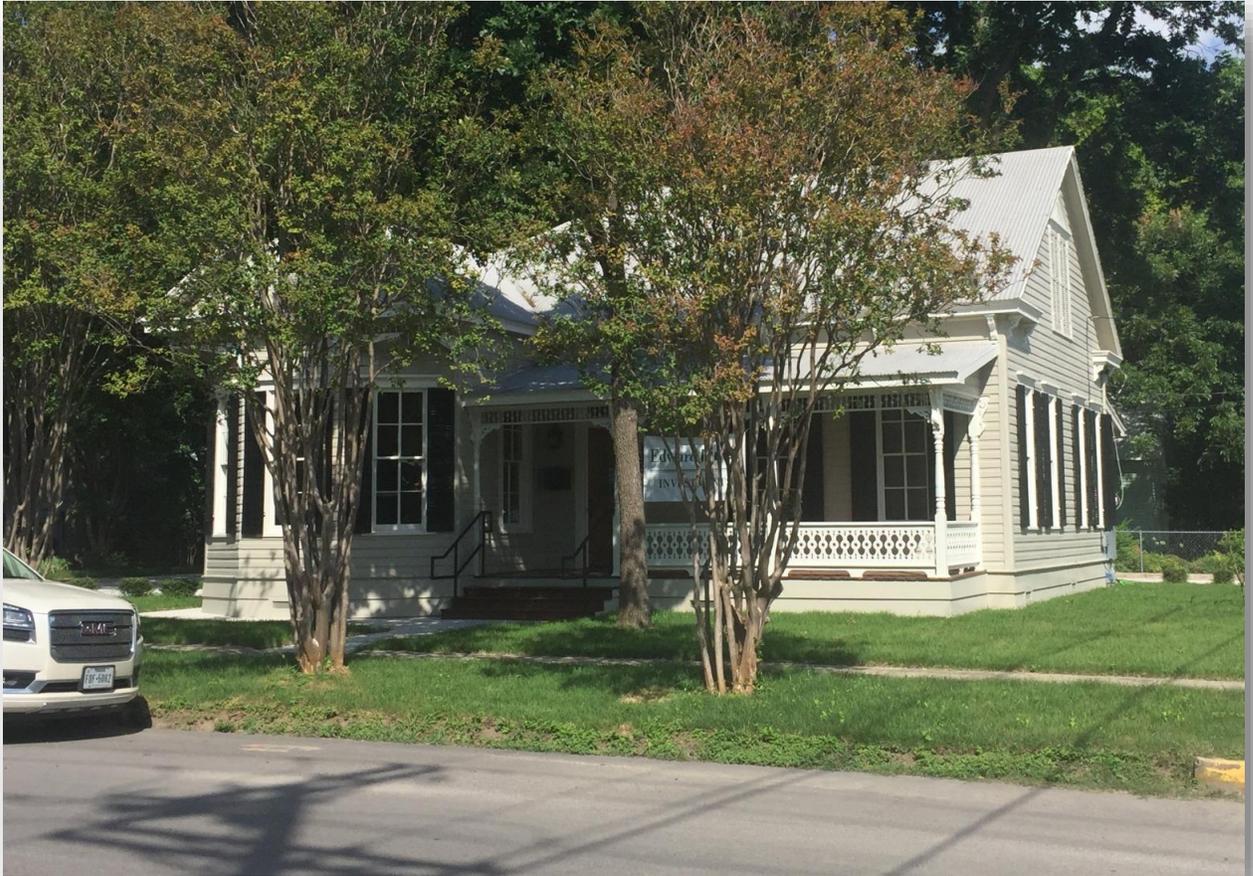
Photograph of subject structure after rehabilitation, camera facing northeast

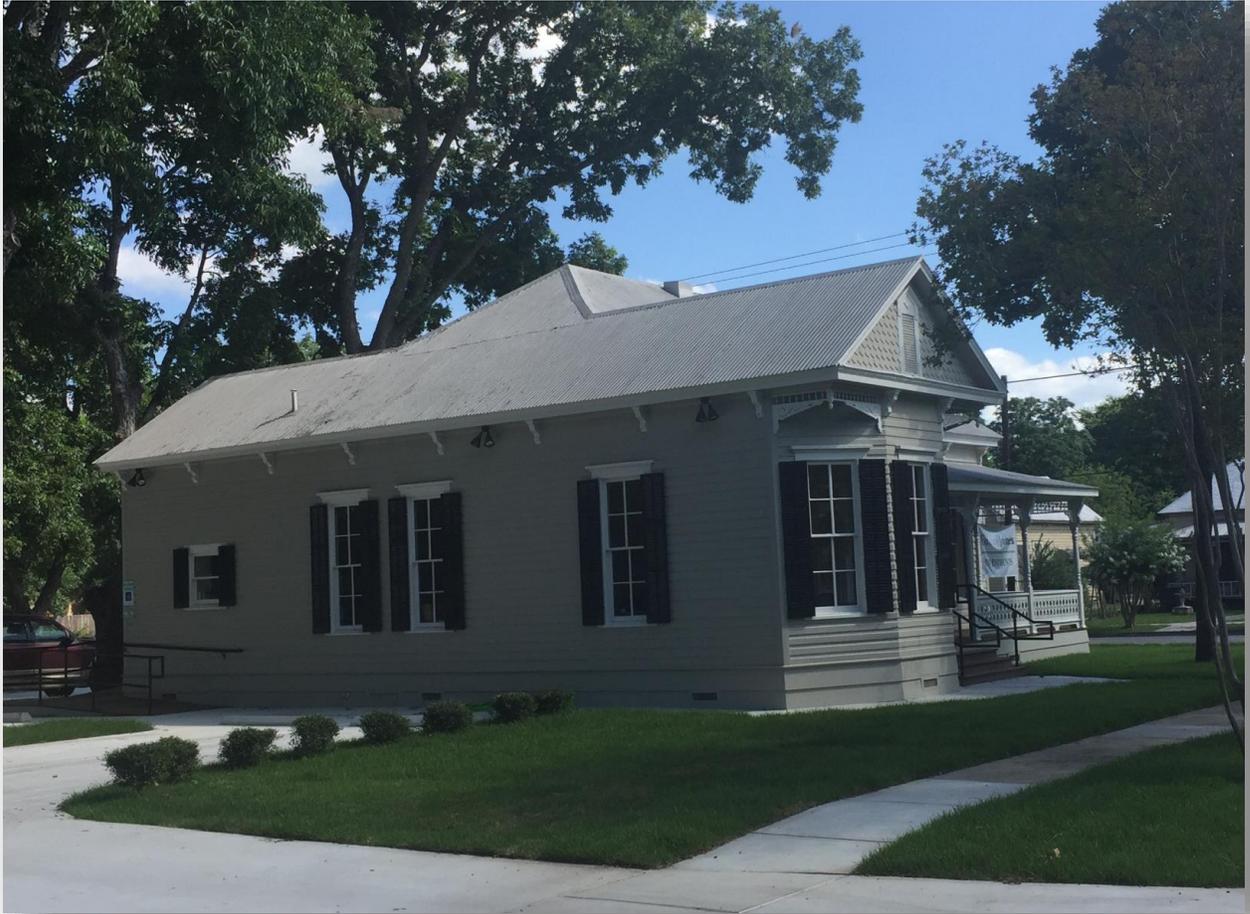
Photograph of subject structure after rehabilitation, camera facing southeast
