# Guadalupe Appraisal District

The Guadalupe Appraisal District Board of Directors (**BOD**) has adopted Resolution 2025-03 proposing the acquisition and renovation of the historic Mary B. Erskine Building located at **216 East College Street, Seguin, Texas**, as the future headquarters of the Appraisal District.

## FOR THE GUADALUPE COUNTY APPRAISAL DISTRICT

MAY 6, 2025

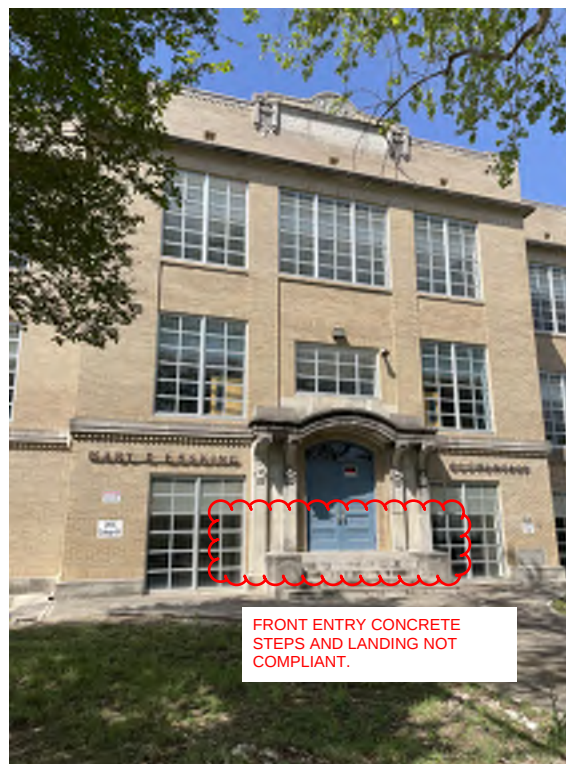
- The front entry curb ramp and door landings exceed the maximum slopes for ADA
- Many areas of the concrete sidewalks to the building are cracked, spalled and uneven
- Rework concrete front entry steps for compliant entry
- Additional parking will need to be constructed. Approximately 30 spaces may be retrofitted on the existing concrete paved basketball court. An additional 25 to 30 parking spaces will be needed to meet City of Seguin ordinances.
- Remove abandoned swing sets and other playground equipment.
- Improve site lighting for better security.
- New mechanical systems will require additional outdoor areas with concrete pads and better security fencing.
- Existing roof downspouts drain across public sidewalks which can cause slippery, unsafe conditions.
- Consider installing sidewalk trench drains to divert drainage to grassy areas.

*Figure 1: Entry sidewalk & curb ramp*

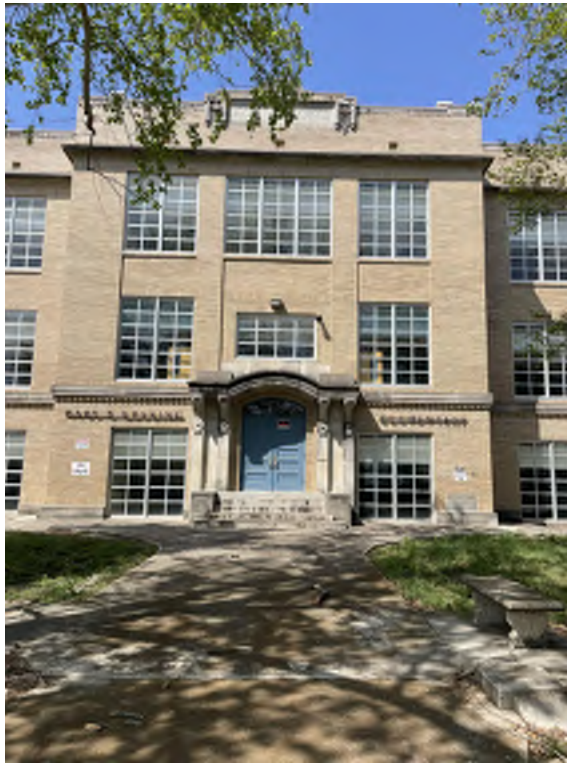
Some cracks were noted at the front entry stairs in the joint between the structural concrete stair framing and the infill wall below. These appear to be cracks caused by differential movement of different materials.

*Figure 2: Front steps-landing*

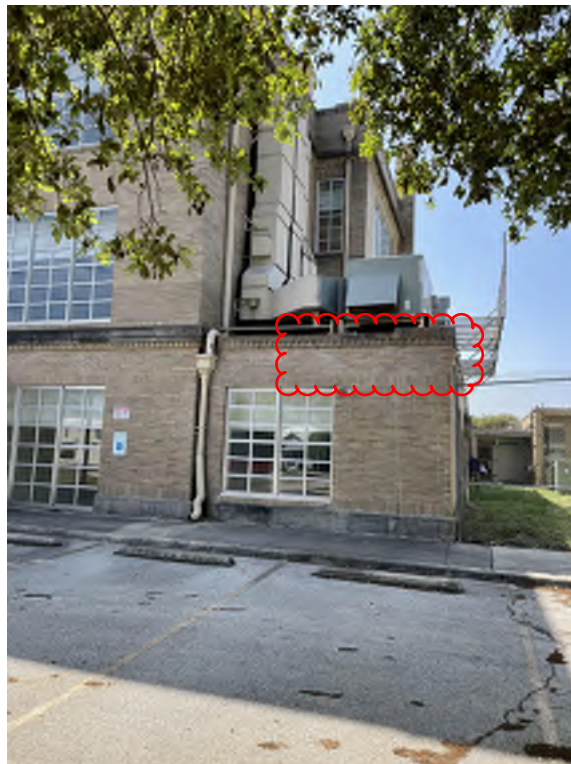
*Figure 3: Exterior clean brick & stone*

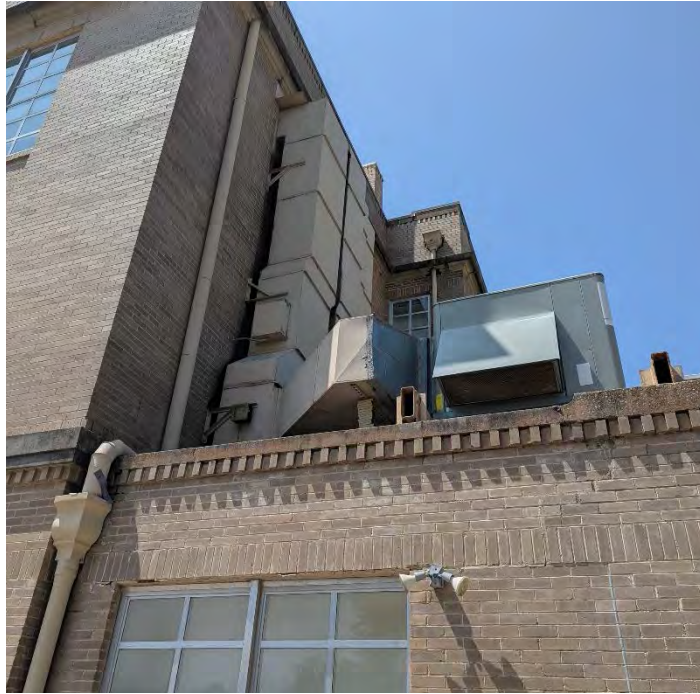
A total of four packaged Rooftop Units (RTUs) were installed on the roof of portions of the first floor, with two on the northeast corner and two on the northwest corner. Each RTU has gas piping routed to it for reheat. Supply and return duct come out horizontally from the unit, and run up along the side of the building into penetrations on the second and third floor. The duct does not appear to be insulated or protected from the elements. While not being able to be observed directly, it was noticed from observations that pieces were missing from the RTUs. The exterior cabinets looked weathered as well.

*Figure 1. Packaged RTUs as seen from ground level*

Outdoor packaged rooftop units would be replaced with new units with variable capacity compressors. The units would have higher efficiency and variable flow fans. New variable air volume terminal units with electric reheat would be installed to accommodate new zoning and occupancies.

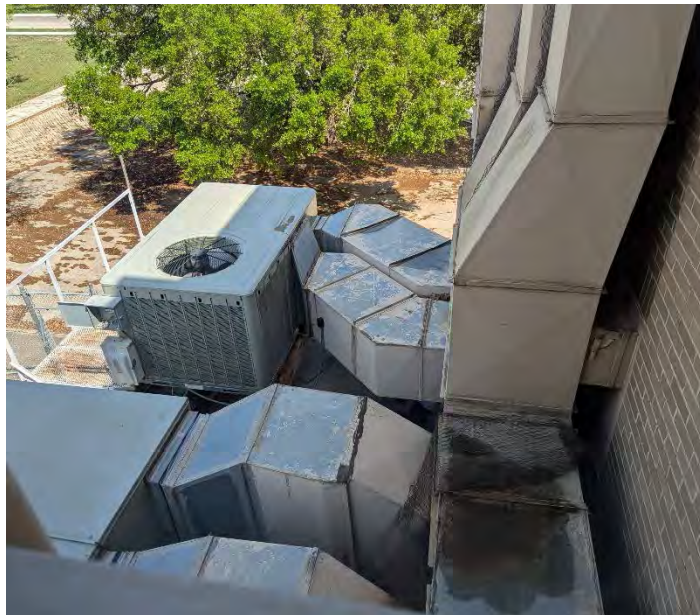
*Figure 2. Packaged RTUs as seen from indoor space*

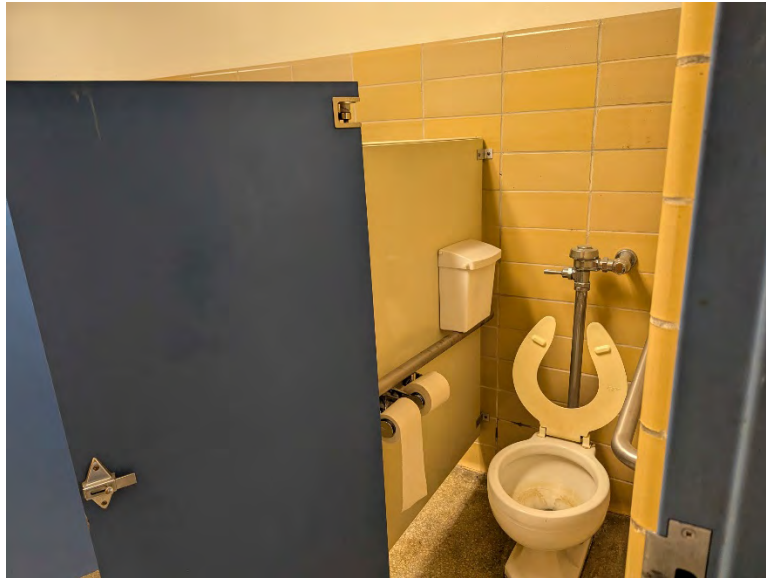
The water closets and urinals were in poor to fair condition. However, many were not sized for adults. The fixtures also were not ADA compliant.

*Figure 3. Typical water closet*

Based on observations of the site, it is recommended that the entire mechanical system be replaced with new equipment, ductwork, insulation, controls, and air devices. It is also recommended to replace all plumbing fixtures to full-sized ADA compliant fixtures and to add men's and women's gang restrooms to the second floor.

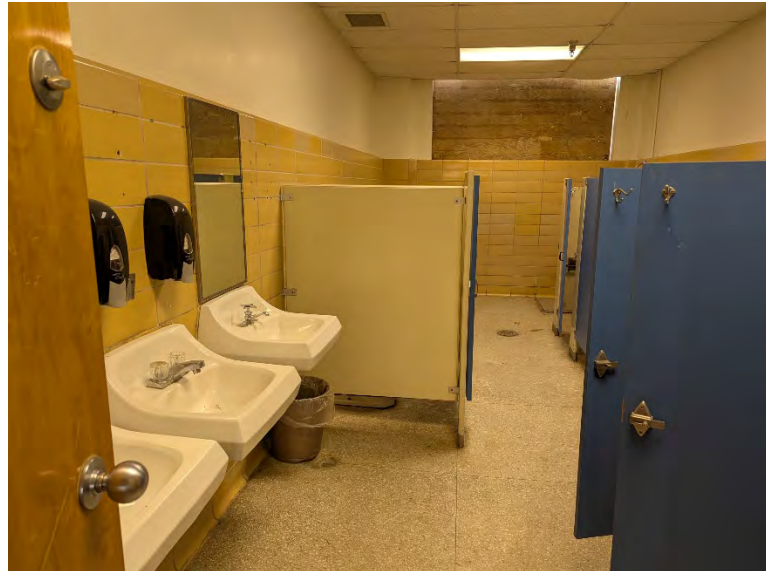
*Figure 4. Typical restroom layout*

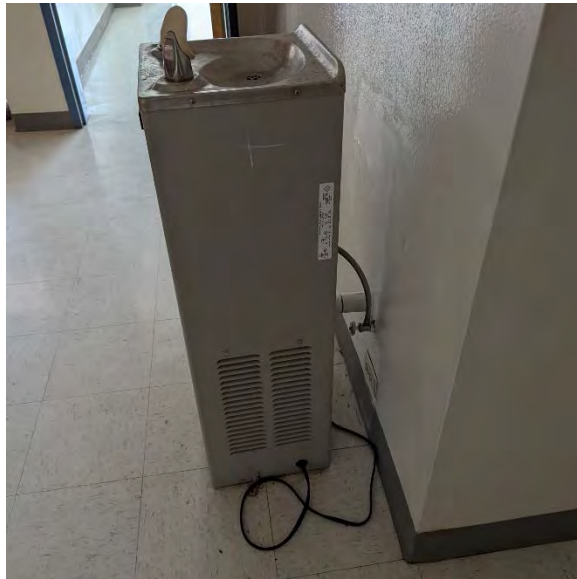
Drinking fountains were observed on each floor. These were in poor condition and were not ADA compliant. No split level fountains or bottle fillers were found.

*Figure 5. Typical drinking fountain*

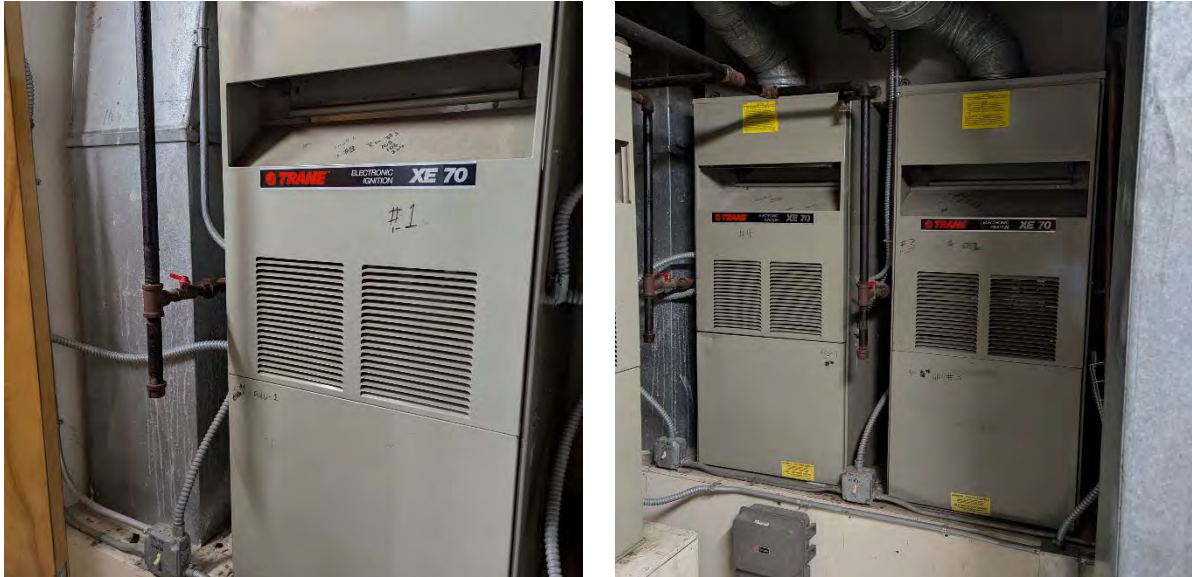
The five DX split systems serving the first floor are comprised of residential-grade indoor air handling units in vertical configuration with natural gas heat paired with an outdoor air conditioner. The nameplates of the air handlers were not accessible to read, however based on the outdoor air conditioner the units appear to be manufactured in 1991. The units are charged with refrigerant R-22, which is no longer permitted to sold in new equipment and is increasingly hard to service.

*Figure 7. First floor vertical air handlers*

This option would involve removing the existing mechanical equipment and replacing with new, similarly functioning equipment. The existing split systems would be replaced with new variable capacity heat pumps. The indoor vertical air handlers would be replaced with higher efficiency fan models.

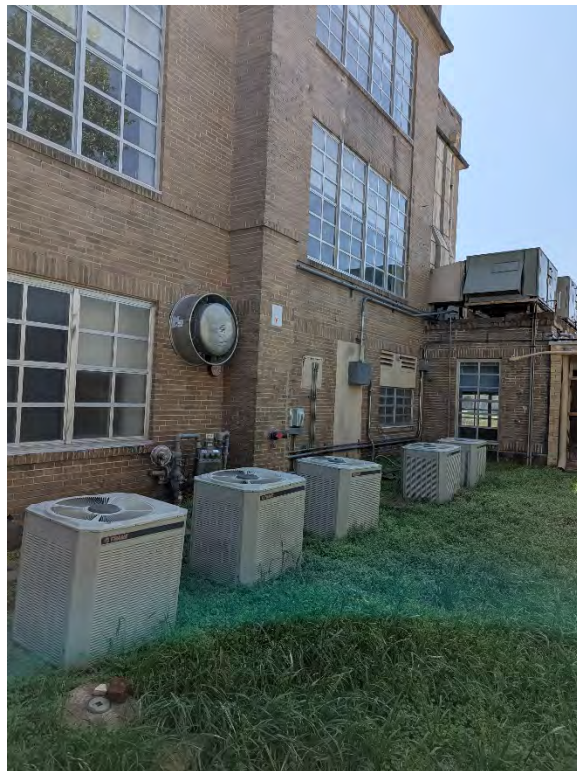
The outdoor air conditioners are mounted to concrete pads just outside of the building in between the main building and gym. The units were observed to be in poor condition and had components missing. The nameplates showed all were the same 5-ton model and manufactured in 1991.

*Figure 10. First floor outdoor units in mechanical yard*

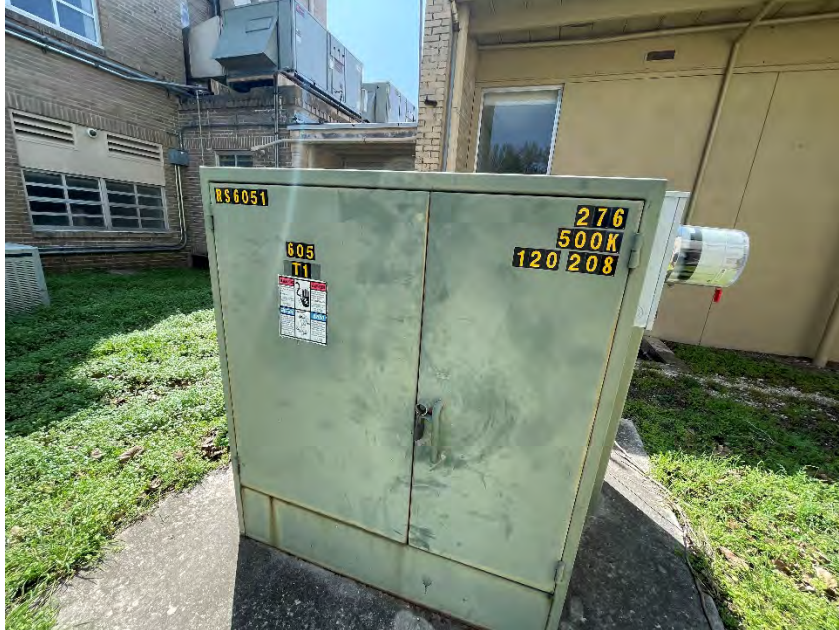
Figure 16. Utility transformer

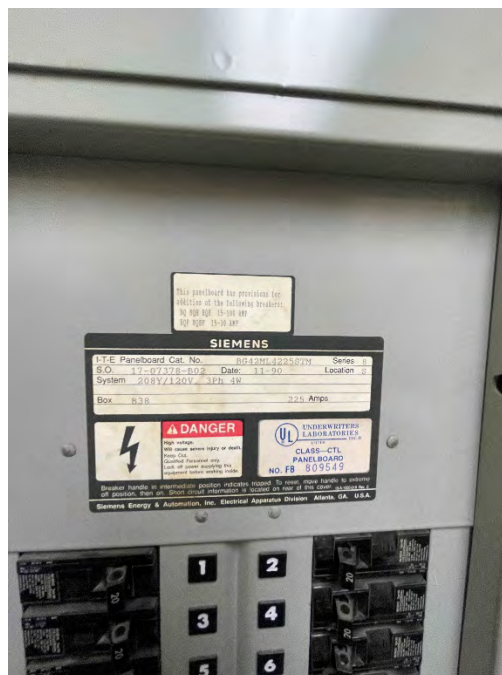
Electrically, the building is served by a 208Y/120V 500kVA utility transformer, which is likely to be sufficient for the renovation. The electrical distribution equipment appears to be dated from 1990 to 2000. The main switchboard was unable to be opened during the site visit. Based on the age of the equipment, it is recommended to replace the electrical distribution equipment and feeders. The new layout of the building and HVAC renovations will also likely require a reconfiguration of the distribution system. Additionally, this will allow for a more efficient electrical design that requires fewer pieces of equipment that can be consolidated to one area, instead of placed throughout the facility.

Figure 17. Panelboard nameplate showing a date of 1990

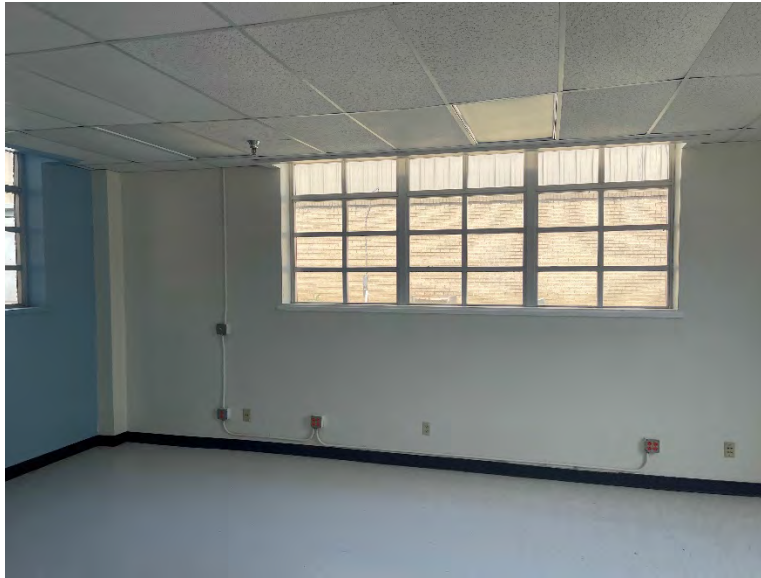
The devices appear dated. Some devices appear to have been added at a later date, and have surface mounted raceway providing power to the receptacles. There is an isolated grounding system in place for some of the receptacles. This can be left intact, but is not required. Optionally, the devices and face plates can be replaced and the raceways moved to inside the walls to freshen up the space.

*Figure 83. Typical wall showing orange isolated ground receptacles and surface mounted raceway*
