Color Photos – Project Area

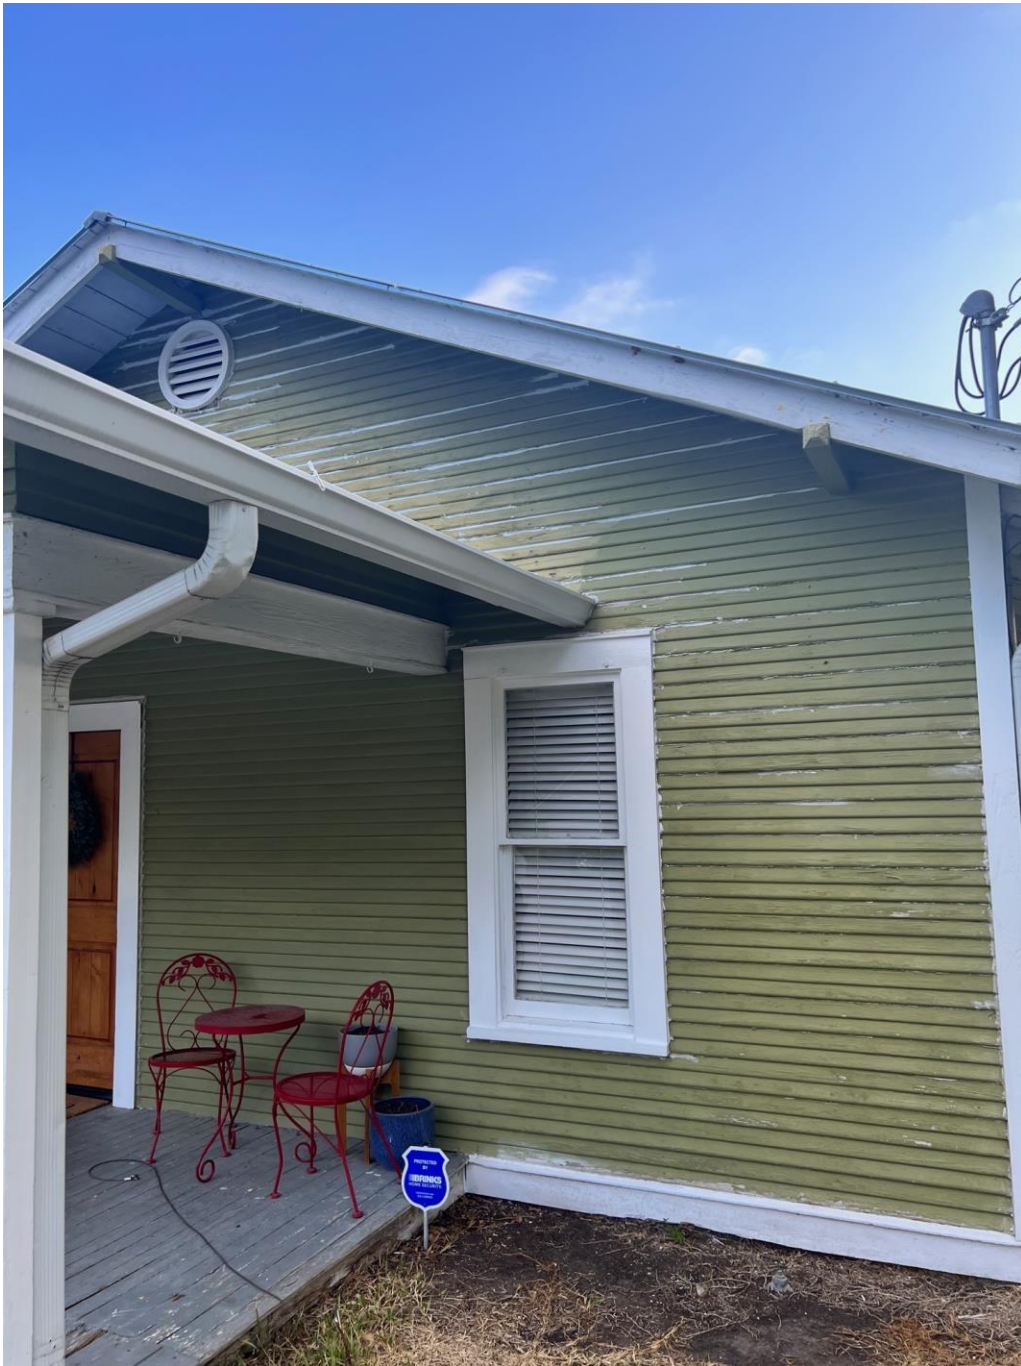
Note: Floor warped and severe rot beneath flooring

****Please Take into Consideration:** Due to the extent of the floor damage caused by moisture, the floor was initially repaired on 10/10/2023. With the floor being opened the original posts were severely leaning and identified severe rotting/decomposition near the base of the post. These were also replaced and additional posts set. Please note this change has already been made. The remaining portion of the project, pending approval, are the installation of the rails and crawlspace vents along with additional coats of primer and paint. Below are current pictures as of 10/21/2023 with updated level columns and porch floor replaced with primer on each.

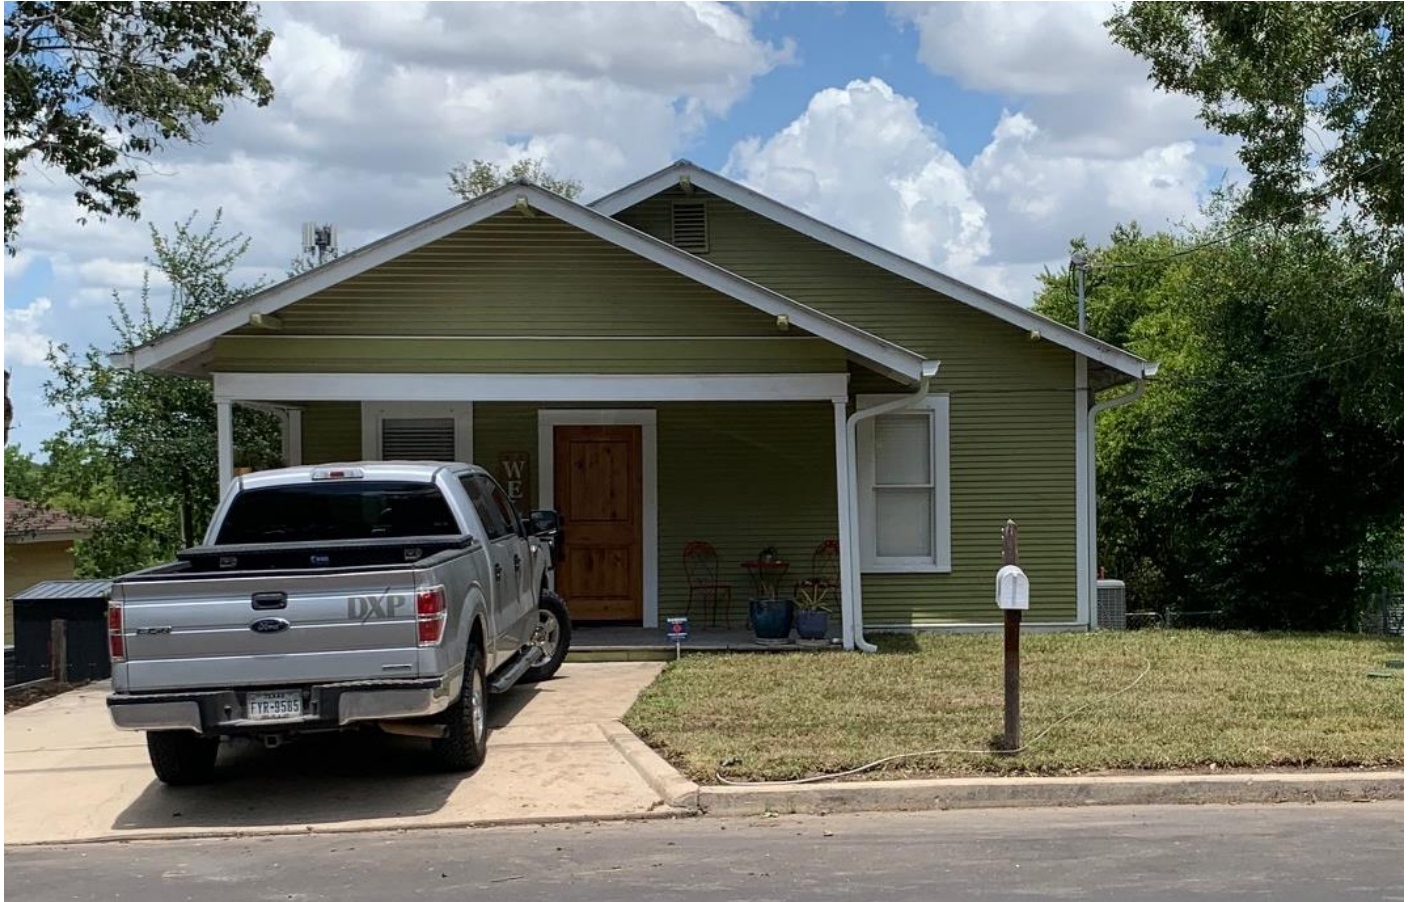
Note: Leaning posts are evident.

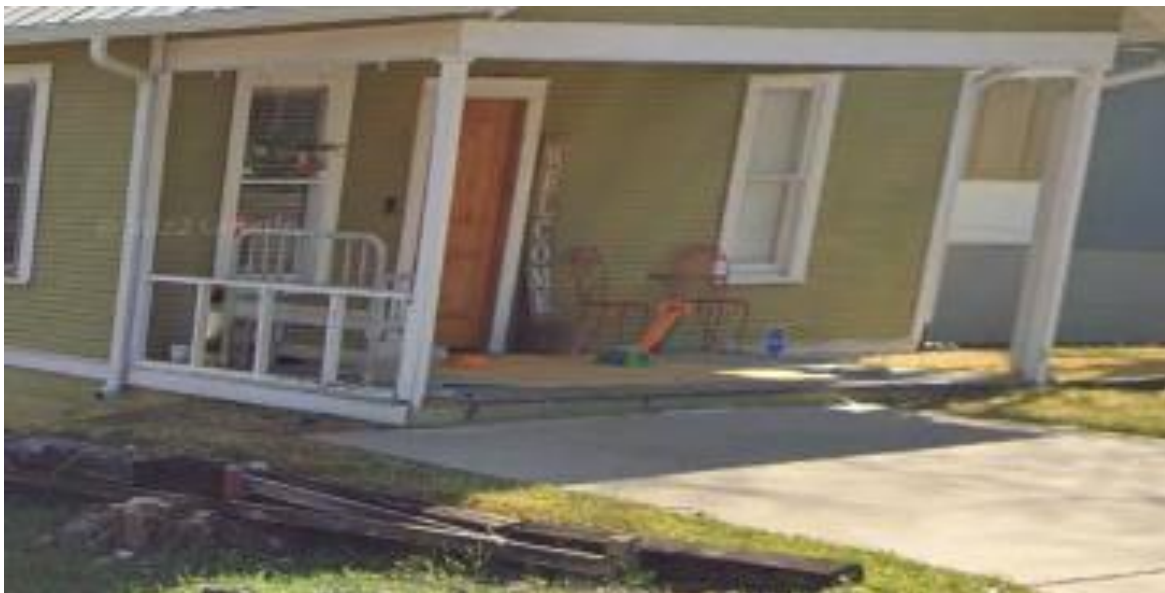
Note: The rot completely rotted out this left side rail to which it had broken off near the post.
