HAWKEYE **REAL ESTATE INSPECTION**

Daniel Wallace
301 Kuehler

PROPERTY INSPECTION REPORT FORM

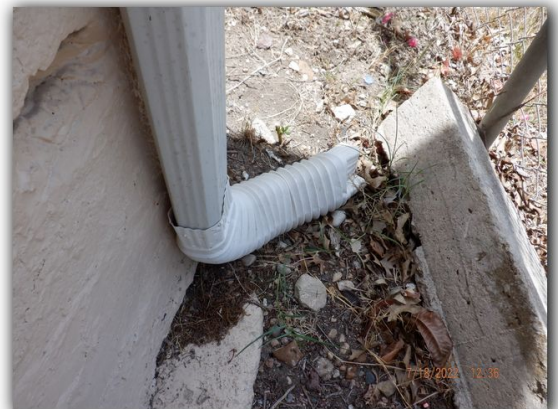
The grading should be improved to promote the flow of storm water away from the house. This can usually be accomplished by the addition of top soil. The ground should slope away from the house at a rate of one inch per foot for at least the first ten feet. Ideally, at least eight inches of clearance should be maintained between soil level and top of the foundation walls.

The gutters system should discharge water at five feet from the house. Storm water should be encouraged to flow away from the building at the point of discharge.

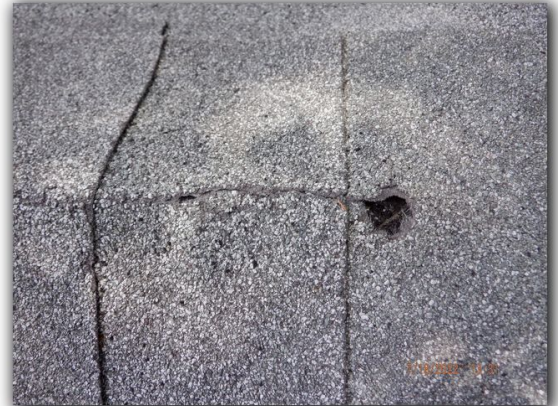
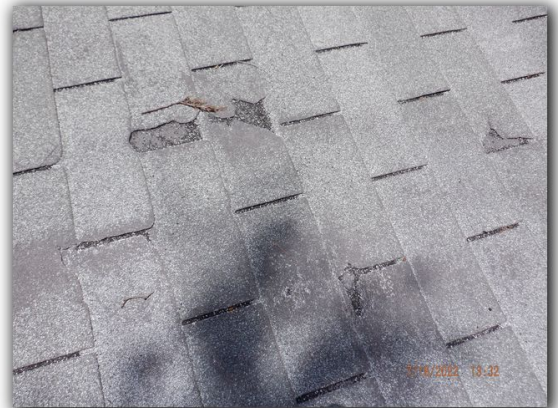
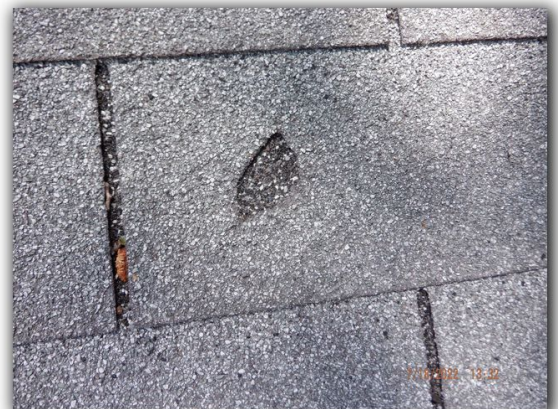
Repairs to the roofing are recommended. Damage or missing roofing materials should be repaired. All roof penetrations should be examined and sealed as necessary. This condition should be further evaluated by a licensed roofing company and all repairs made as necessary.

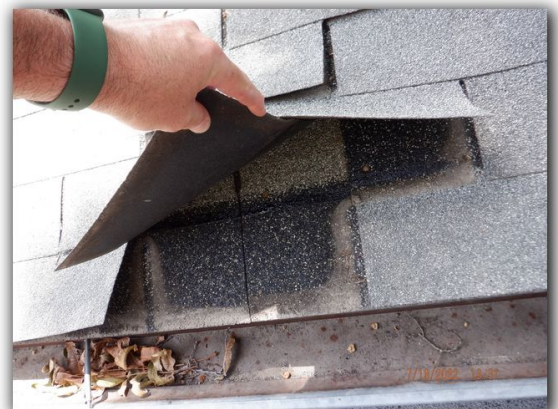
The starter run along the edge of the roofing does not appear to have been installed properly. Various shingles were observed to be loose and not properly fastened. These conditions should be further evaluated by a licensed roofing company and all repairs made as necessary.

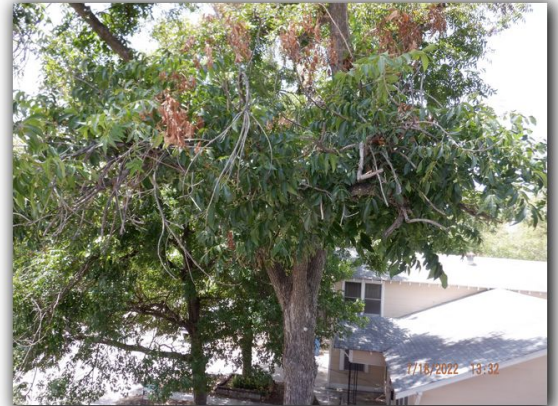
Tree limbs and branches should be removed from nearing and protruding over the roof covering as per current standards of practice.

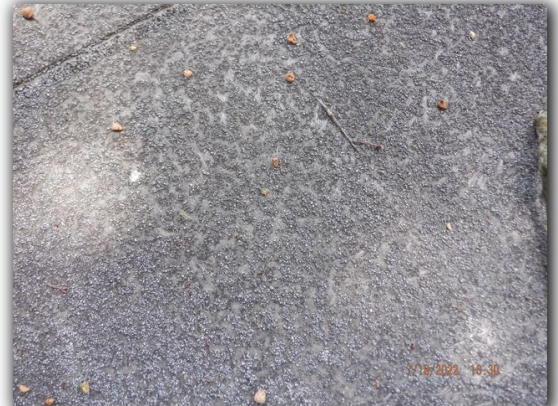
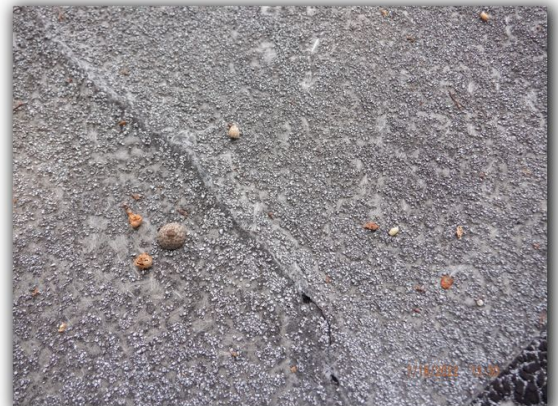
The granules of the flat rolled roofing on the roof covering were observed to be thinning which is an indication of ageing materials, replacement may be needed in the near future. Lifting of the rolled material was observed. These conditions should be further evaluated by a licensed roofing company and all repairs made as necessary.

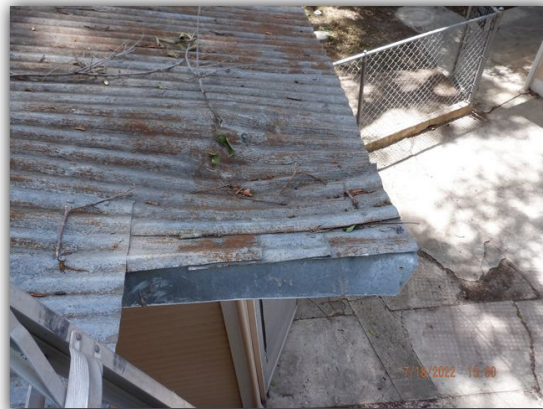
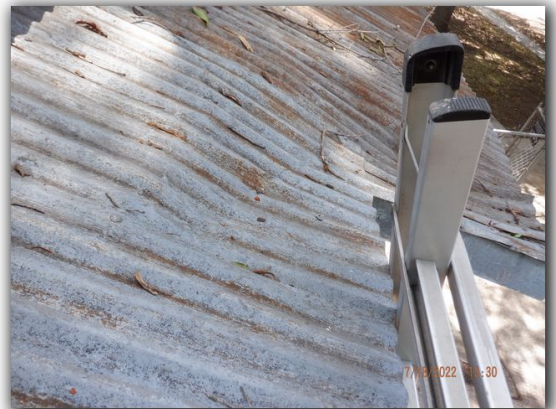
Tree, tree limbs and branches should be removed from touching, nearing and protruding over the roof covering as per current standards of practice.

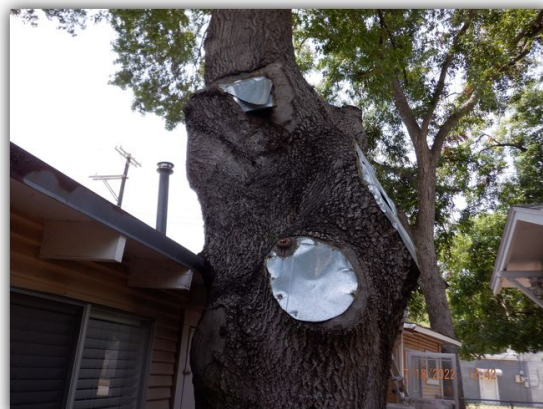
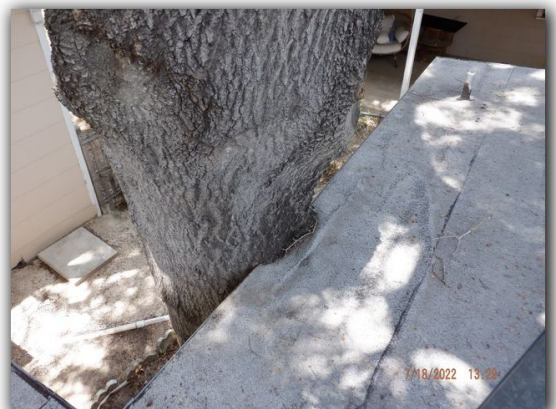
The rake flashing is loose and should be re-secured and properly sealed to avoid leaks.

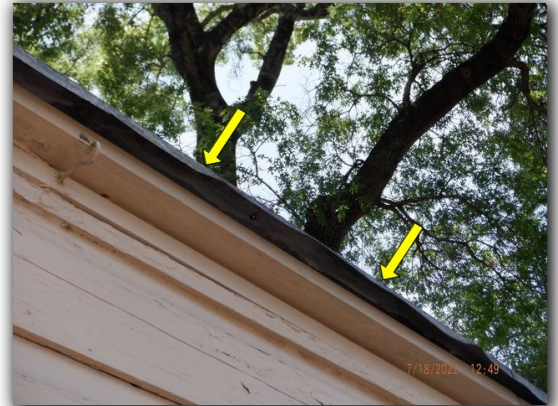
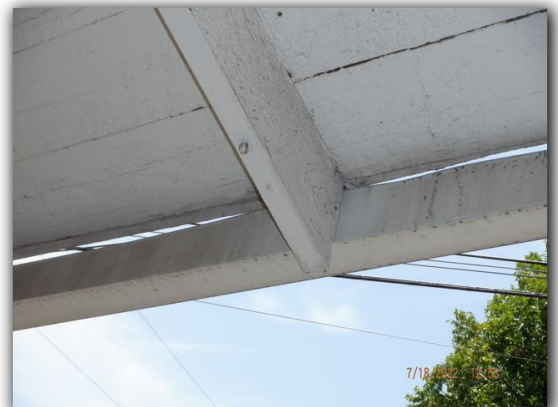
The gutters require cleaning to avoid spilling roof runoff around the building - a potential source of water entry or water damage. The gutters require cleaning to avoid spilling roof runoff around the building - a potential source of water entry or water damage and leaks in the gutters should be repaired. Various leaks in the gutters and damages should be repaired. Loose or damaged downspout's should be repaired promptly.

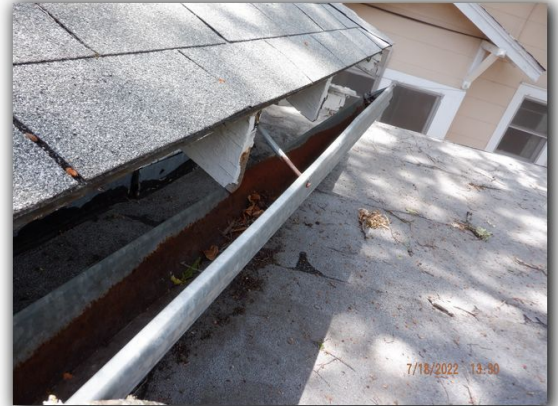
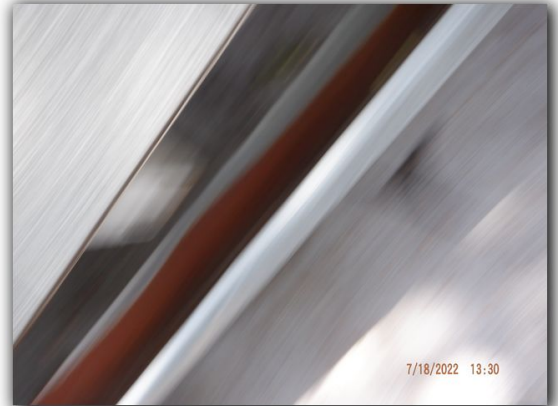
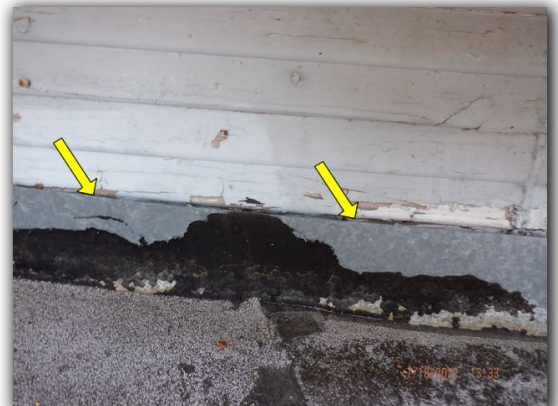
The flashing at the roof covering under the east overhang is loose and should be re-secured and properly sealed to avoid leaks. The metal flashing was not properly installed and prone to leaks. This condition should be further evaluated by a licensed roofing company and all repairs made as necessary.

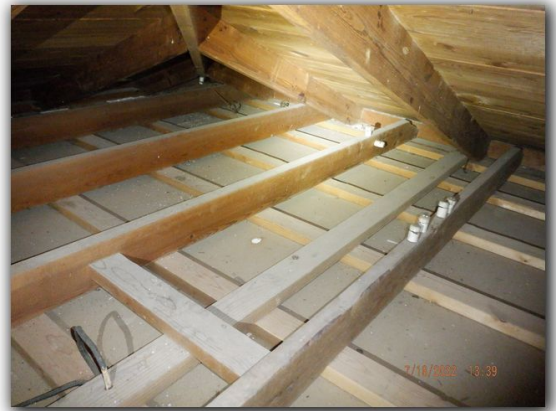
No insulation was observed in attic space and should be added as per current standards of practice. Insulation improvements may be cost effective, depending on the anticipated term of ownership.

No soffit or roof covering passive vents were observed for the attic space. The level of ventilation should be improved. It is generally recommended that one square foot of free vent area be provided for every one hundred and fifty square feet of ceiling area. Proper ventilation will help to keep the house cooler during warm weather and extend the life of roofing materials. In colder climates, it will help reduce the potential for ice dams on the roof and condensation within the attic.

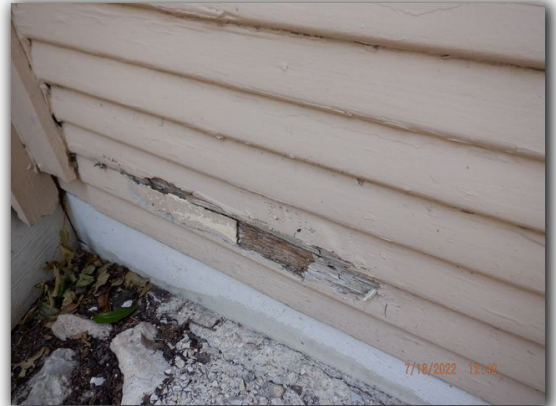
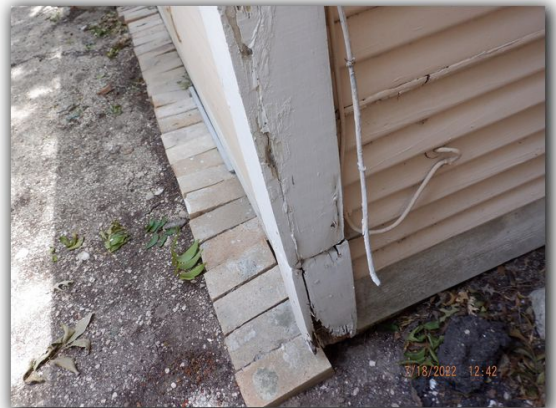
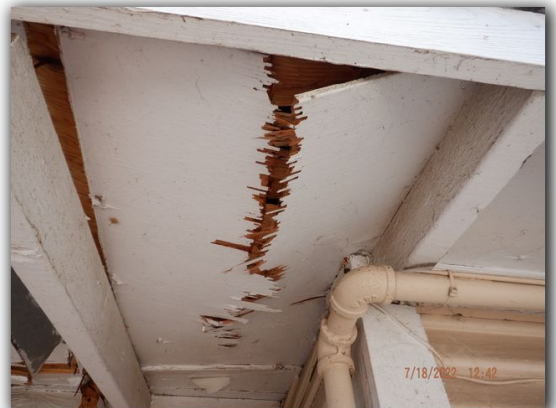
Wood rot and damage around various exterior walls, fascia, overhang and windows are in need of repair.

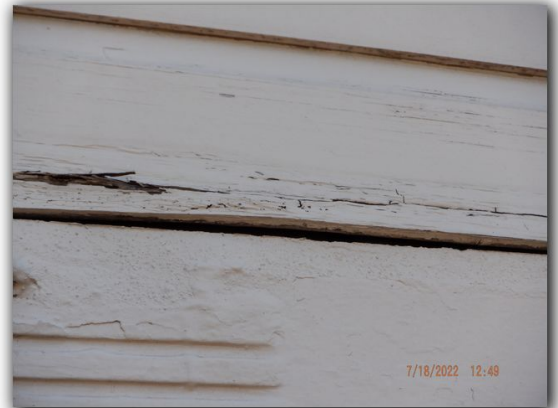
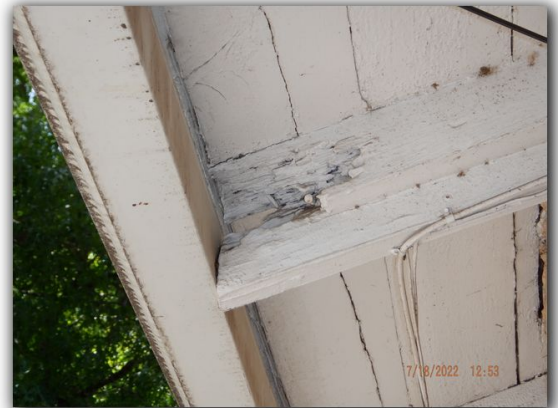
Water staining was noted at the front storage shed exterior wall. The cause for the staining should be determined and repairs undertaken, if necessary, to prevent structural damage.

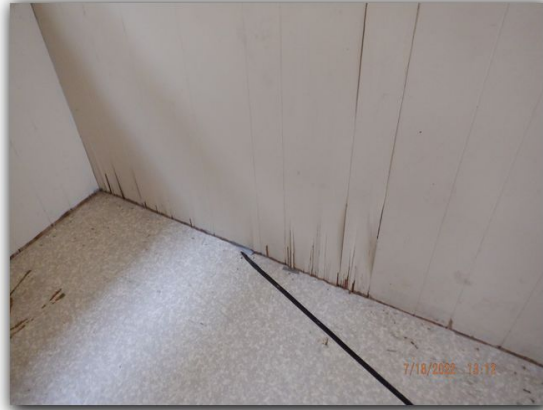
Damage to the interior finish was observed in the west closet area at wall and ceiling area and should be repaired.

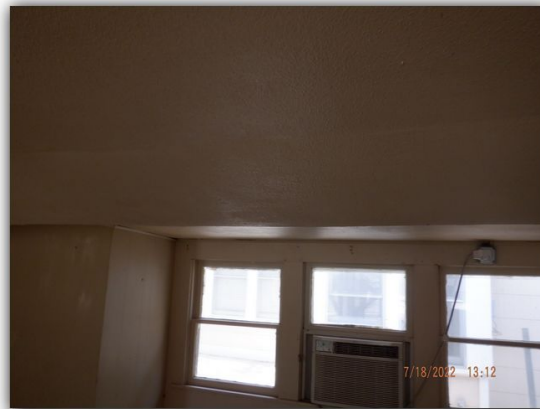
Finish covering and insulation missing above the front entry area at the exterior top side of the ceiling and in need of repair.

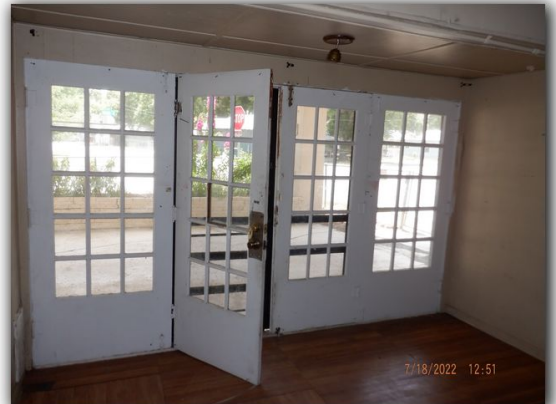
Safety glass etchings were not observed on the glass within the front and back doors. Safety glass is required for glass doors and is generally identified by an etching in the corner of the glass pane. Weather stripping is damaged/missing at the front back door and is in need of repair.

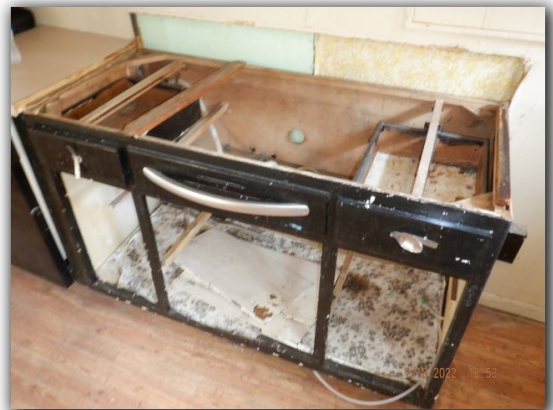
Cabinet doors missing at the kitchen and bathroom and in need of repair.

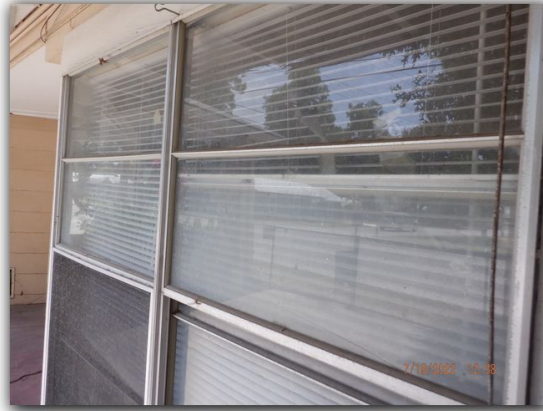
The windows are relatively low quality single pane glass. They are in a state of mild disrepair and are not considered very energy efficiency. Trimming and or adjustment , hardware improvements and weatherproofing improvements could be undertaken. In practice, improvements are performed on an as needed basis. Installing replacement windows may be the best long term approach. In the interim, it is important that the window exteriors be well maintained to avoid rot or water infiltration.

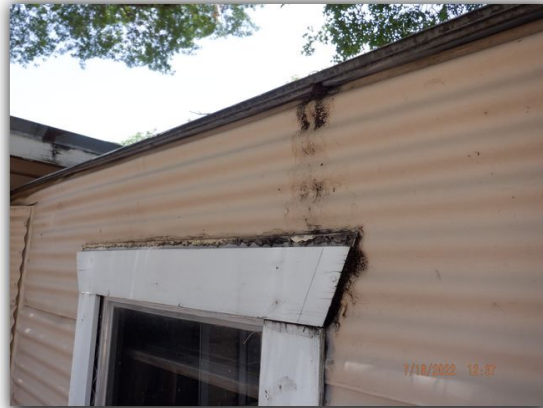
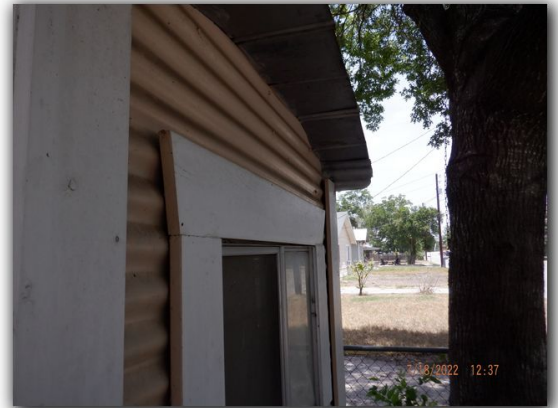
Various damaged screens were found on the windows and should be repaired or replaced.

No evidence of header flashing were observed above the exterior windows which help prevent water penetration in the wall. This condition should be further evaluated and all repairs made as needed.

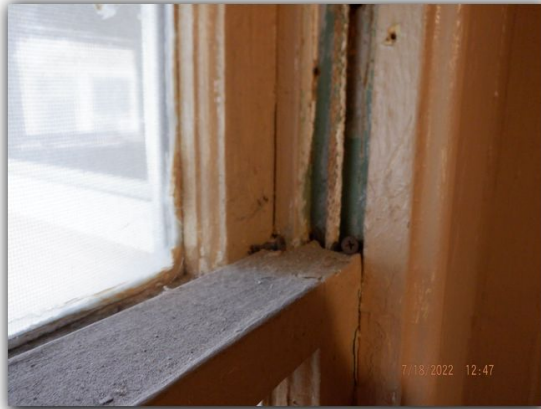
Various windows were inoperative. Nailed and or painted shut and Improvement can be undertaken to allow normal operation of the window.

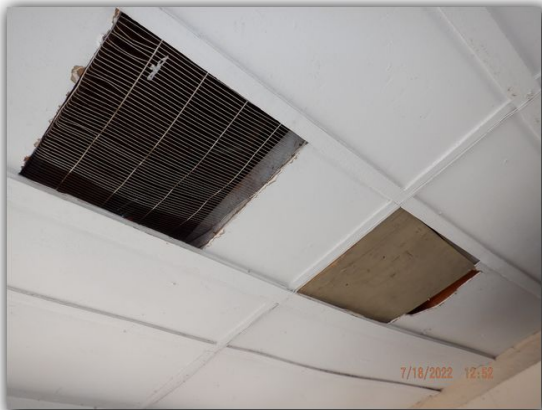
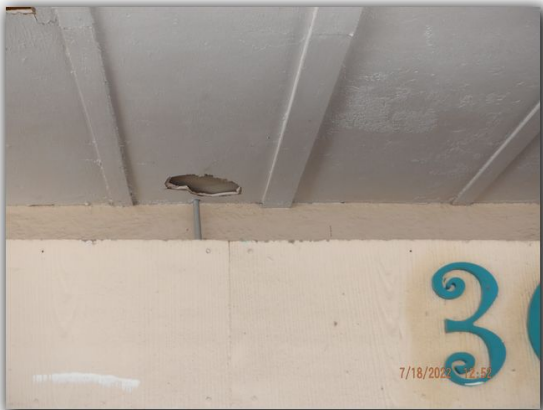
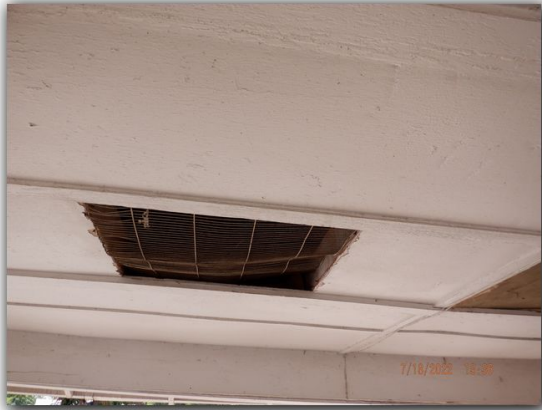
Damaged was noted at the ceiling of the front patio ceiling and in need of repair. Missing attic access cover should be repaired.

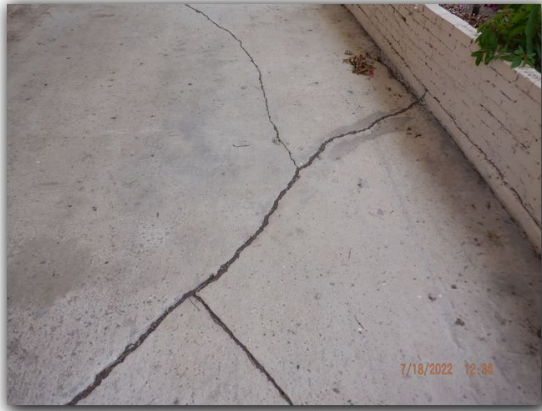
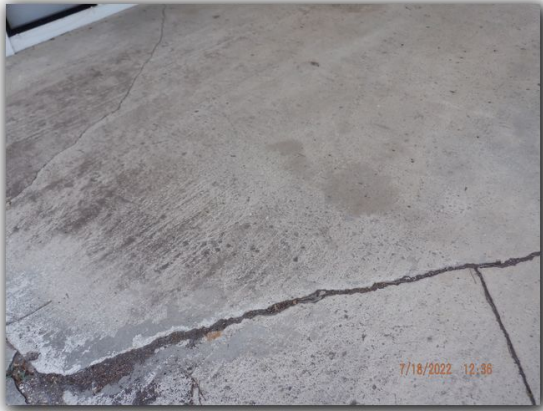
Large cracks and damages were observed in the driveway and are in need of repair.

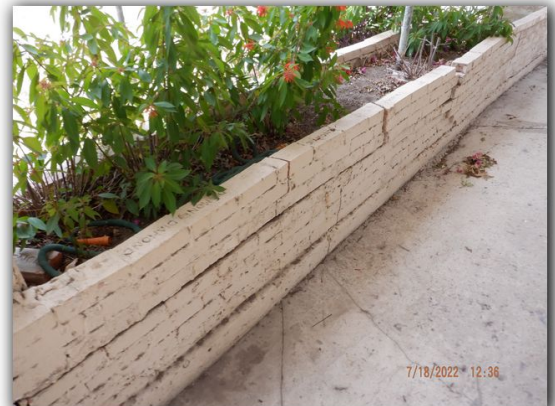
Damaged at the front column at driveway area and damaged brick at the front flower bed and are in need of repair.

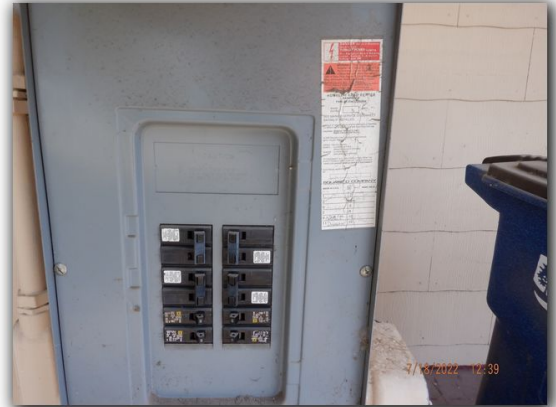
Main service panel is located at the exterior West wall. Breakers are not labeled at the main panel box and should be mark accordingly. When more than six breakers exist in the main service panel box, a main disconnect is required. A main disconnect is required at the main service panel box as per current standards of practice but was not required when the house was built. This condition should be further evaluated by a licensed electrician and all repairs made as necessary.

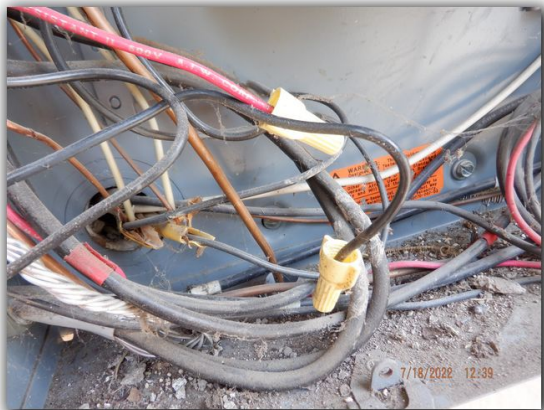
Abandoned wiring in the main panel box should be replaced or appropriately terminated. Information should be gathered as to what the wires were intended for and all repairs made as needed.

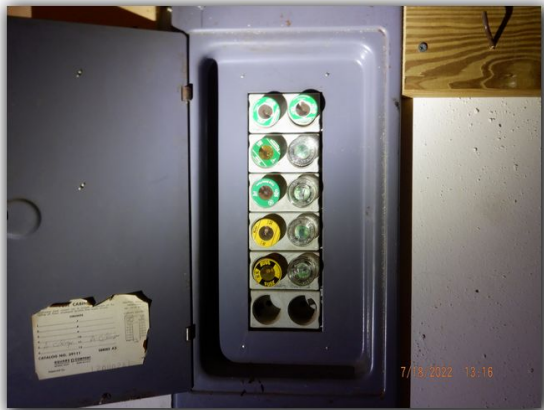
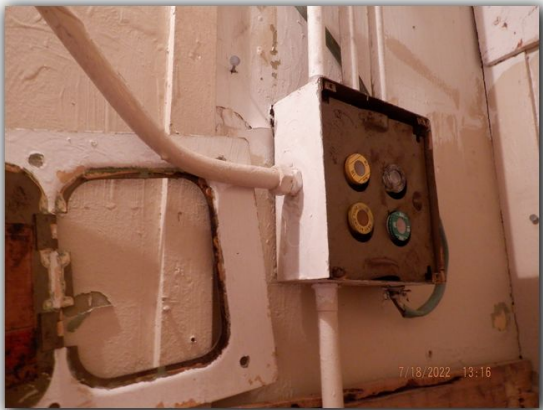
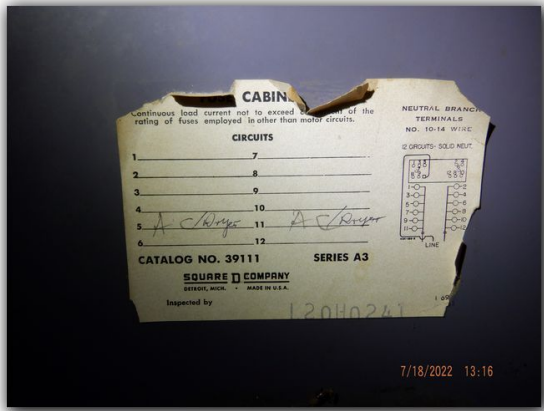
Sub Panel located north closet and utility closet in the house. Fuses are not labeled at the both sub panel boxes and should be mark accordingly.

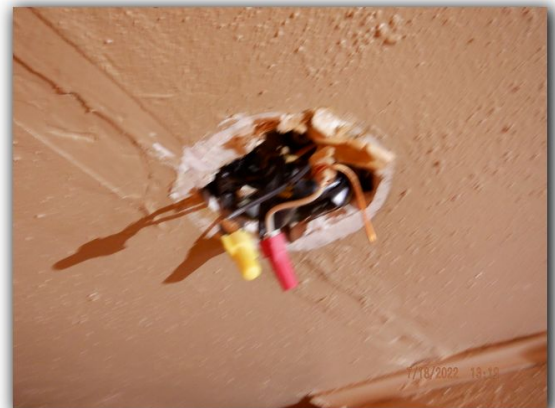
Wiring exposed on exterior finishes should be relocated or protected by a rigid conduit. The wiring does not appear to be for exterior moisture/weather rated wiring. These condition should be further evaluated by a licensed electrician and all repairs made as necessary.

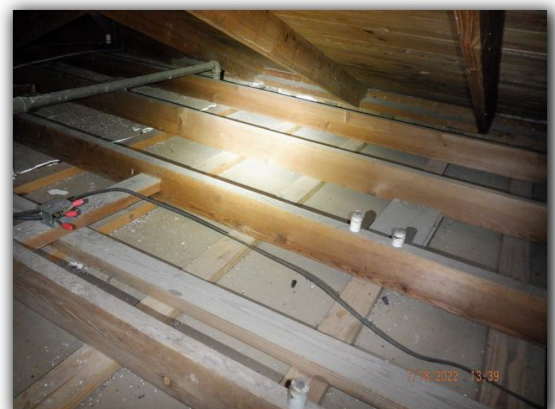
The house appears to consist of the old knob and tube wiring through out the electrical system, this condition can pose a safety hazard and should be further evaluated by a licensed electrician and all repairs or replacements made as necessary.

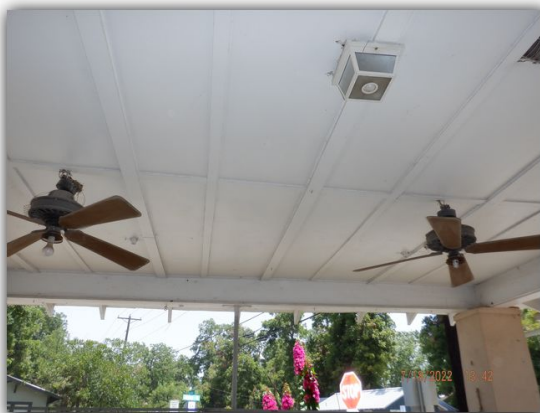
The front patio ceiling fan and lights were inoperative at the time of inspection. If the bulbs are not blown, the circuit should be investigated.

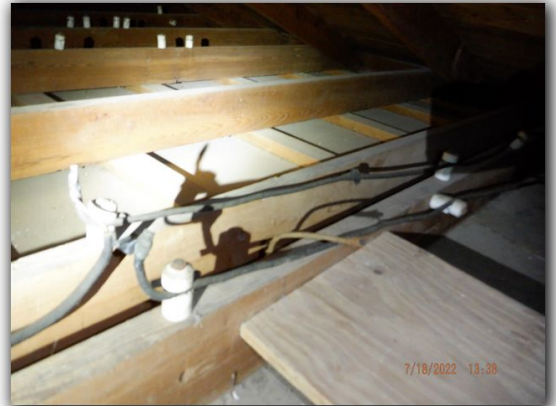
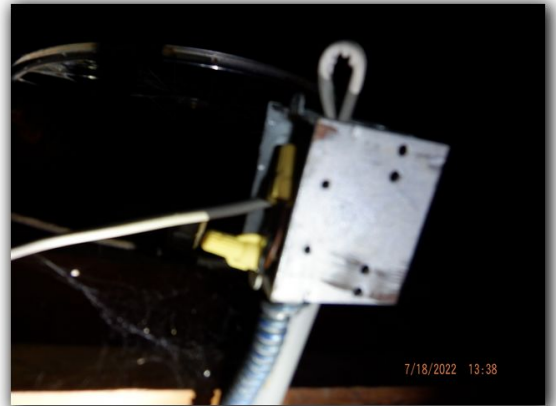
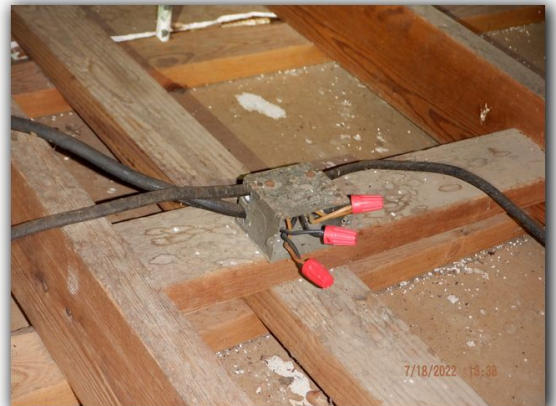
All spliced wires in the attic spaces should be enclosed in a junction box for safety purposes as per current standards of practice. Missing junction box cover in the attics should be properly covered as per current standards of practice.

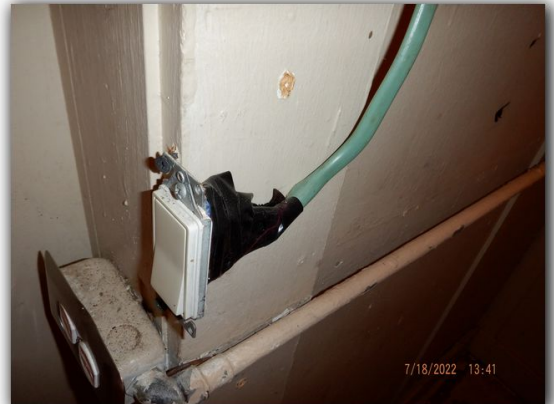
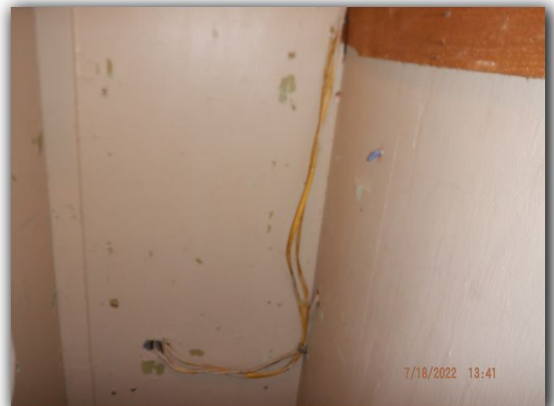
Wiring exposed on interior finishes should be relocated or protected by a rigid conduit. The installation of the distribution wiring is non-standard. It is suspected that installation was performed by an amateur, rather than a licensed electrician. This condition should be further evaluated by a licensed electrician and all repairs made as necessary.

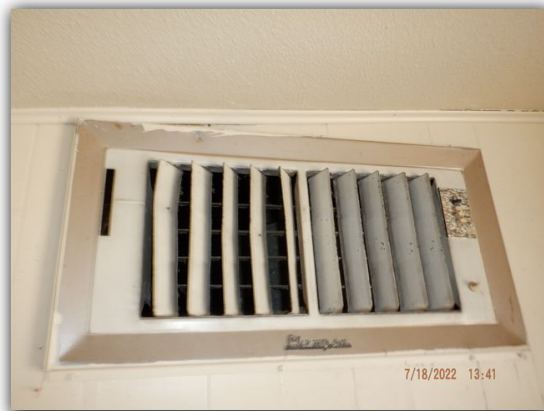
The air vent at the east interior wall did not function at the time of inspection and in need of repair. This condition should be further evaluated by a licensed a/c technician and all repairs made as necessary.

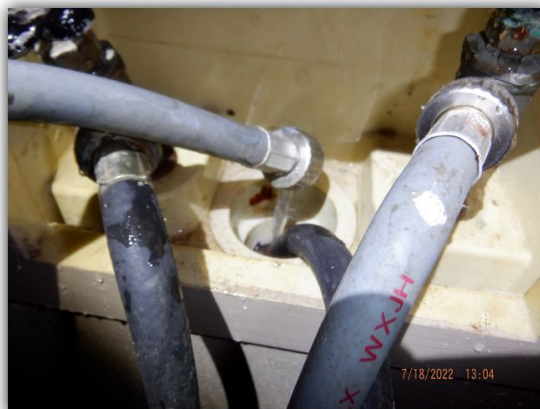
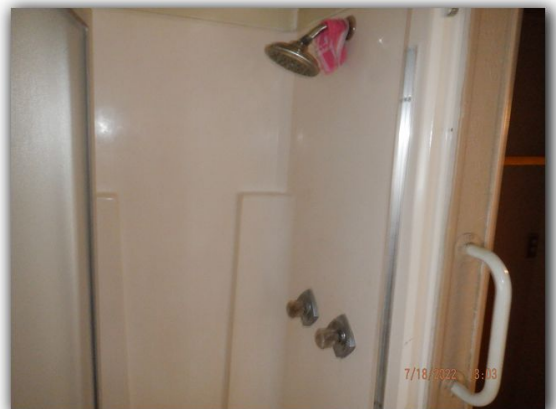
The laundry hose bibs and shower stall faucets were inoperative and should be repaired. This conditions should be further evaluated by a licensed plumber and all repairs made as necessary.

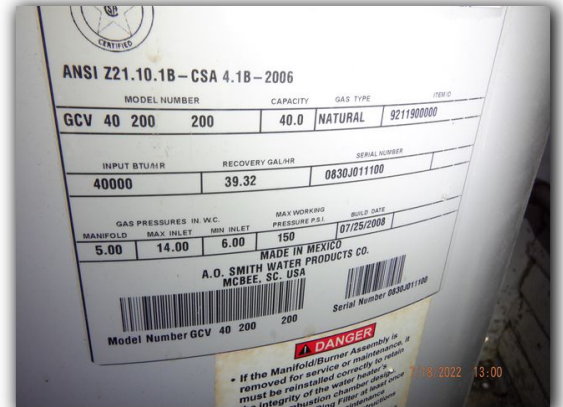
Mfg Date: 2008; The water heater is an older unit that may be approaching the end of its useful life. It would be wise to budget for a new unit. One cannot predict with certainty when replacement will become necessary.

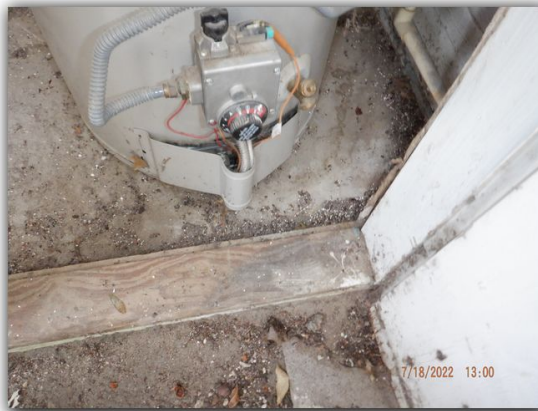
No safety pan and drainpipe was found for the water heater. It is recommended that the installation of a pan with a drain pipe to the exterior of the house be installed by a qualified professional. A moisture meter can also be used under the unit to detect for leaks.

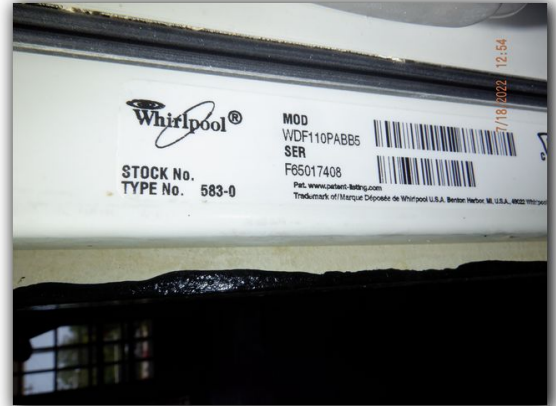
The dishwasher is inoperative and should be repaired or replaced. Could not test due to no sink.

The heat and noise reduction insulation body wrap appears to be missing on the exterior/backside of the unit and should be placed as per manufacture.
