Dam Safety Inspection Report

Fischer Park No 1 Dam

TX07410

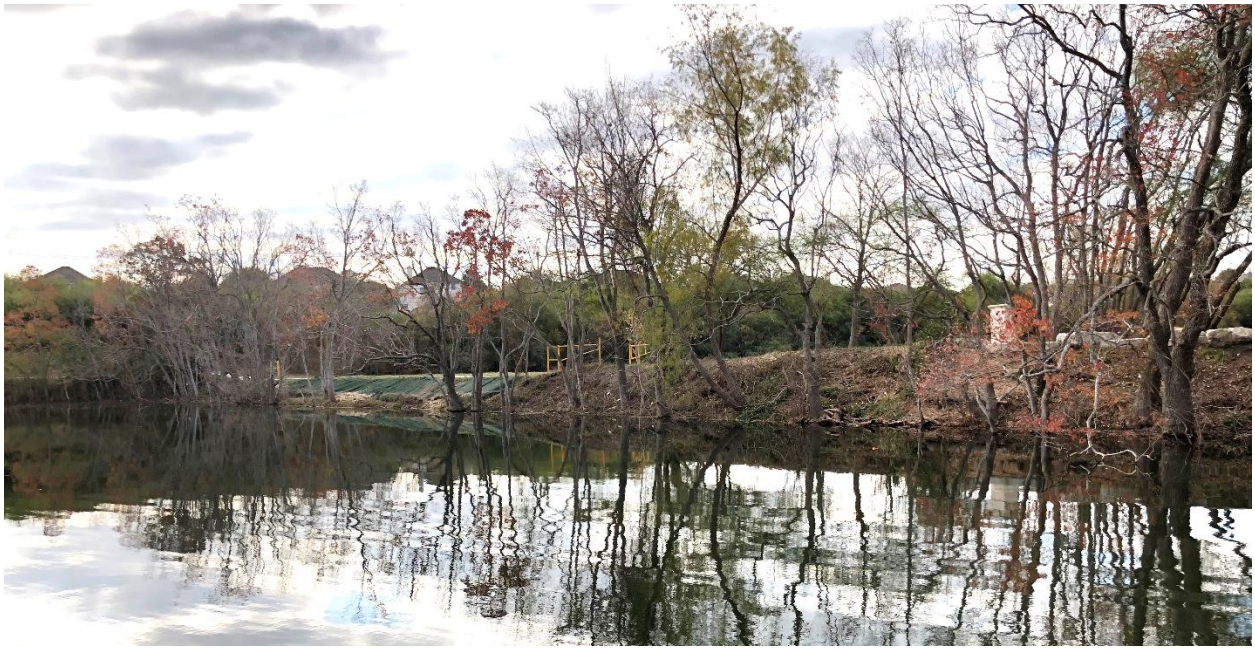
Photo 1: Embankment Overview (Looking Upstream)

The earthen embankment has an overall length of approximately 350 feet (including the spillway) with a crest width of approximately 12-15 feet. The embankment was found to be in fair condition. Photos 1 through 4 show the crest and slopes of the embankment. The following observations were noted:

- City of New Braunfels staff had cleared the majority of the woody overgrowth and small trees (below 4" in diameter), vines, and brush. Many trees remain along the slopes of the embankment, including below the spillway.
- The concrete sidewalk along the crest was in good condition.

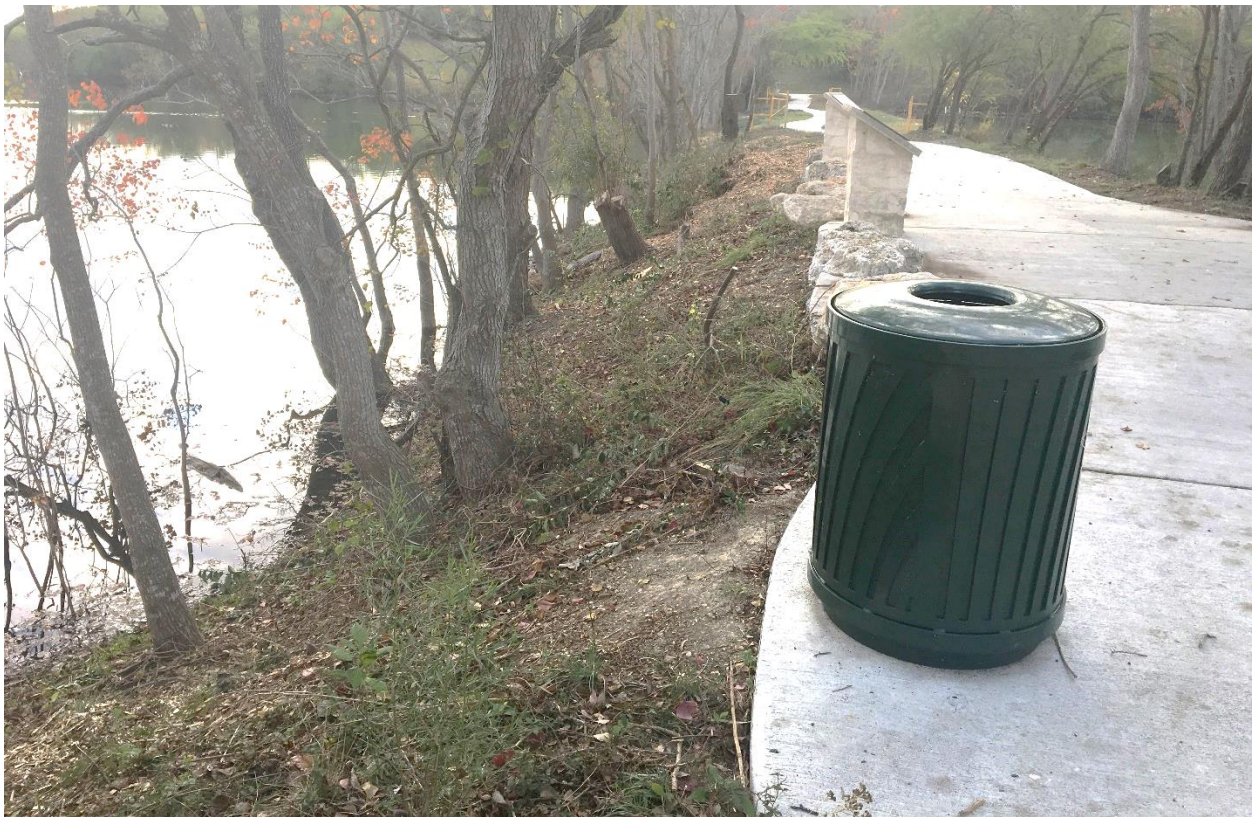
Photo 2: Downstream Slope

- Some areas along the slopes and crest of the embankment lacked a good cover of grass.
- Isolated areas of minor erosion rills were noted on the downstream slope.

Downstream Face General Condition: ☐ Good ☒ Fair ☐ Poor Slope: 1.5H:1V
Problems Noted: ☐ None ☐ Riprap ☐ Sloughing ☒ Erosion ☐ Too Steep ☐ Burrows ☒ Trees ☐ Cattails
☐ Depressions ☐ Bulges ☐ Livestock Damage ☐ Slides ☐ Concrete Decay ☐ Cracks ☐ Sinkhole
☐ Other: _____
Comments: Lack of good grass cover

4. To the extent that it is feasible, bare areas along the embankment should be seeded with grass. It is unlikely that establishment of high-quality grass cover will be possible on the shady slopes and crest of the embankment. Regular monitoring of the embankment will be required to identify and repair erosion before it becomes significant.

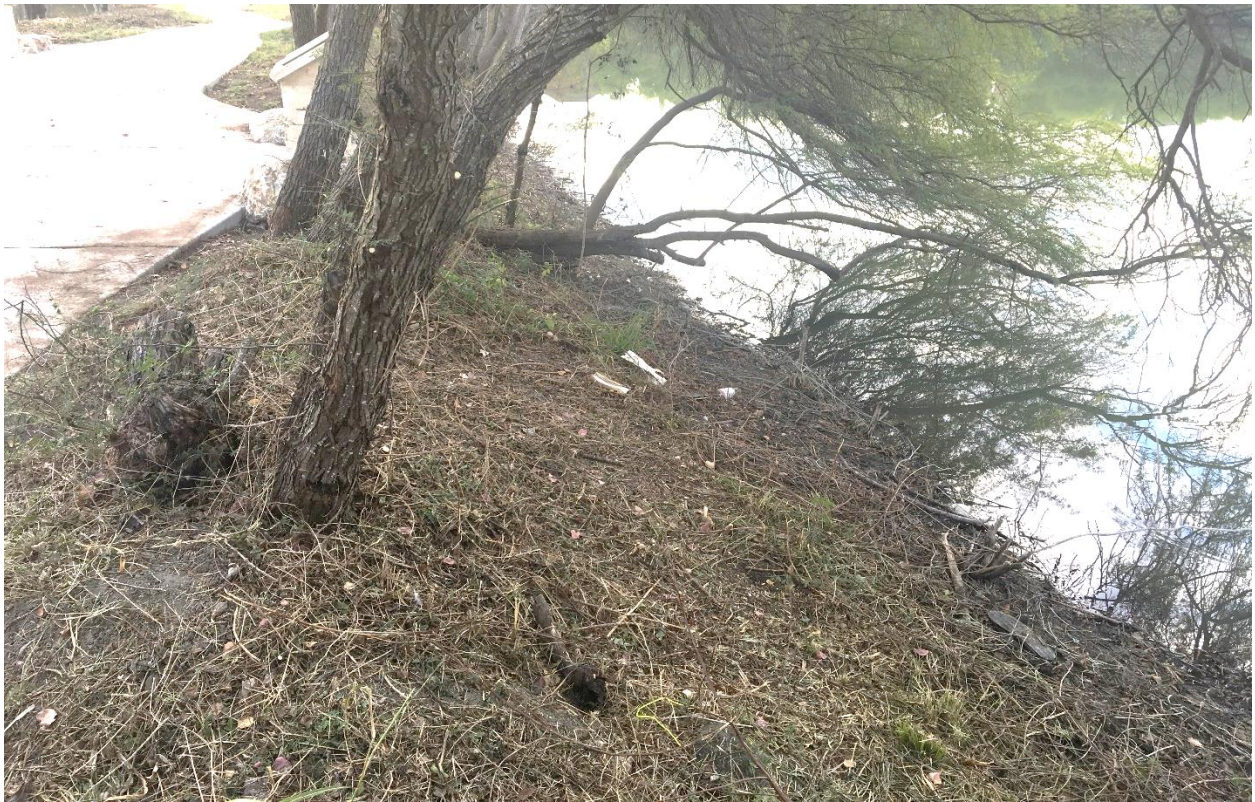
Photo 3: Upstream Slope

Upstream Face General Condition: ☐ Good ☒ Fair ☐ Poor Slope: 2H:1V
Problems Noted: ☐ None ☐ Rip-Rap ☐ Erosion ☐ Too Steep ☐ Burrows ☒ Trees ☐ Cattails
☐ Depressions ☐ Bulges ☐ Livestock Damage ☐ Slides ☐ Concrete Decay ☐ Cracks ☐ Sinkhole
☐ Benching ☐ Misalignment of Rip-rap ☐ Open Joints in Concrete ☐ Other: _____
Comments: Lack of good grass cover

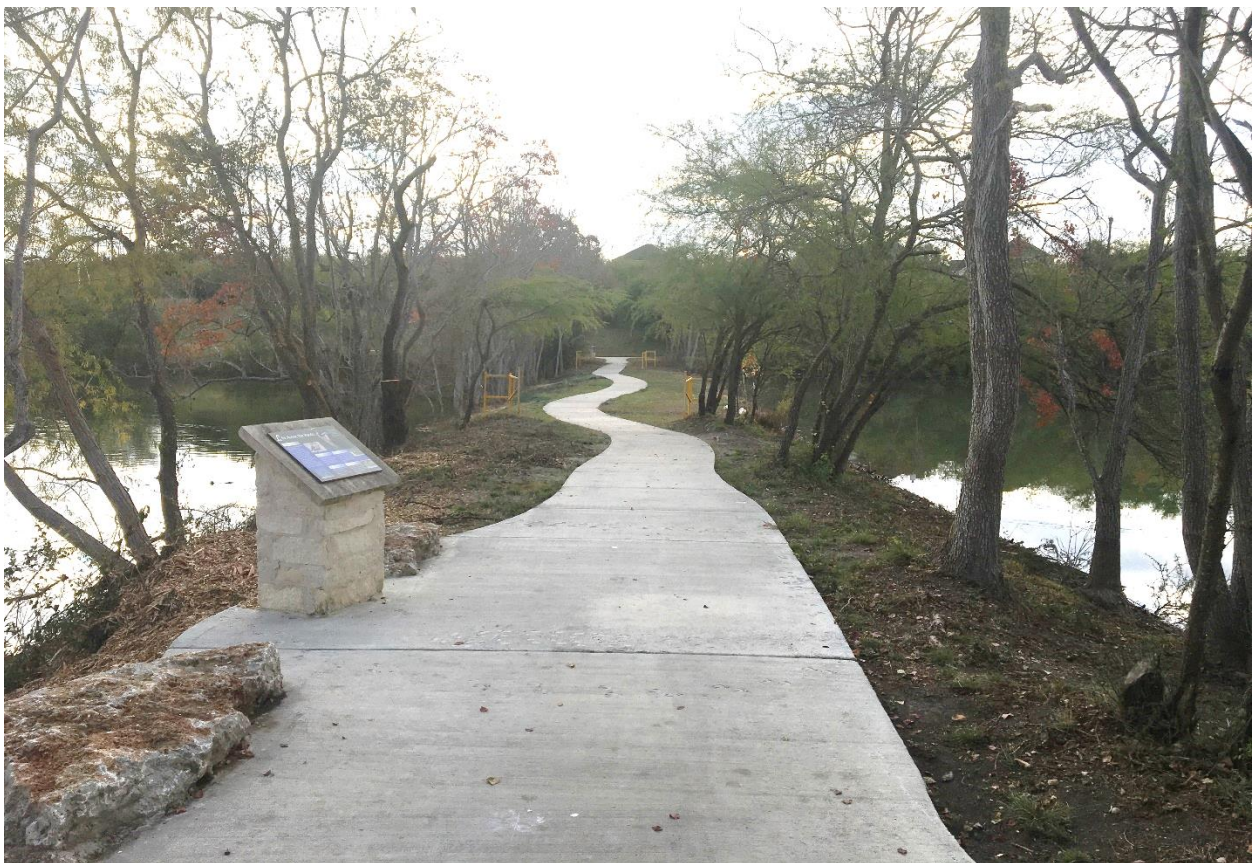
Photo 4: Embankment Crest

Crest of Dam General Condition: ☐ Good ☒ Fair ☐ Poor Width: 12-15 feet
Problems Noted: ☐ None ☐ Rutting ☒ Erosion ☐ Poor Drainage Height: 29 feet
☒ Trees ☐ Depressions ☐ Bulges ☐ Livestock Damage ☐ Cracks Length: 350 feet
☐ Misalignment of Crest ☐ Misalignment of Utility Poles ☐ Misalignment of Fences or Rails ☐ Sinkhole
☐ Burrows ☐ Breached ☐ Other: _____
Comments: Lack of grass

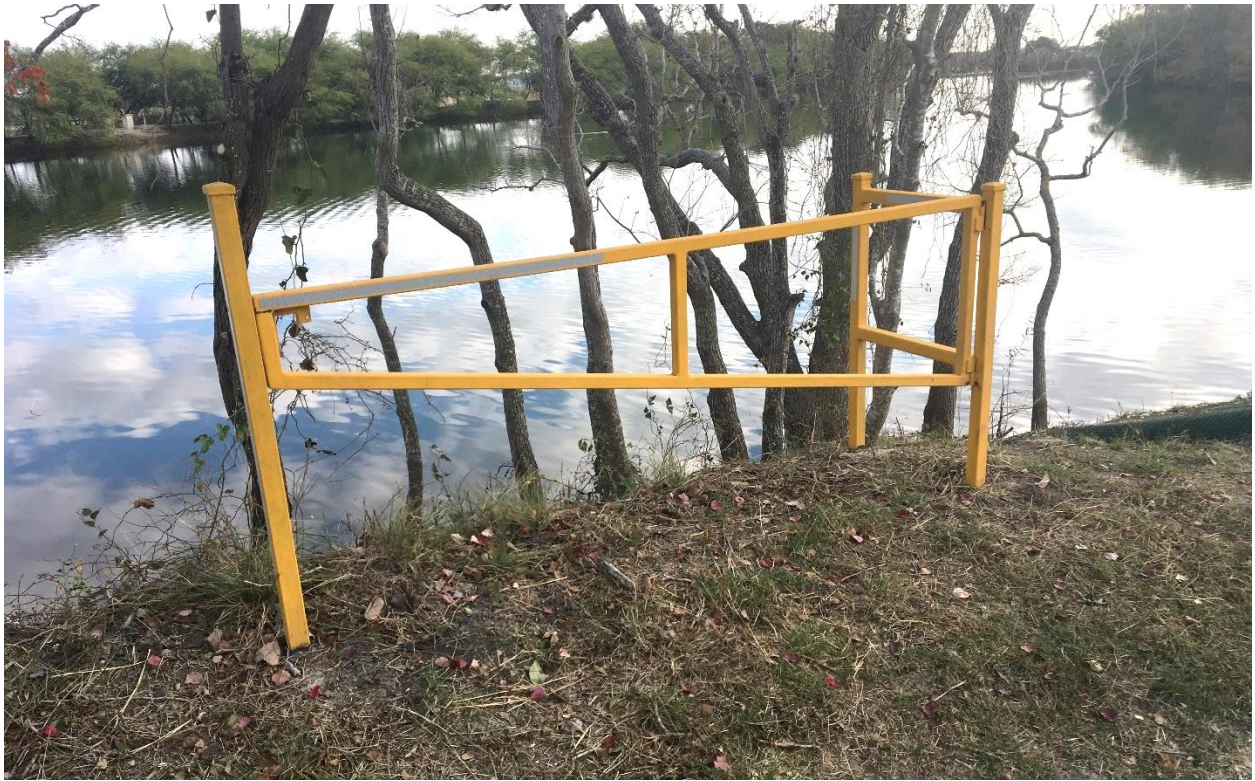
- Park curfew is 12 midnight to 6:00 am. The park does not have a gate or fence.
- The dam has gates on either side of the spillway that can be closed if the spillway is flowing.

Photo 5: Spillway Pedestrian Gate

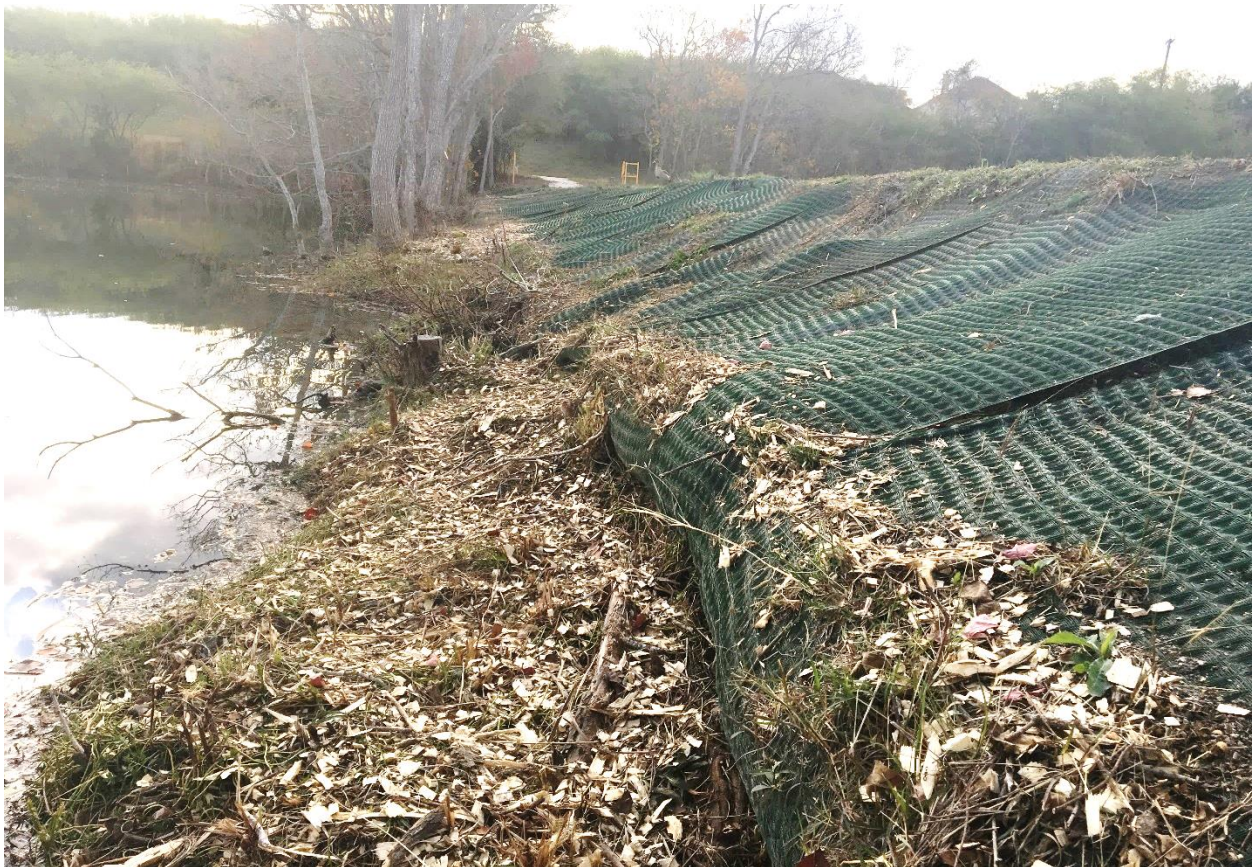
- The TRM lacked an adequate cover of grass which is necessary for proper performance of the matting. Isolated areas on the upstream portion of the spillway had adequate cover.
- The TRM did not have intimate contact with the soil along nearly the entire downstream portion of the spillway. Intimate contact is necessary for proper performance of TRM. Erosion below the TRM was evident along the entirety of the downstream slope of the spillway.
- The area immediately downstream of the TRM anchor trench was eroded, creating a benched area.
- Regular flow over the sidewalk has resulted in growth of algae which can present a safety hazard to pedestrians. The spillway was not overflowing at the time of the inspection.

Photo 6: Erosion at Downstream Toe of Spillway

Spillway Condition: ☐ Good ☐ Fair ☒ Poor Depth: ~2 feet Width: 150 feet
Problems Noted: ☐ None ☐ Blockage ☐ Not Located ☒ Trees ☐ Burrows ☒ Back-Cutting Erosion
☐ Inaccessible ☐ Livestock Damage ☐ Concrete Cracking ☐ Concrete Spalling
☐ Reinforcement ☐ Corrosion ☐ Damaged Water-stops ☐ Open Joints ☐ Sinkholes
☐ Holes in Spillway Chute ☐ Seepage ☐ Misalignment of Walls/Slabs ☐ Damaged Gates
☐ Nonfunctional Gates ☐ Lubrication of Gates ☐ Testing of Gates
Comments: Failure of TRM erosion protection.

5. The TRM spillway has failed and requires modifications or repairs:
 - a. TRM over an earthen embankment is not appropriate for the service spillway to maintain the normal level in the pond because regular flows prevent establishment of grass cover over the matting. Flows over the spillway, shade, and loss of intimate contact with the subgrade have limited the effectiveness of the TRM to prevent erosion of the embankment.

- c. FNI recommends that the spillway be repaired or modified to address these issues for improved long-term performance. At a minimum, repairs should include measures to pass normal flows below the sidewalk, additional erosion protection downstream of the spillway, and repair/replacement of the failed TRM.

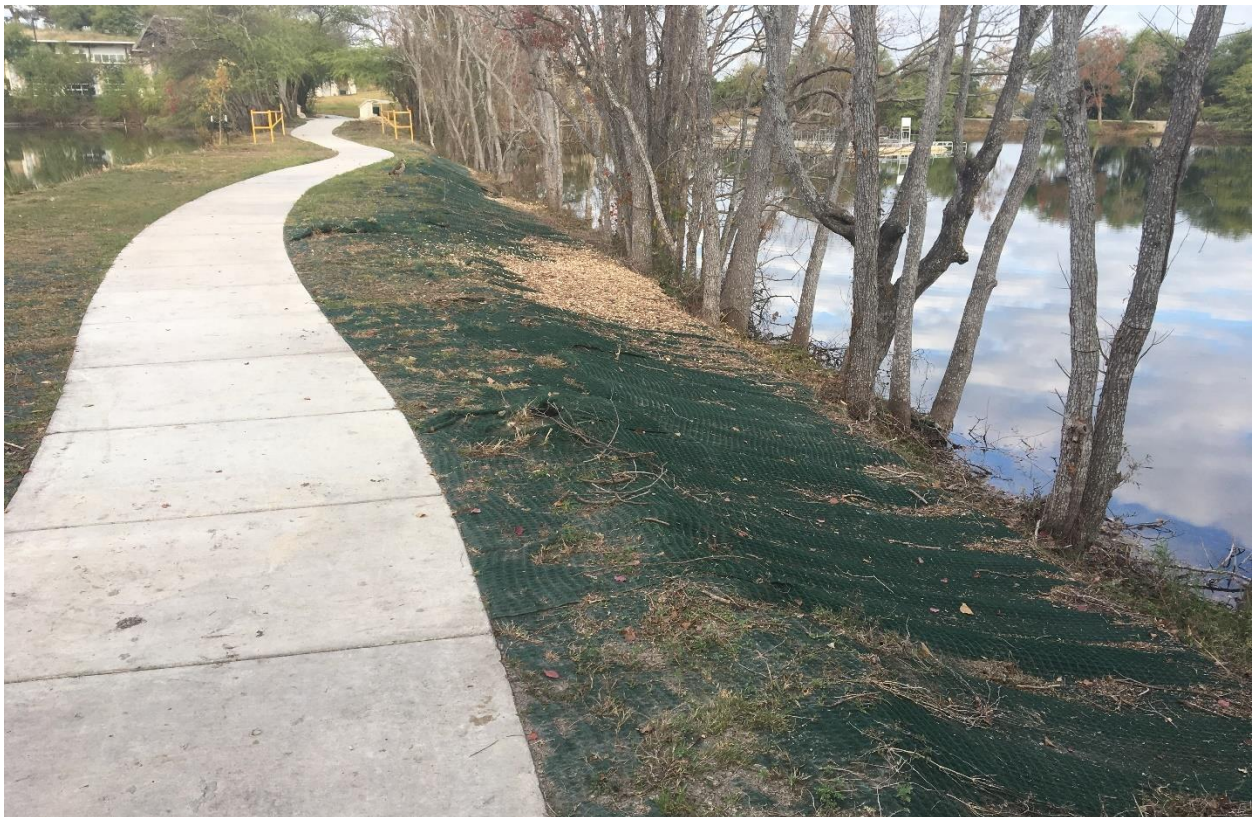
Photo 8: Spillway Crest and Downstream Slope

- b. This configuration also presents a safety hazard because the water regularly passing over the sidewalk results in growth of algae which can be slippery to pedestrians.
