January 15, 2021

RE: Limited Asbestos Survey Report
Monica Jergins
456 Magazine Avenue
New Braunfels, Texas 78130

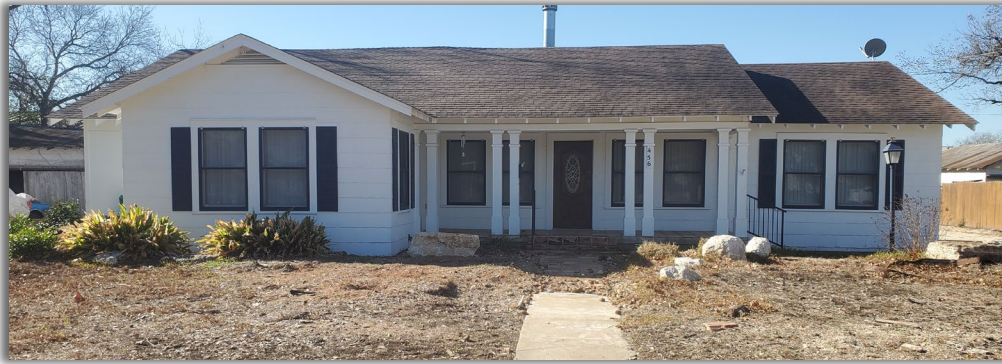
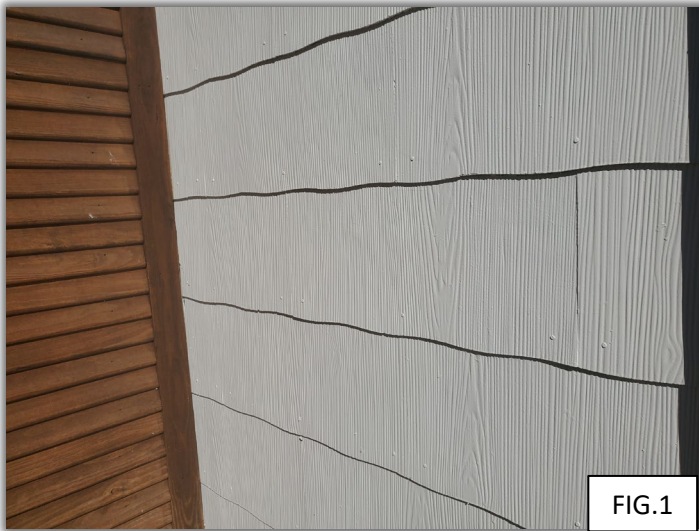
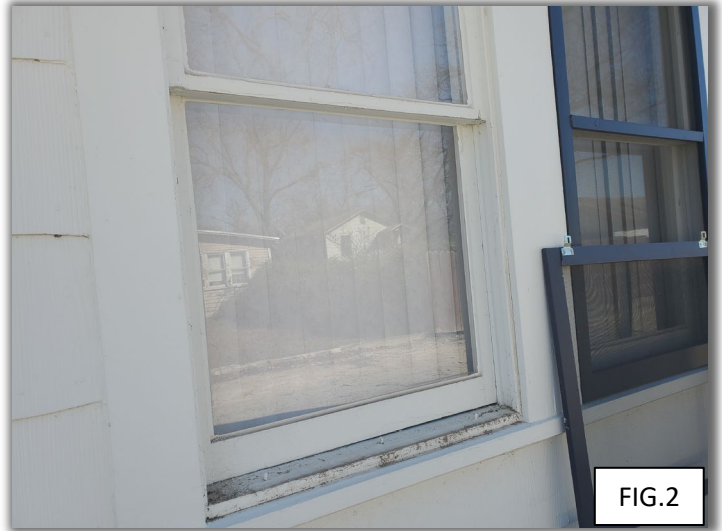
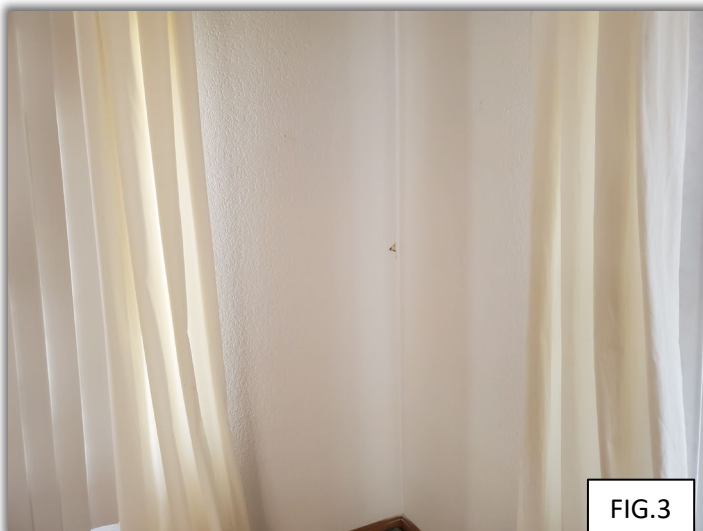
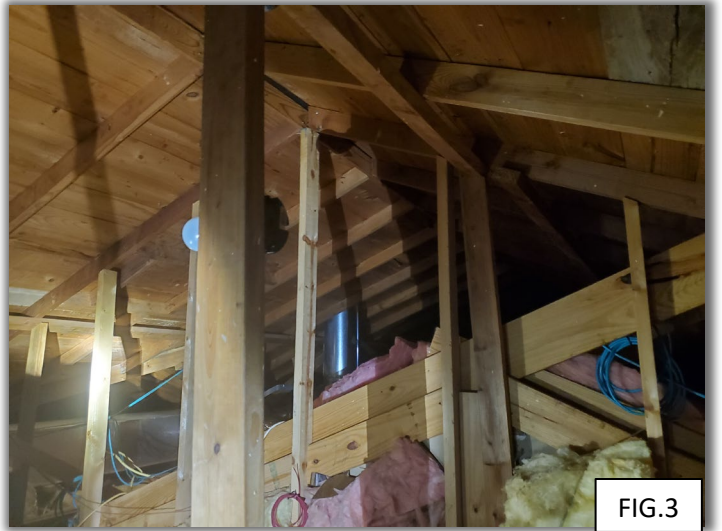
The home at 456 Magazine Avenue is located in Comal County, was built in 1948, and is approximately 2000 square feet. The exterior siding of the house is asbestos containing transite (Fig.1), except the eastside and a south portion of the home that has fiber cement boards and natural wood planks, respectively. The wooden windows have tested positive for lead based paint and have white glazing around the glass (Fig.2). The interior space has wooden floors, and the walls are comprised of texture, joint compound, fasteners, and drywall (Fig.3). The attic space insulated with yellow and pink fiberglass insulation (Fig.4), and the HVAC system does not have mastic on the seams. The vent pipes are made of polyvinyl chloride (PVC) and the chimney pipe is stainless steel.

Sample No.	Location	Material	Results
456-TR-01	West Exterior Wall	Transite Siding	40% Chrysotile
456-WG-02	South Exterior Window	Window Glazing	NAD
456-WG-01	West Exterior Window	Window Glazing	NAD
456-SR-04	West Interior Wall	Texture/Joint Compound/Drywall	NAD
NAD – No Asbestos Detected			
Laboratory analytical report is in Appendix B

1. All the following building materials have been laboratory analyzed to be asbestos containing and should be removed if the materials are to be disturbed during renovation/demolition (pictures in Appendix A):
 - Approximately 1300 ft² of asbestos-containing transite siding (Fig.1)
2. The asbestos containing material listed above should be removed by a Texas Licensed Asbestos Abatement Contractor under the supervision of a Texas Asbestos Consultant prior to renovation or demolition. Residences, however, are not subjected to state regulations, however, federal regulations, like OSHA, still apply.
