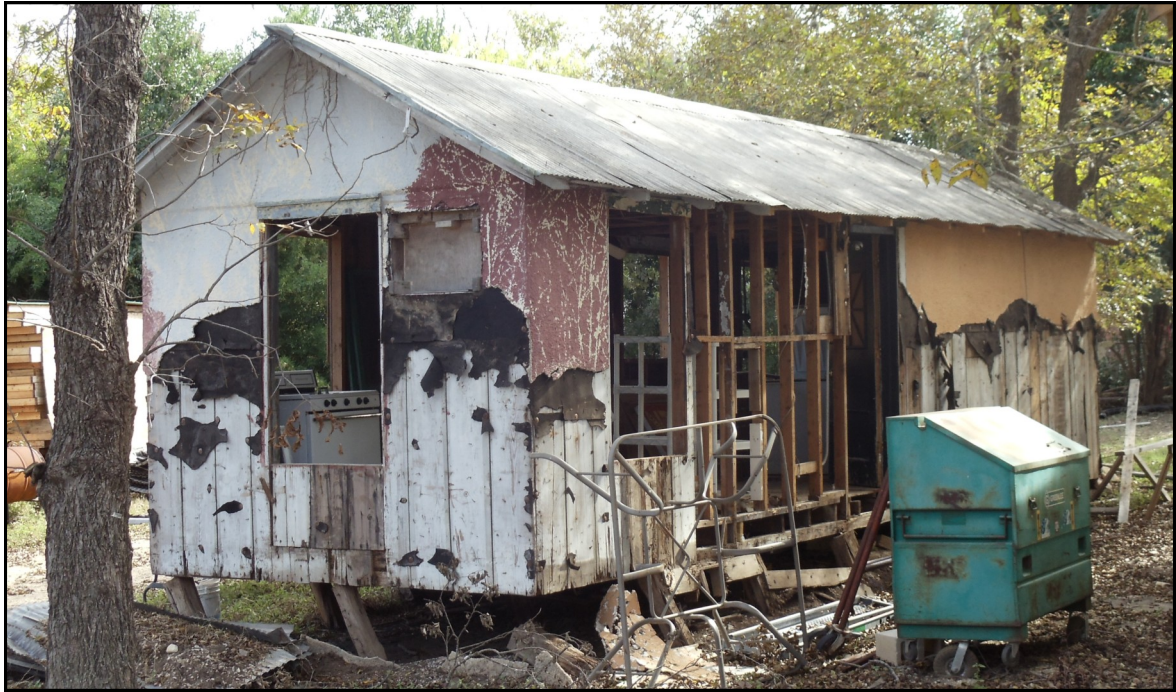
Sample condition of original cabin.

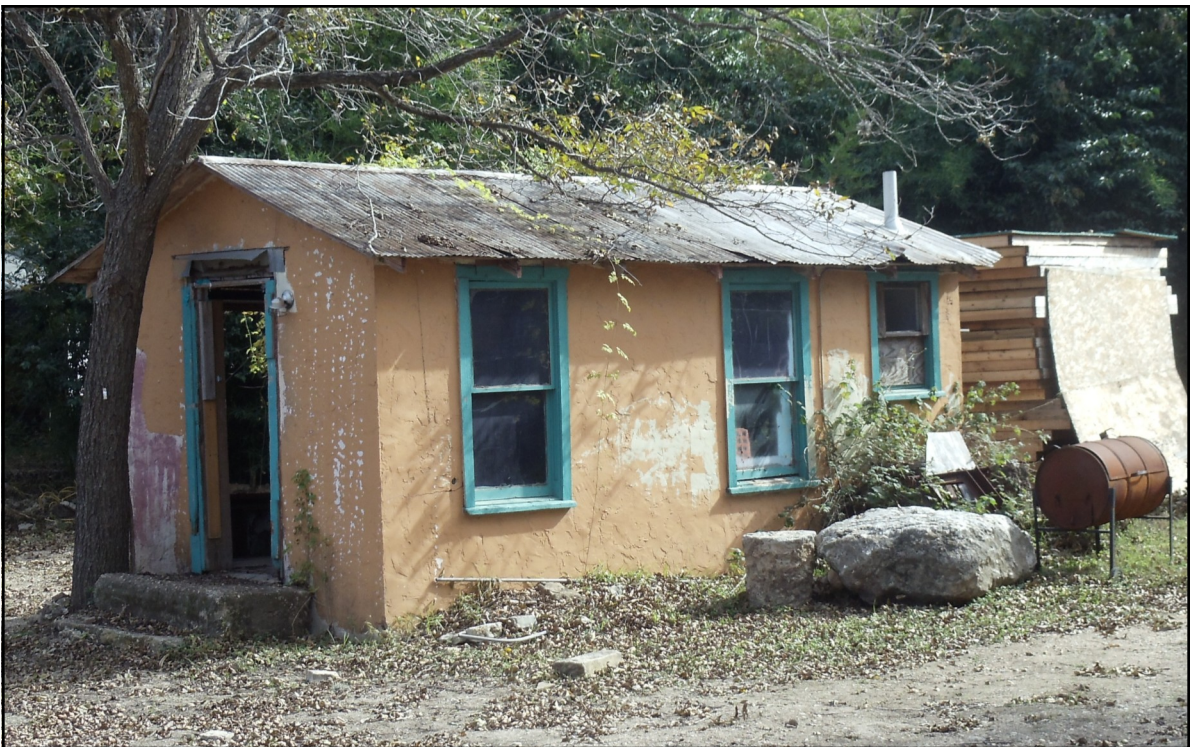
Sample condition of original cabin.
