TIRZ 3 Grant Application

Project Name Exterior wall repair and sealant

Address of Project 239 W San Antonio St

Project: New Braunfels Art League Gallery

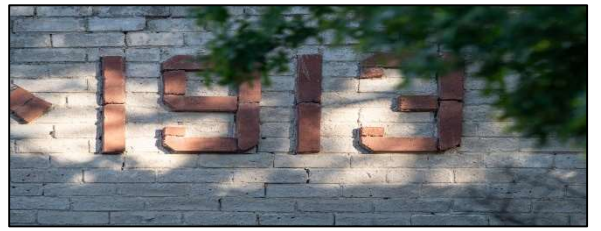
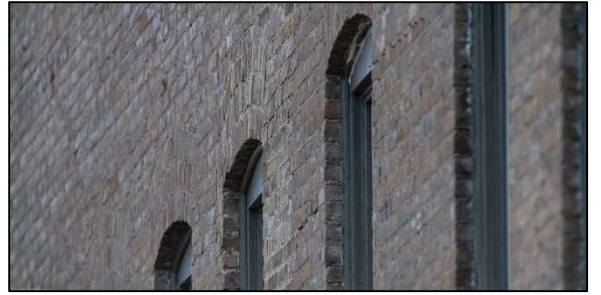
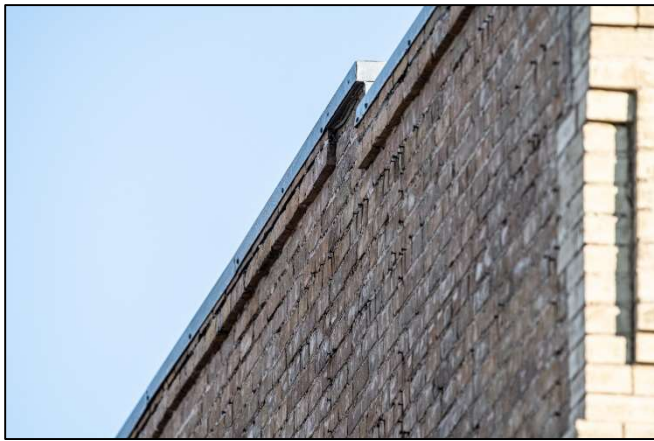
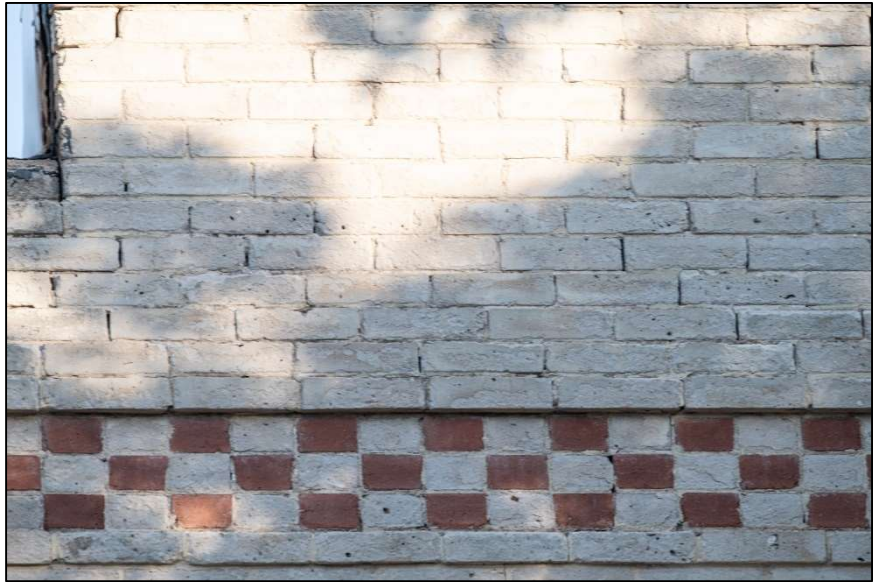
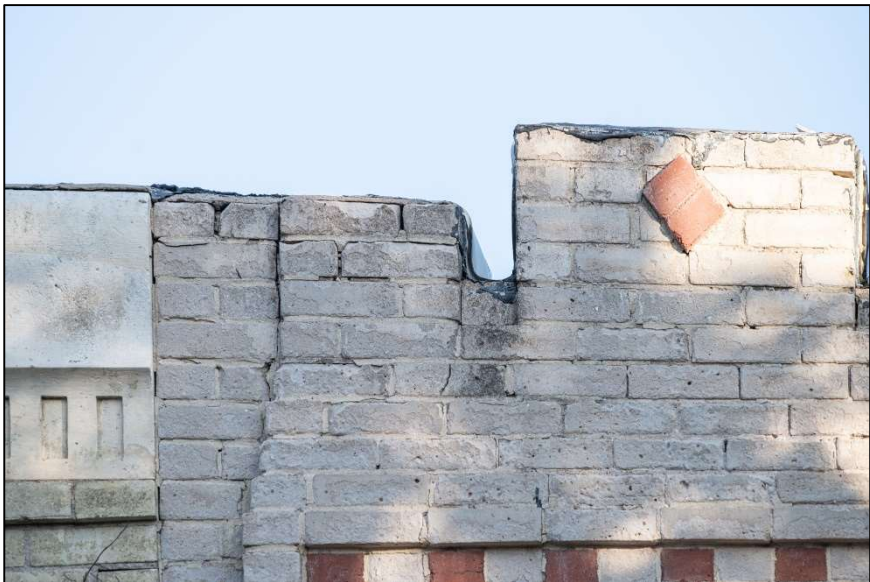
New Braunfels Art League
Existing Brick

Project Summary The front wall and side wall of the building are in need of repair. We have had difficulty with rain leaking into the building. Last year, we had the two walls chemically cleaned to remove mold/dirt so we could see the state of the brick and mortar. Now it is time to replace failed sealant and reseal the perimeter of the windows, seal penetrations in the brick, and apply a water repellent on the front wall. The side wall is scheduled for similar treatment to the perimeter of the windows. This wall also has large cracks in mortar joints over 3 windows and several large holes in the brick. This wall will also receive a water repellent.

- 1) Remove existing failed sealant at the perimeter of the 8 upper windows & the transom windows above the canopy & reseal using Tremco's Dymonic 100 Sealant or equal.
- 2) Rout the mortar at 2 soft joints to create a control joint & seal using Tremco's Dymonic 100 Sealant or equal.
- 3) Seal penetrations in brick and any gaps at top of brick ledge using Tremco's Dymonic 100 Sealant or equal.
- 4) Apply one heavy coat of BASF's H177 of Master Protect H440 VT water repellent, a clear silane water repellent at all exterior brick on the front wall.

- 1) Remove existing failed sealant at the perimeter of the 8 upper windows & reseal using Tremco's Dymonic 100 Sealant or equal.
- 2) Rout the mortar at 2 soft joints to create a control joint & seal using Tremco's Dymonic 100 Sealant or equal.
- 3) Rout large cracks in mortar joints over 3 windows (approx. 45 linear feet) and re-point using a mortar mix to closely match.
- 4) Patch several large holes/voids on brick using a cementitious mix to closely match in color.
- 5) Pull/remove existing nails in exterior brick and patch any mortar that may come off during removal.
- 6) Apply one heavy coat of BASF's H177 of Master Protect H440 VT water repellent, a clear silane water repellent at all exterior brick on the left side wall.
