**209 W San Antonio St**  
Historic Review

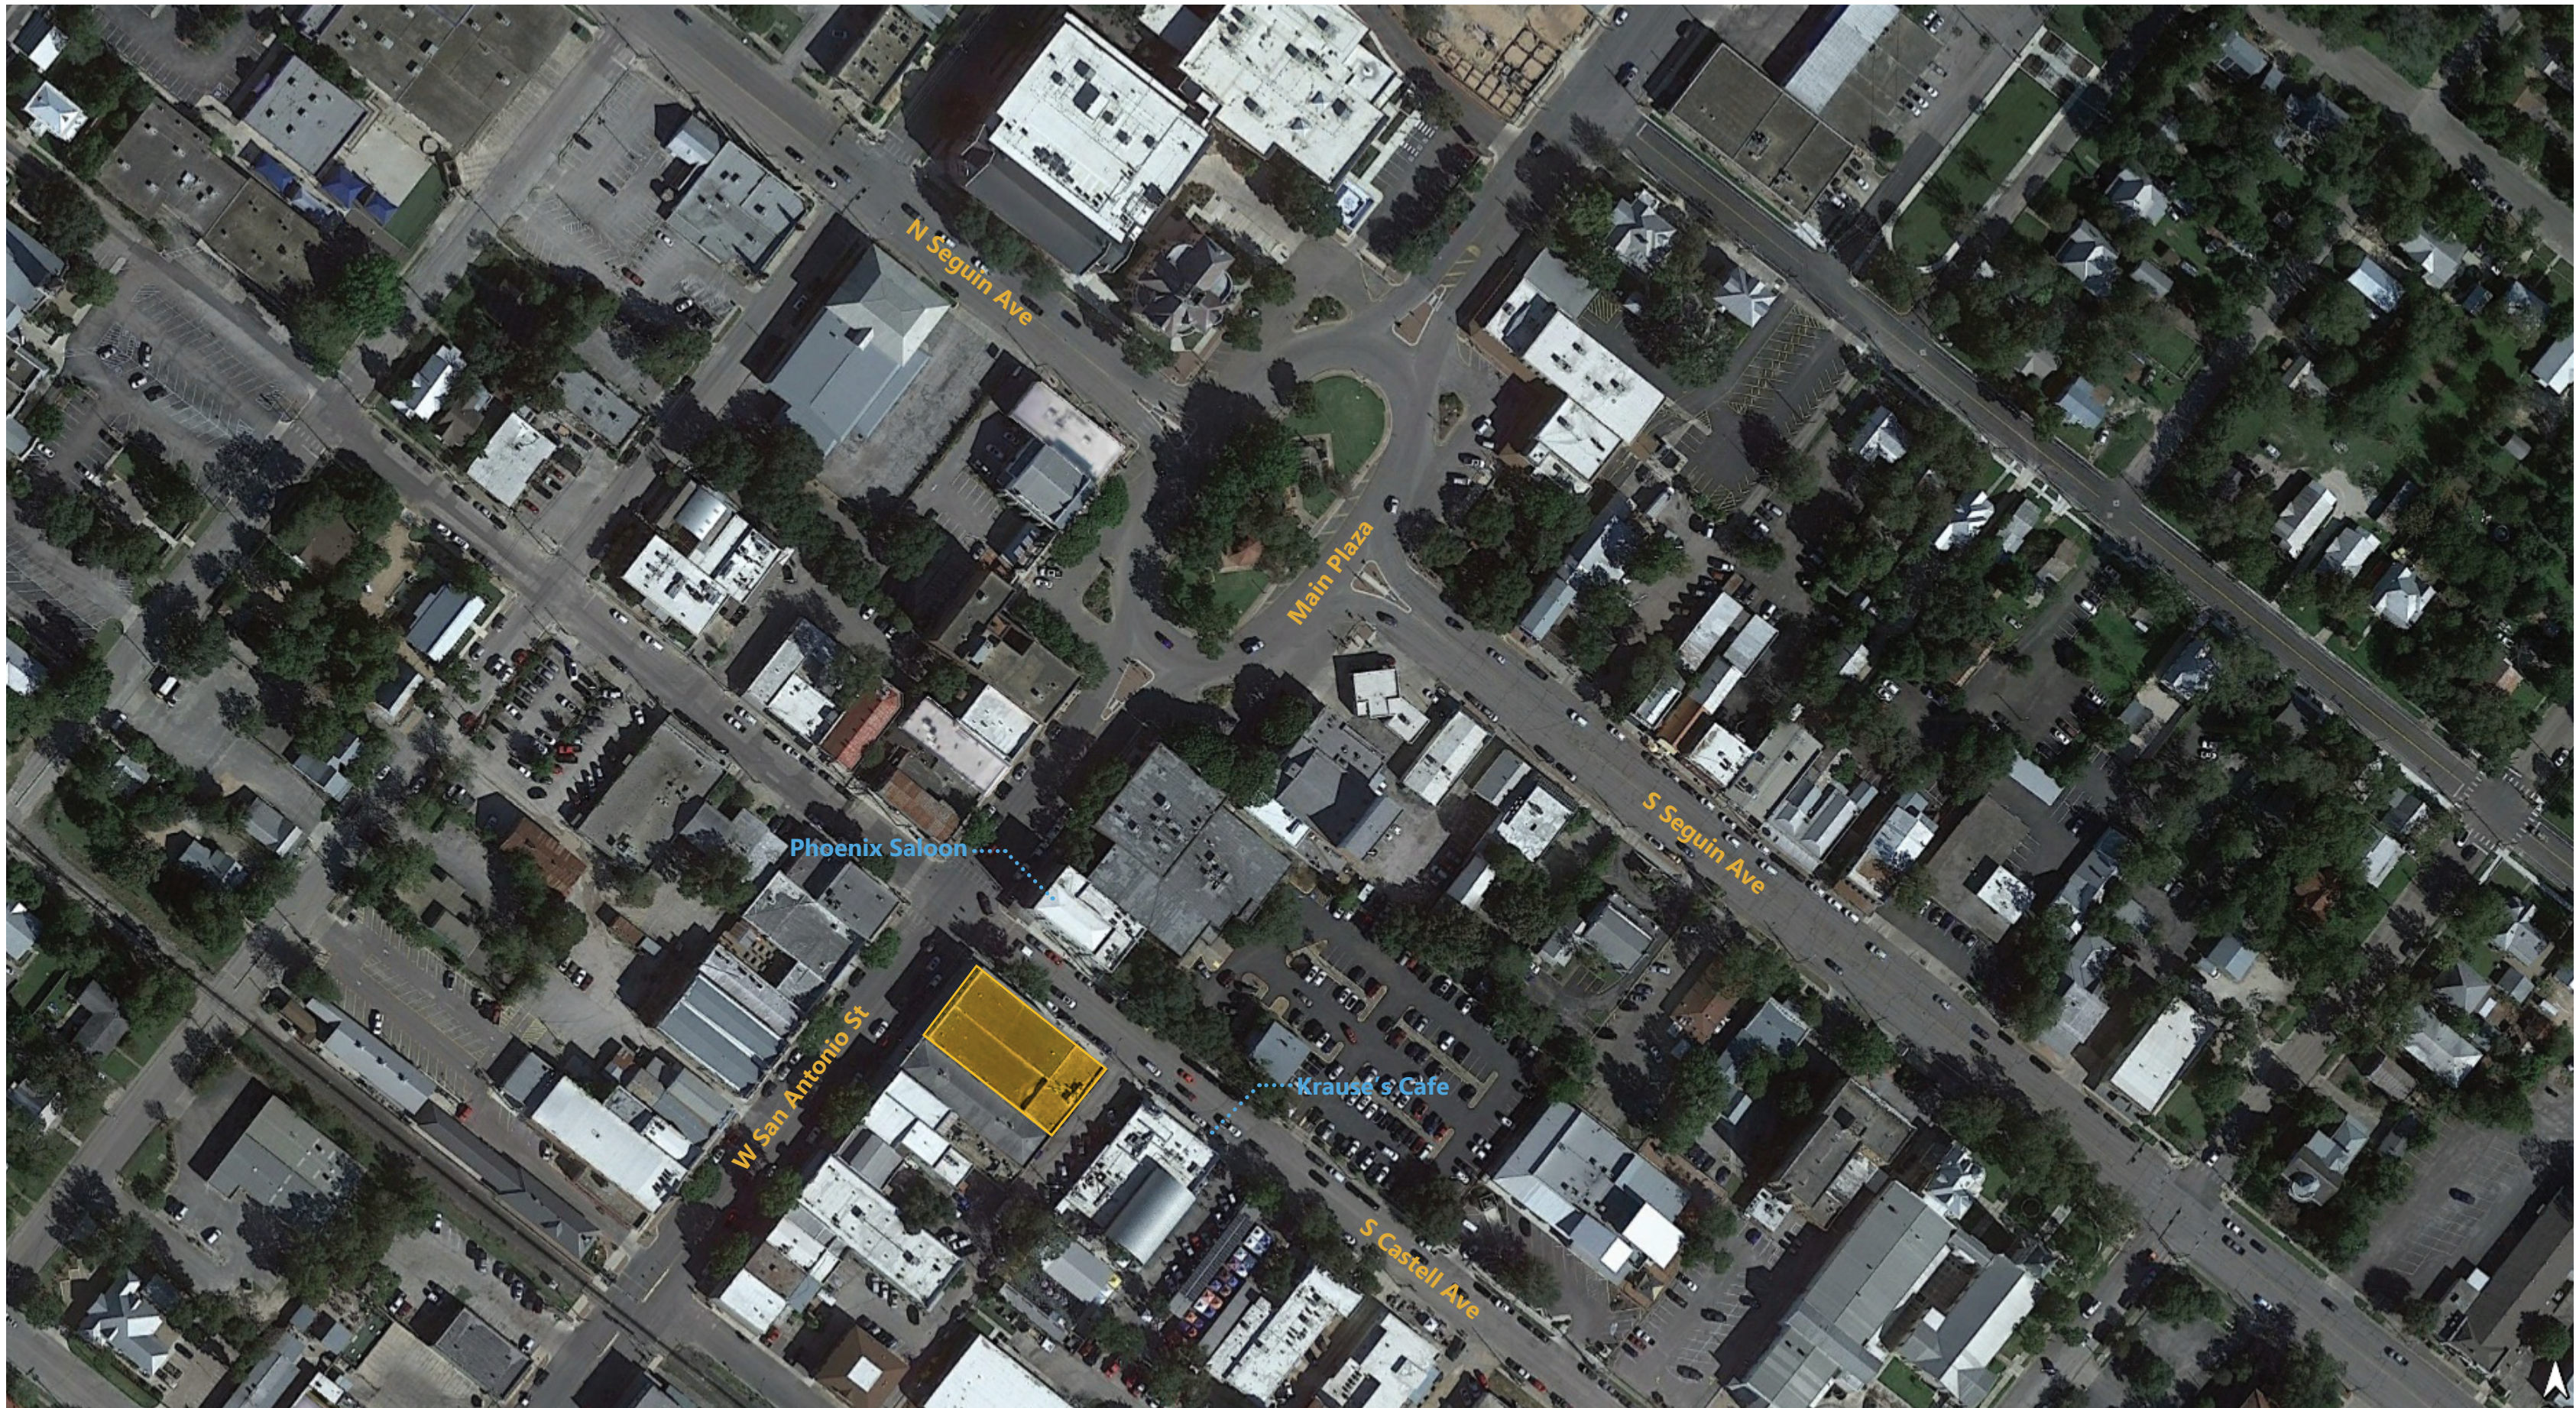
Stucco added over brick in 1940's

Existing parapet detail covered up

Multiple existing anchors (used and unused)

Mural over existing stucco in early 2000's

Transom in-filled and covered in stucco

Stucco added over brick and existing windows in 1940's

Tie-back awning condition not considered structurally sound

Existing wood windows and window displays replaced in 1940's

Expose historic cast iron columns

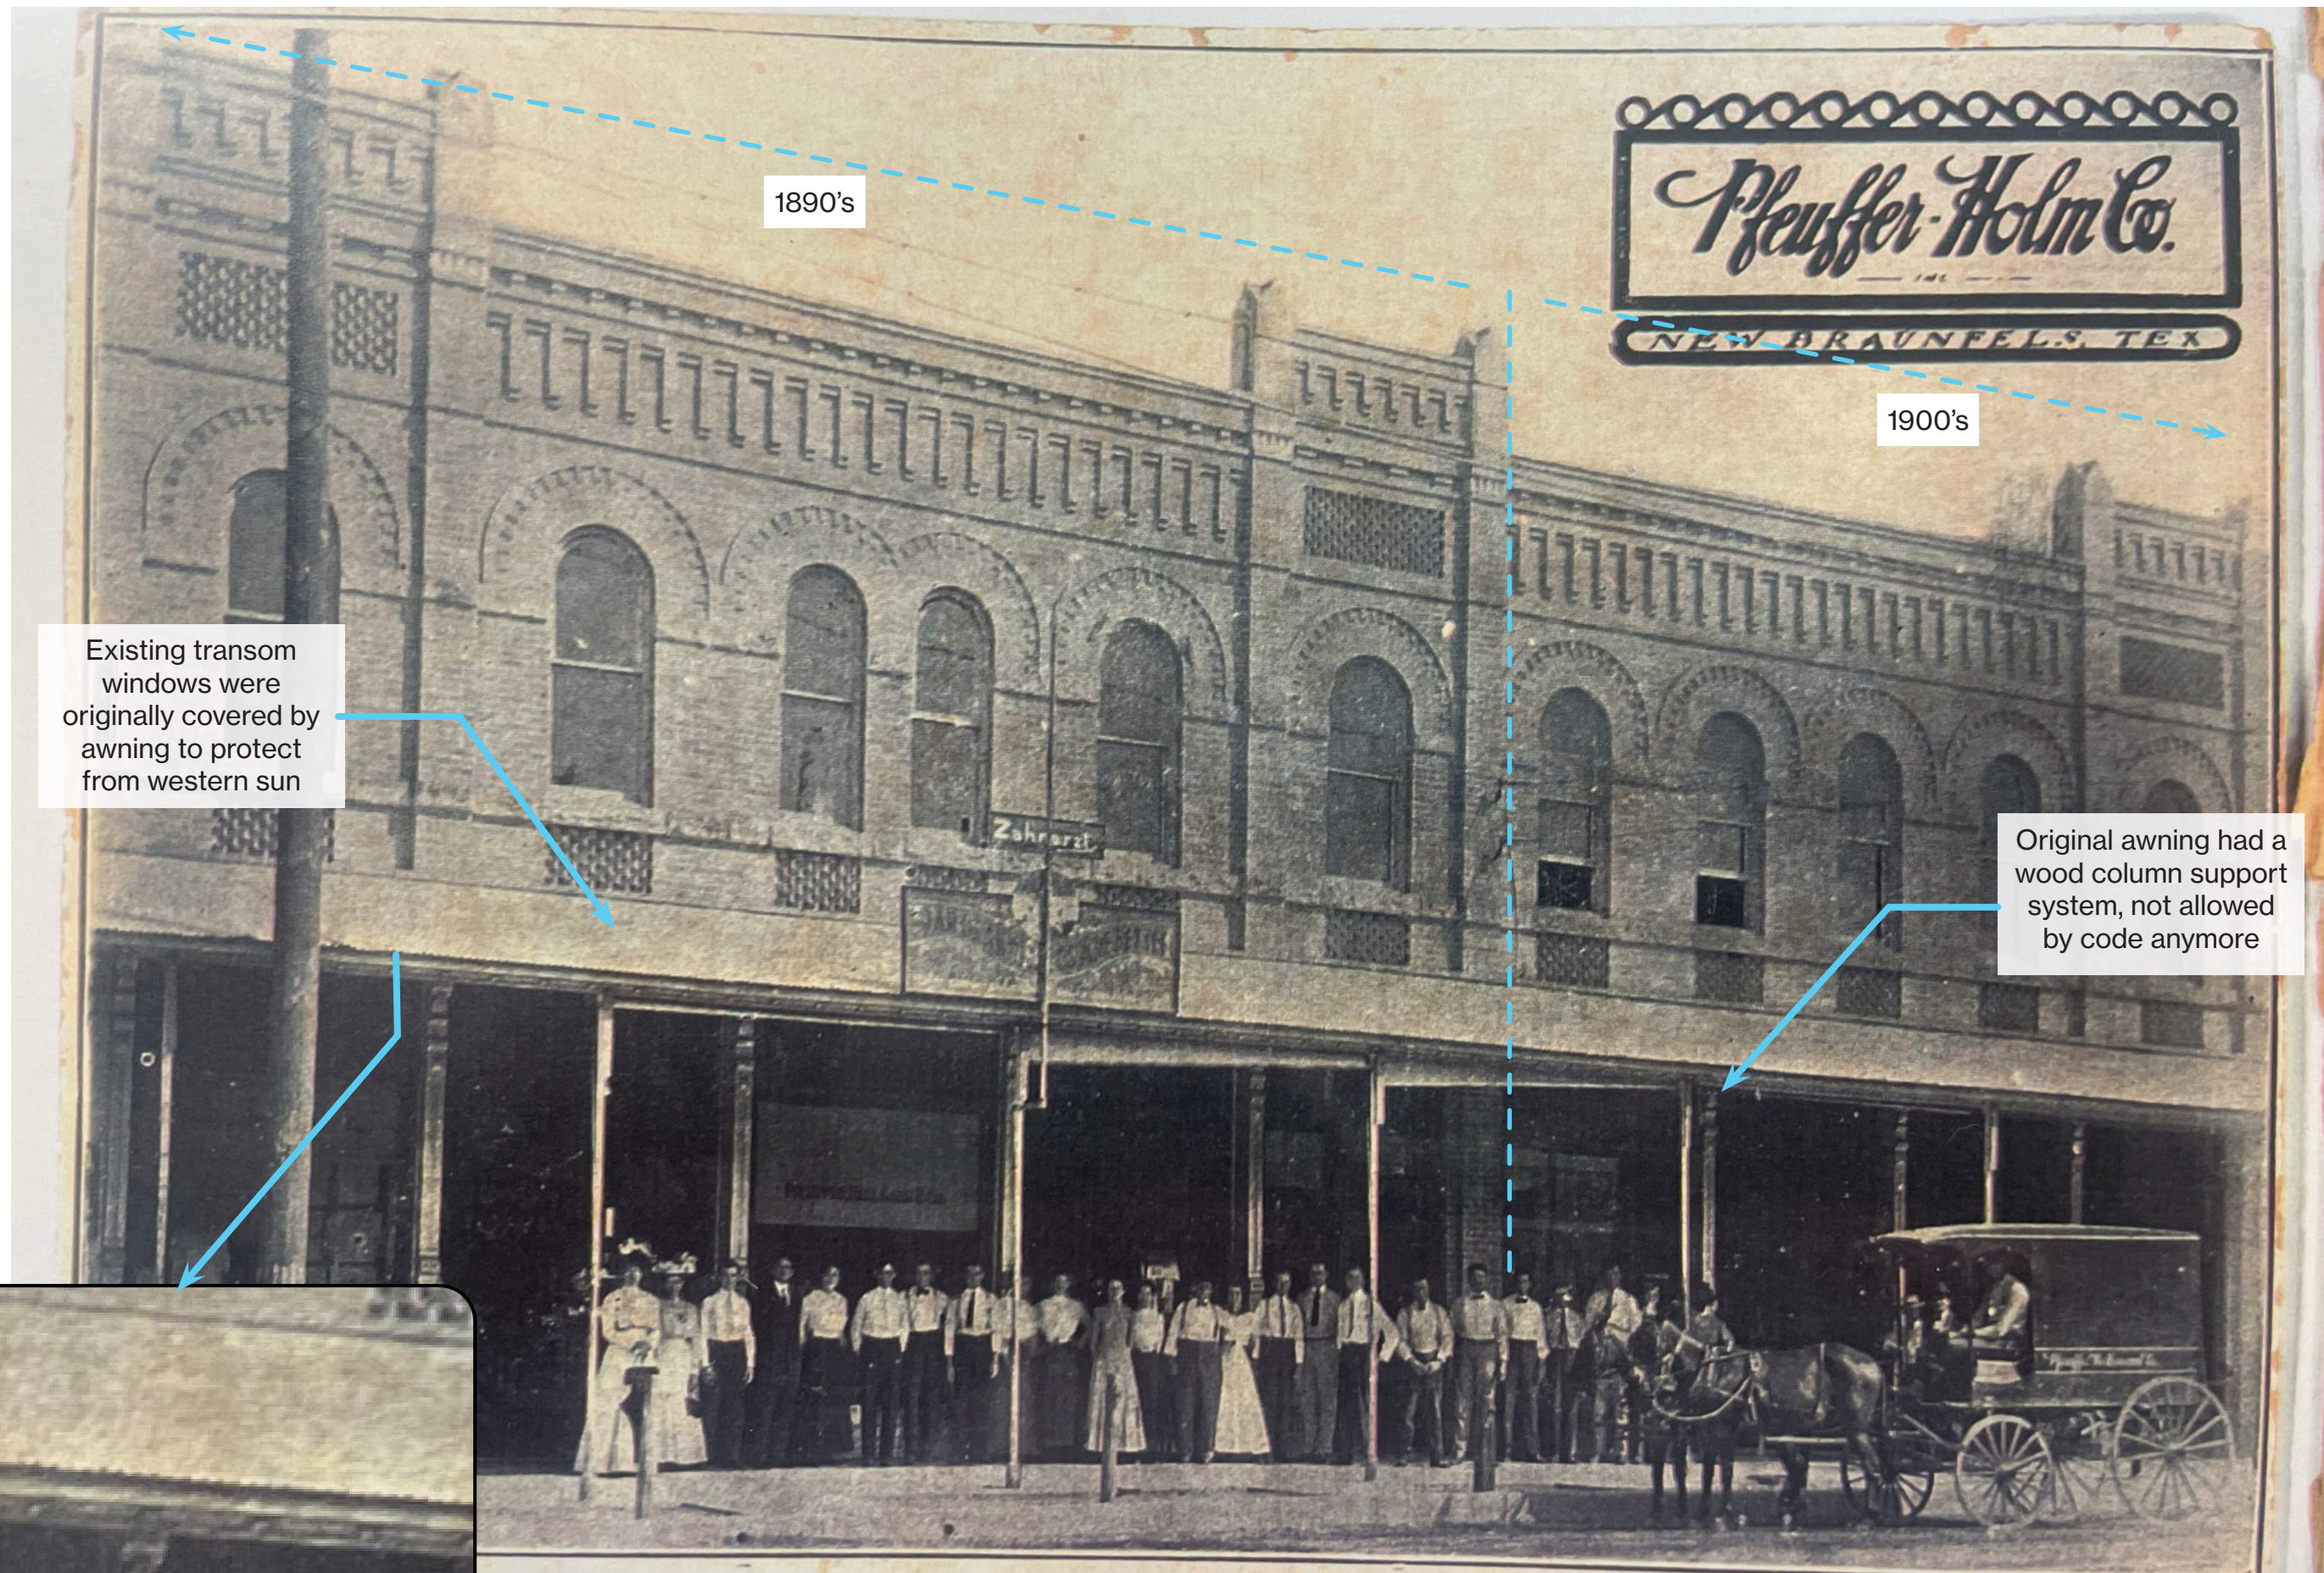
1900's

Existing transom windows were originally covered by awning to protect from western sun

Original awning had a wood column support system, not allowed by code anymore

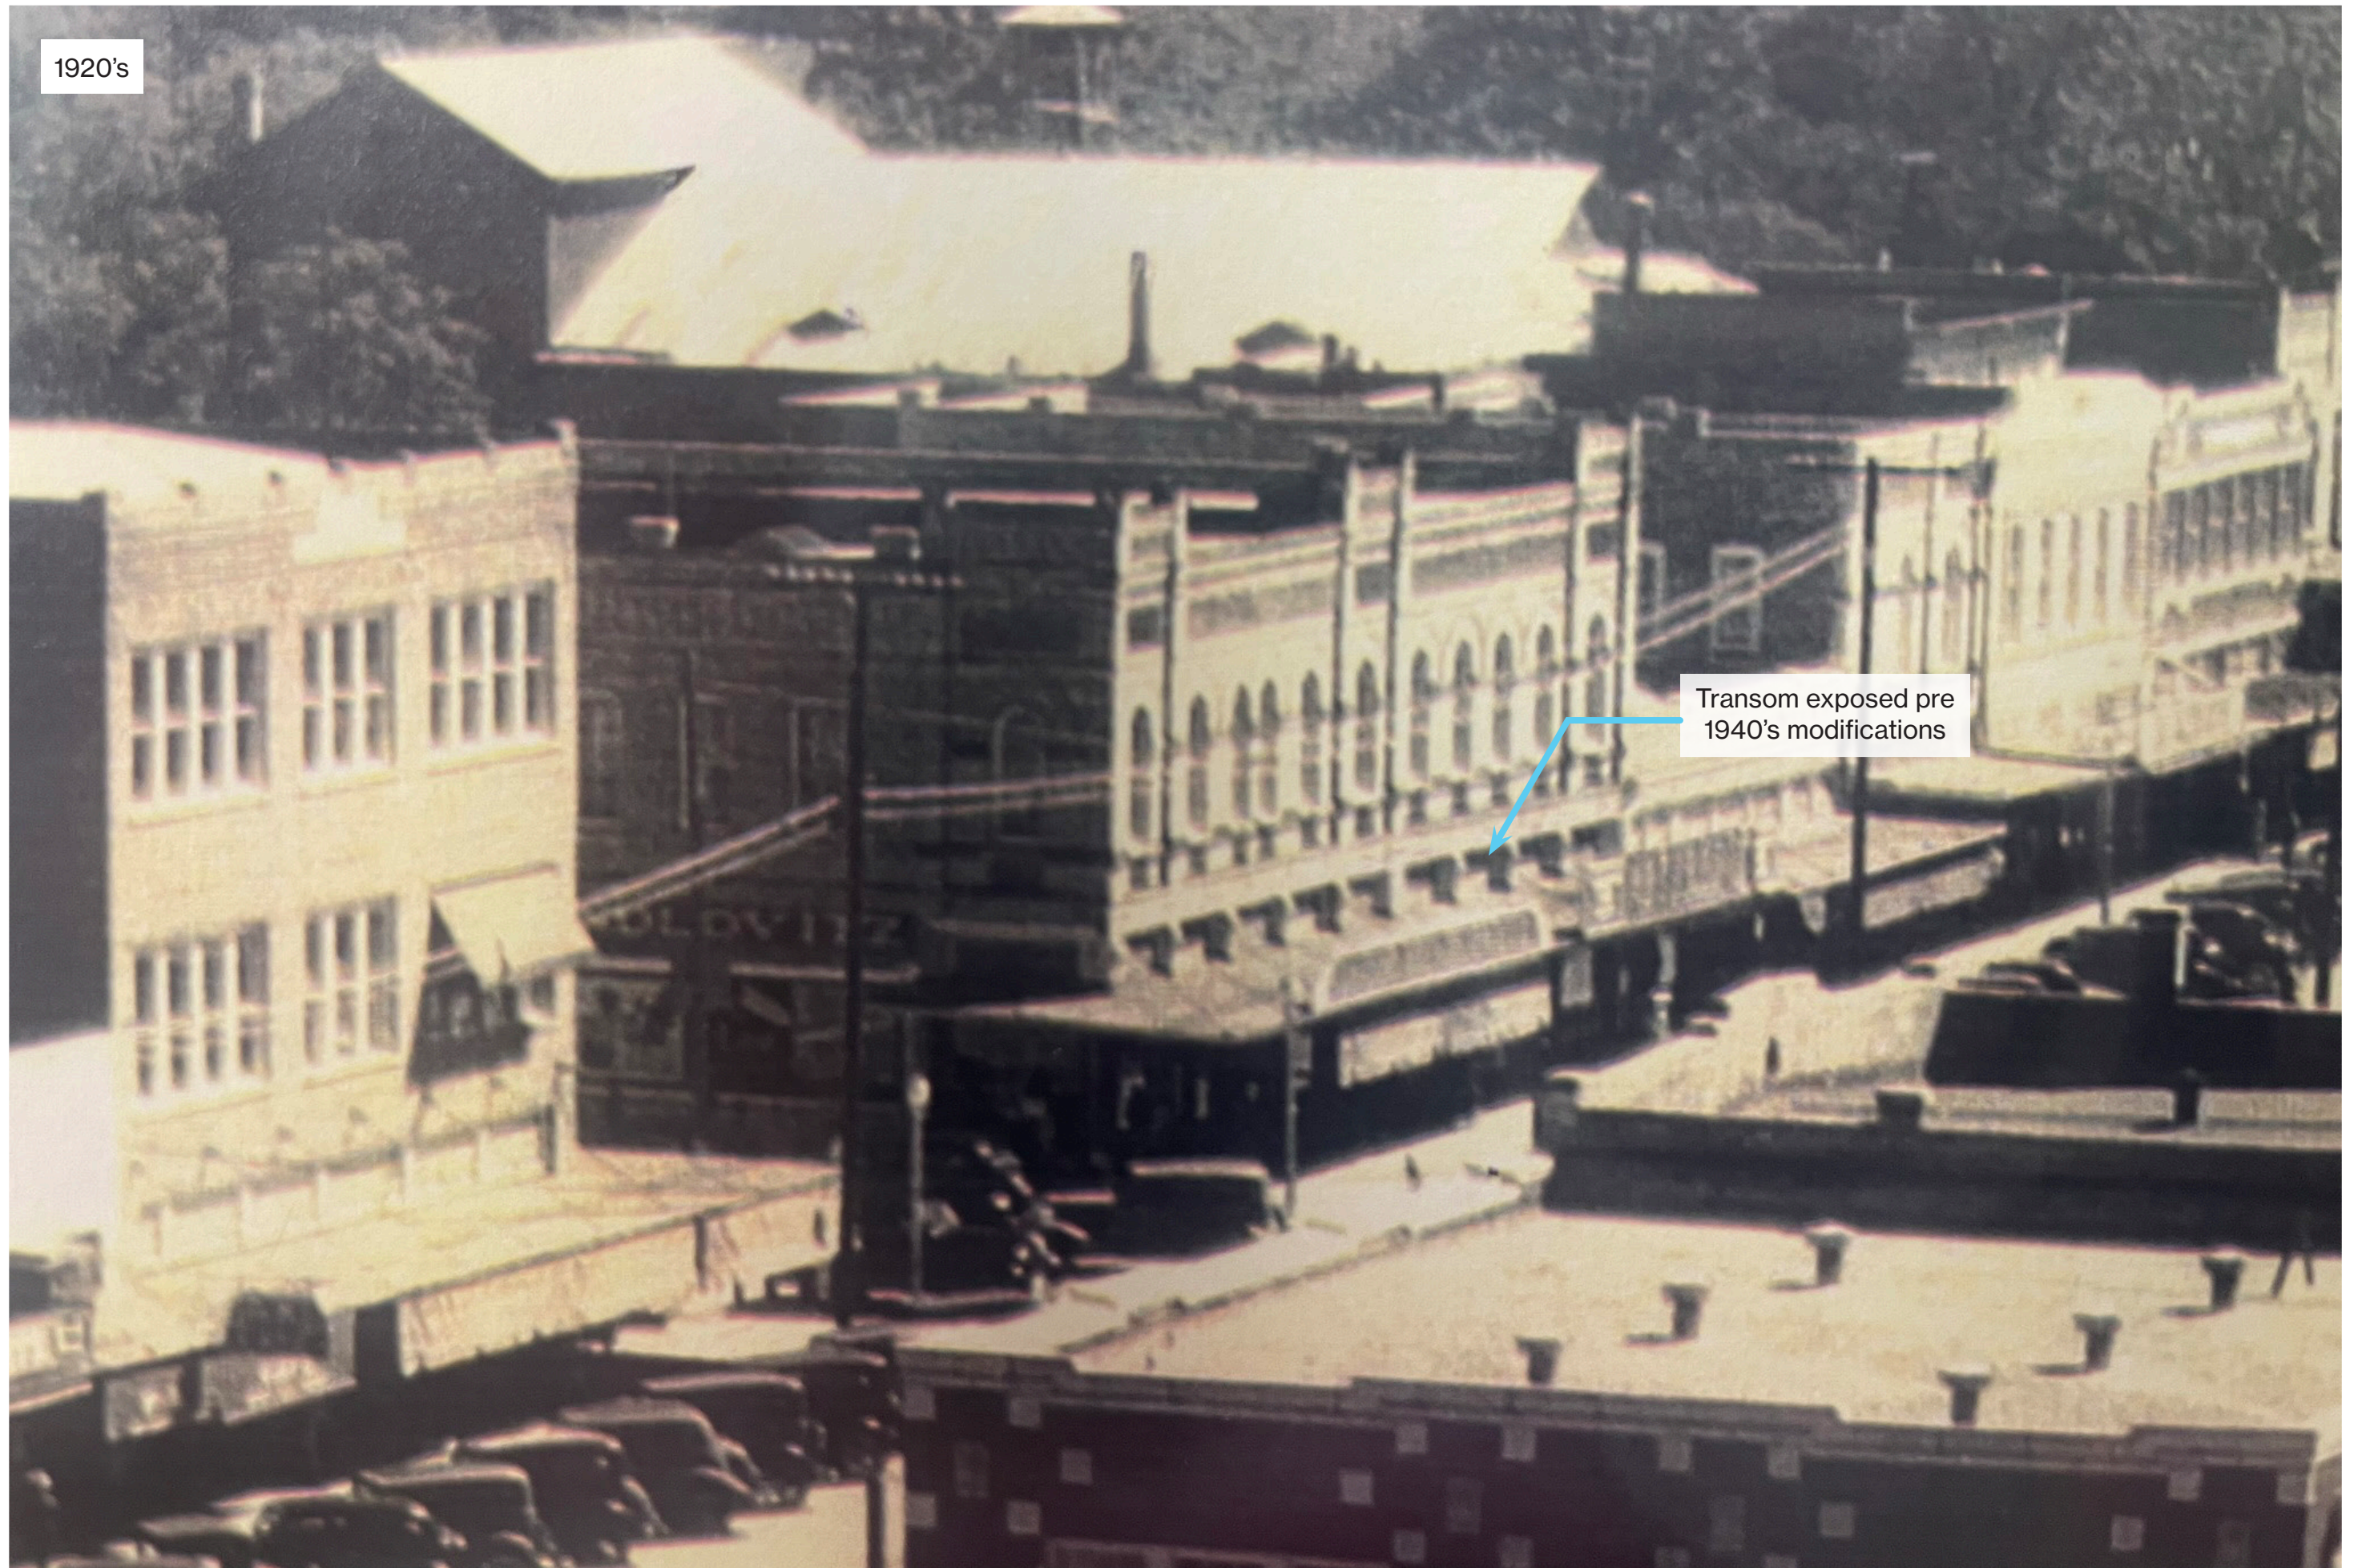
1920's

Transom exposed pre 1940's modifications

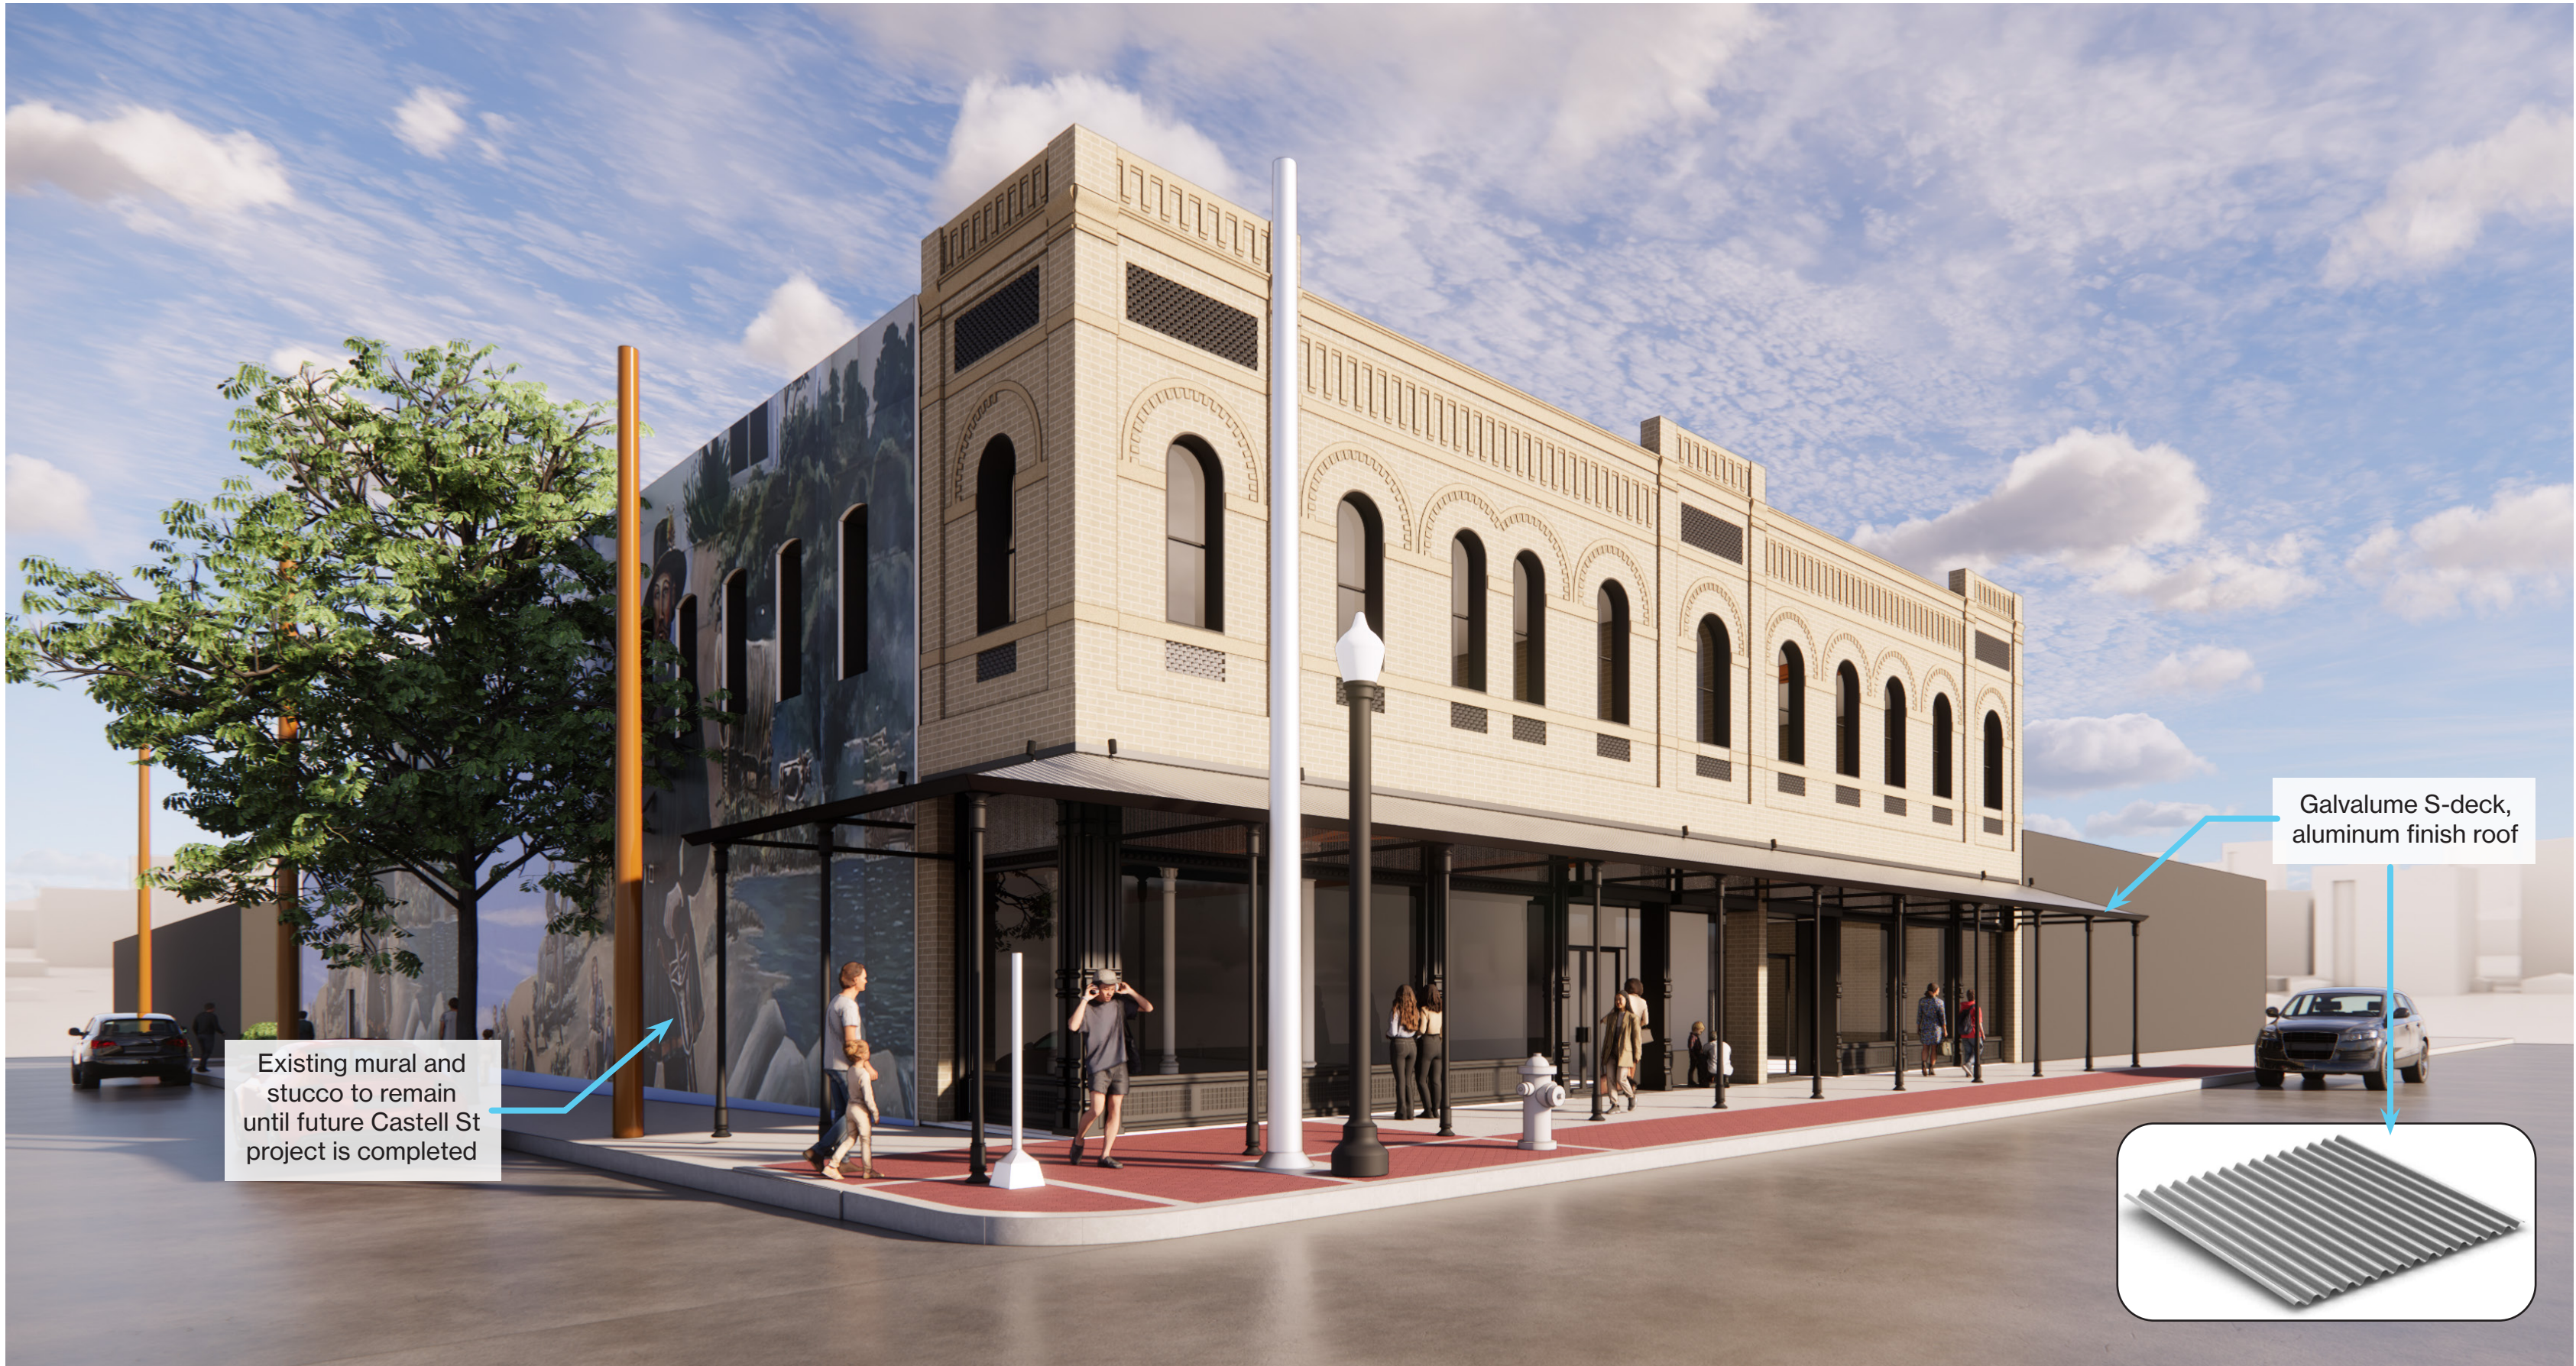
Existing mural and stucco to remain until future Castell St project is completed

Galvalume S-deck, aluminum finish roof

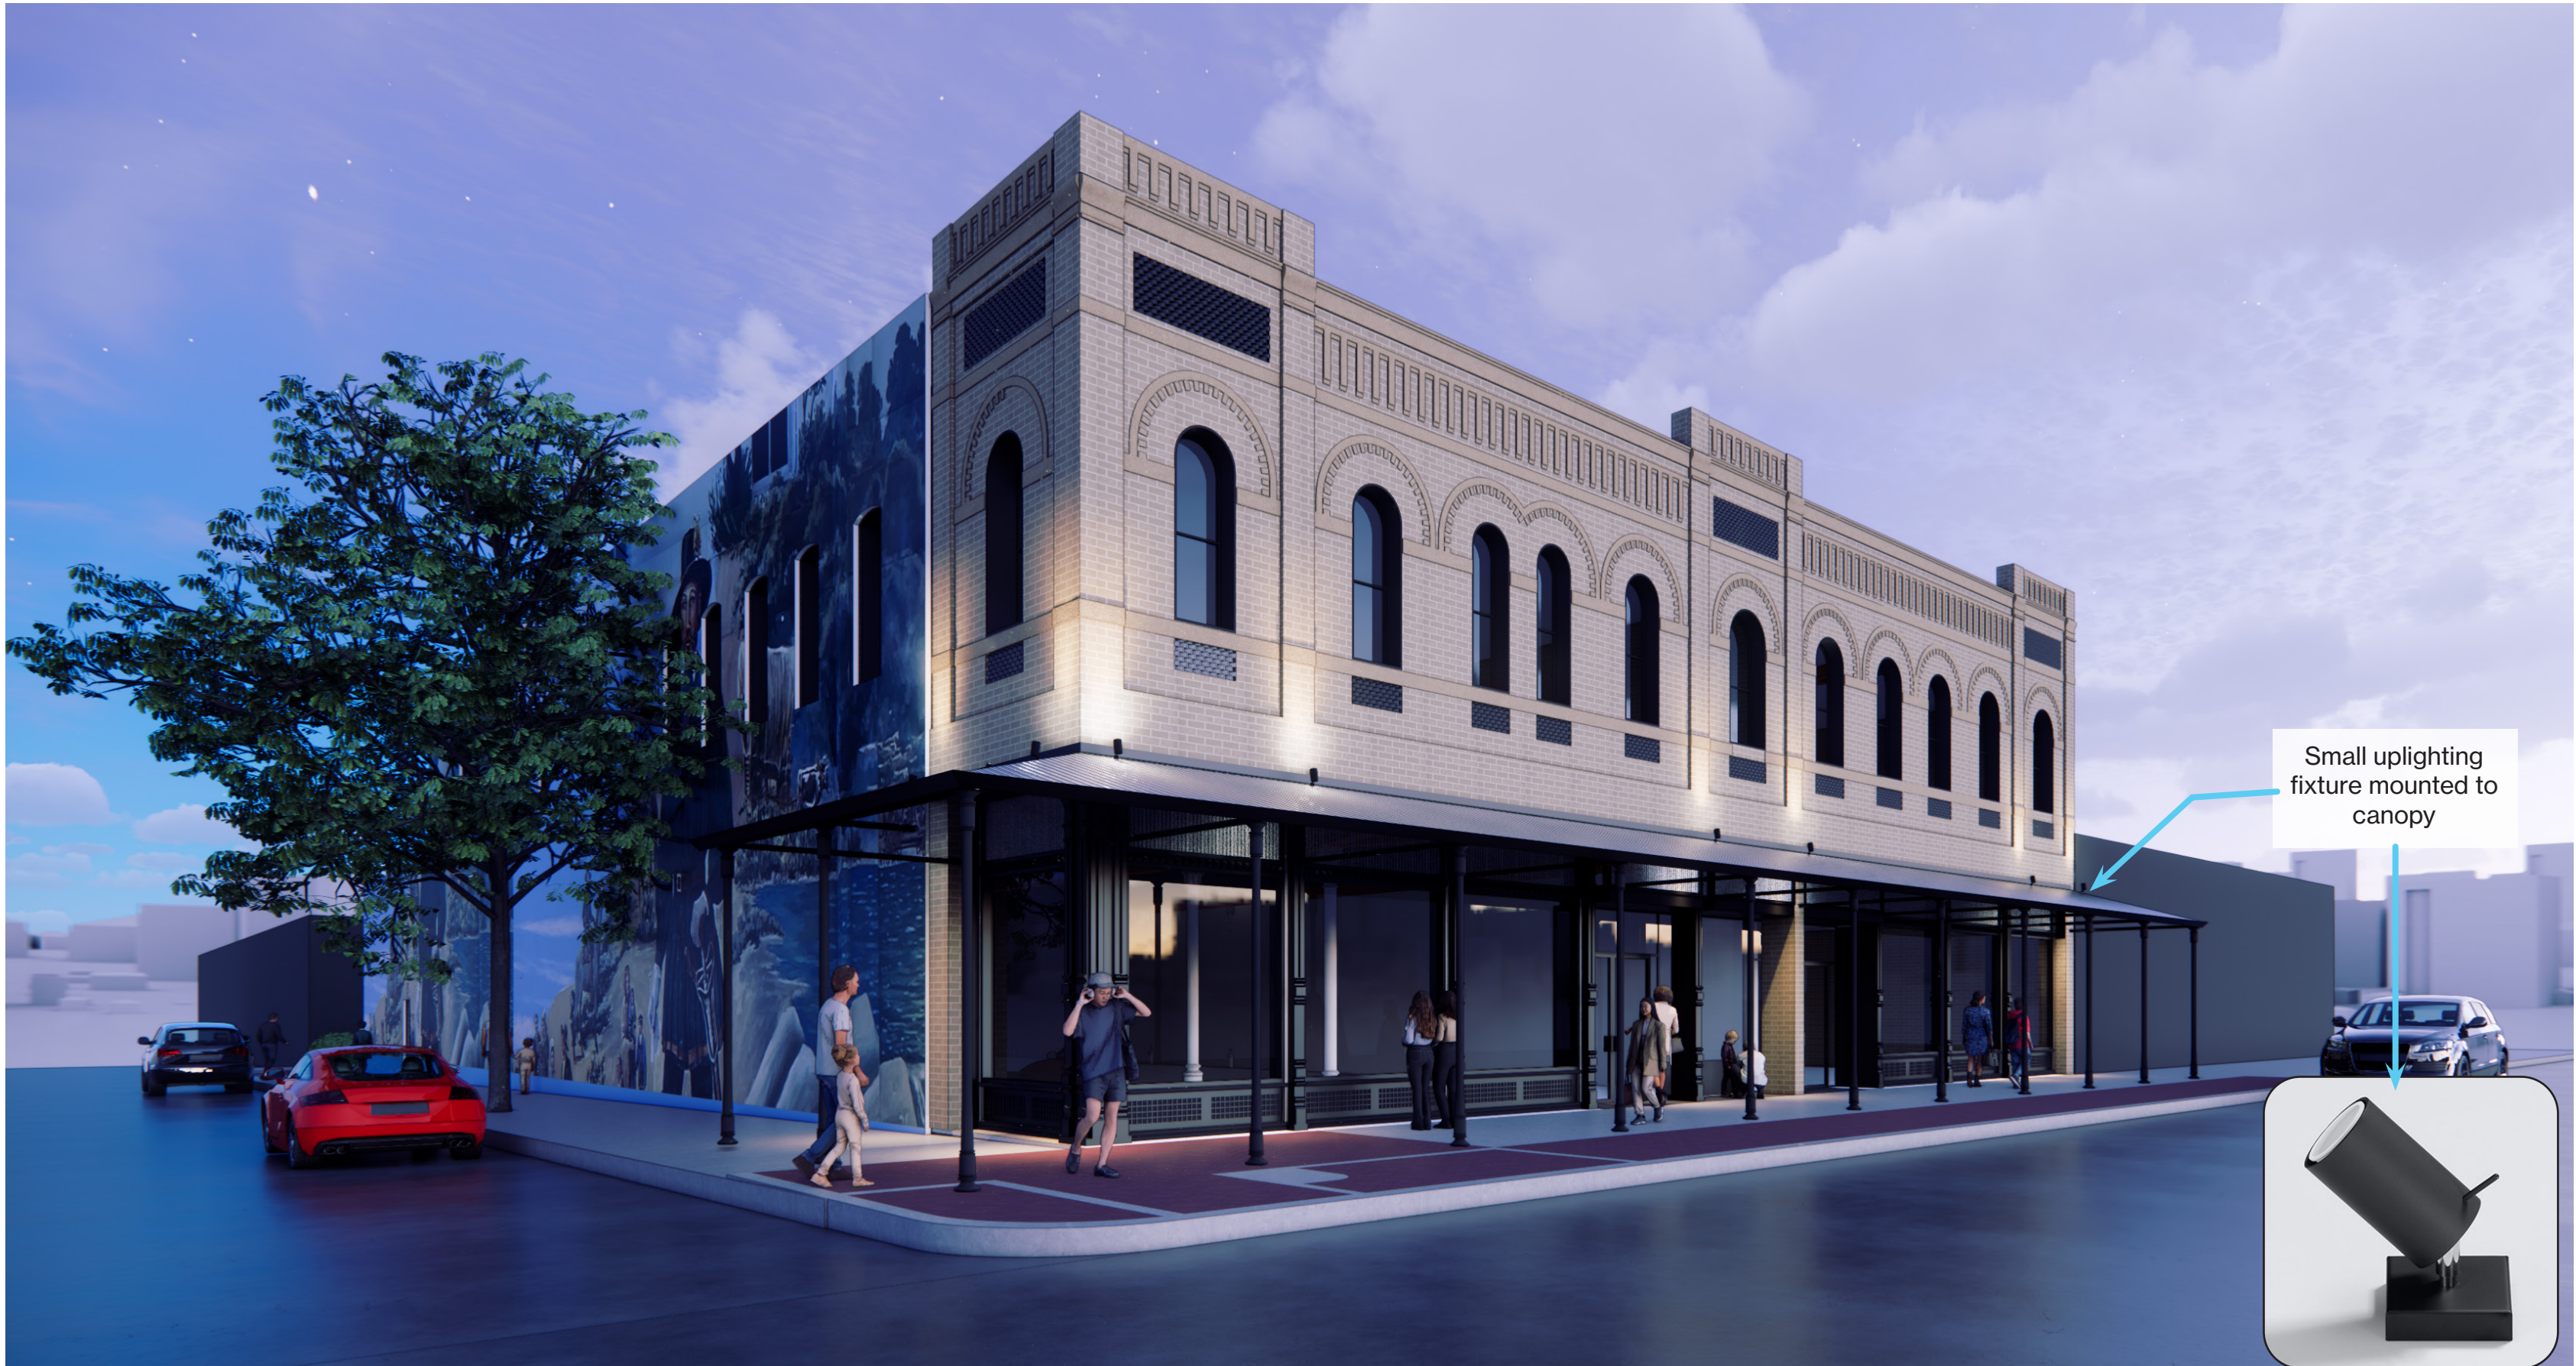
Small uplighting fixture mounted to canopy

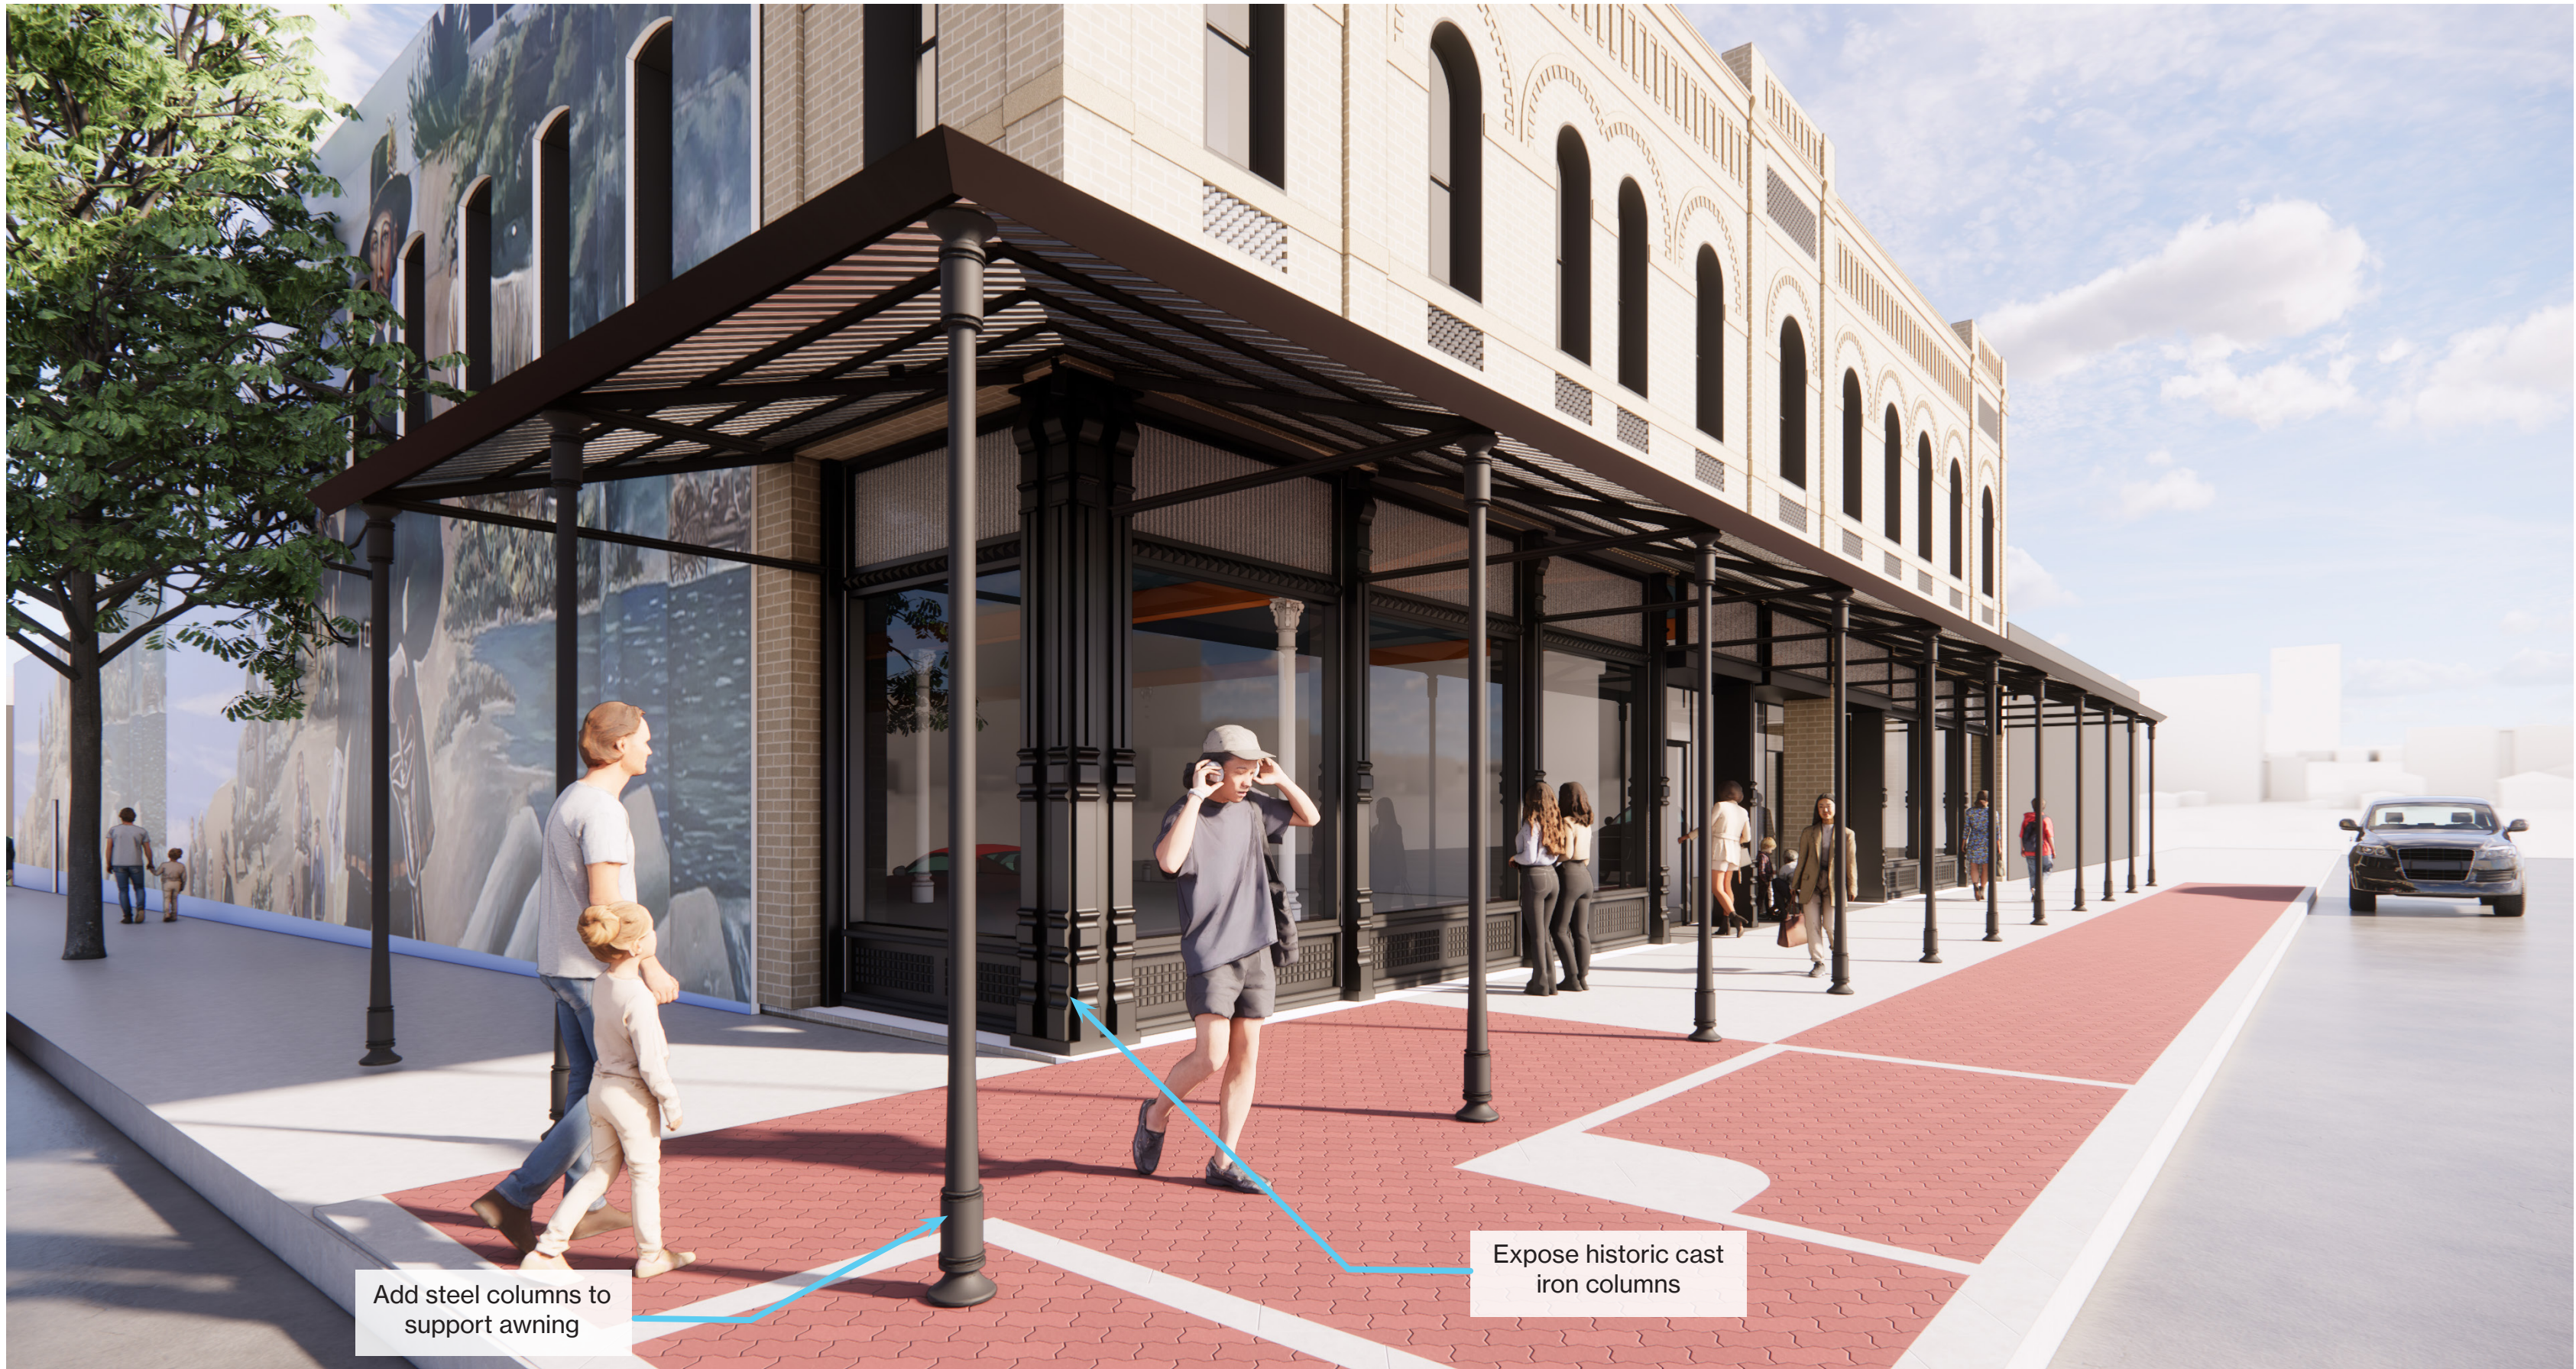
Add steel columns to support awning

Expose historic cast iron columns
