## E: Supplemental Documents (NPS Document on Historic Windows)

### Technical Preservation Services

# Building Exterior **Windows**

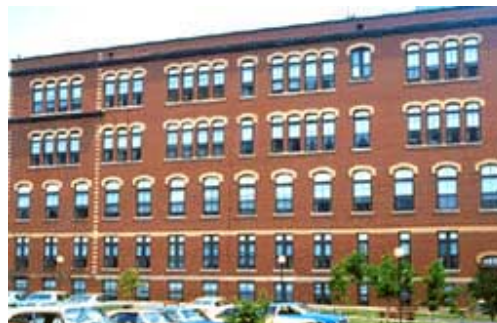
Distinctive window design on 19th century building.

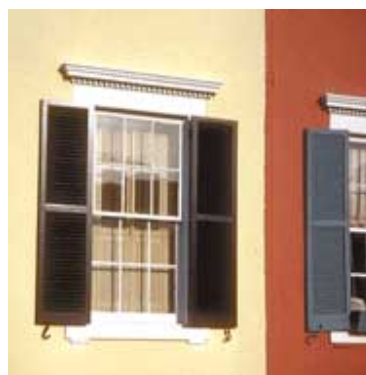
Delicate muntins and multi-pane sash on early 19th c. row houses.

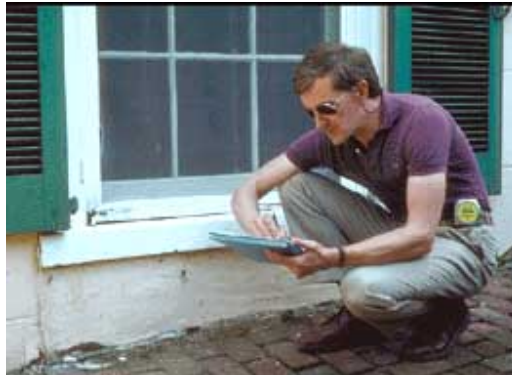
Window condition assessment preceding repair work.

**Conducting an indepth survey of the conditions of existing windows early in rehabilitation planning so that repair and upgrading methods and possible replacement options can be fully explored.**

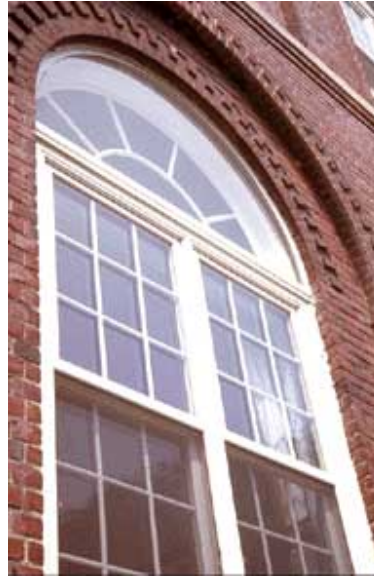
Newly painted double-hung wood windows.

Protecting and maintaining the wood and architectural metal which comprise the window frame, sash, muntins, and surrounds through appropriate surface treatments such as cleaning, rust removal, limited paint removal, and re-application of protective coating systems.

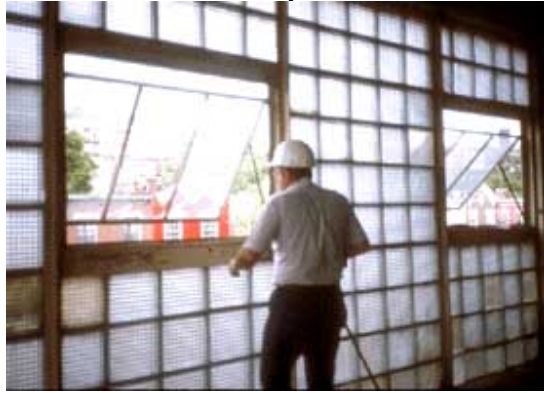
Preparing historic steel windows for repairs and re-finishing.

Repairing window frames and sash by patching, splicing, consolidating or otherwise reinforcing.

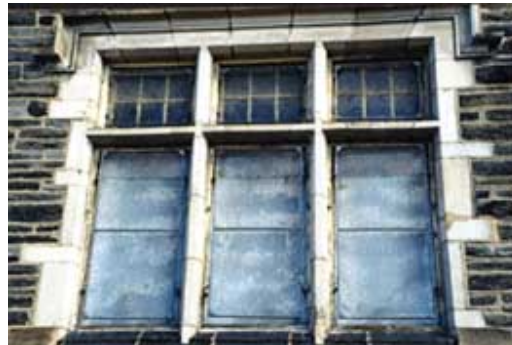
Deteriorated lower window sash shown prior to its replacement in kind.

Replacing in kind an entire window that is too deteriorated to repair using the same sash and pane configuration and other design details. If using the same kind of material is not technically or economically feasible when replacing windows deteriorated beyond repair, then a compatible substitute material may be considered.

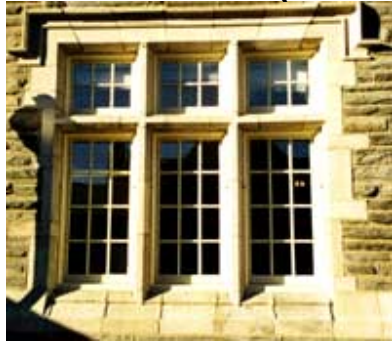
**Lower window sash replaced, based on physical documentation.**

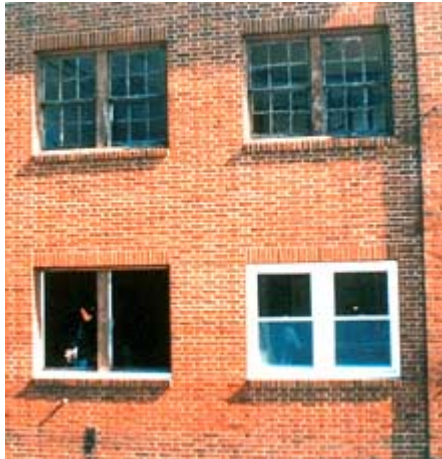
**Incompatible new window (lower right), resulting in loss of the building's historic character.**

Installing new windows, including frames, sash, and muntin configuration that are incompatible with the building's historic appearance or obscure, damage, or destroy character-defining features.
