# Guadalupe Appraisal District

The Guadalupe Appraisal District Board of Directors (**BOD**) has adopted Resolution 2025-03 proposing the acquisition and renovation of the historic Mary B. Erskine Building located at **216 East College Street, Seguin, Texas**, as the future headquarters of the Appraisal District.

## FOR THE GUADALUPE COUNTY APPRAISAL DISTRICT

MAY 6, 2025

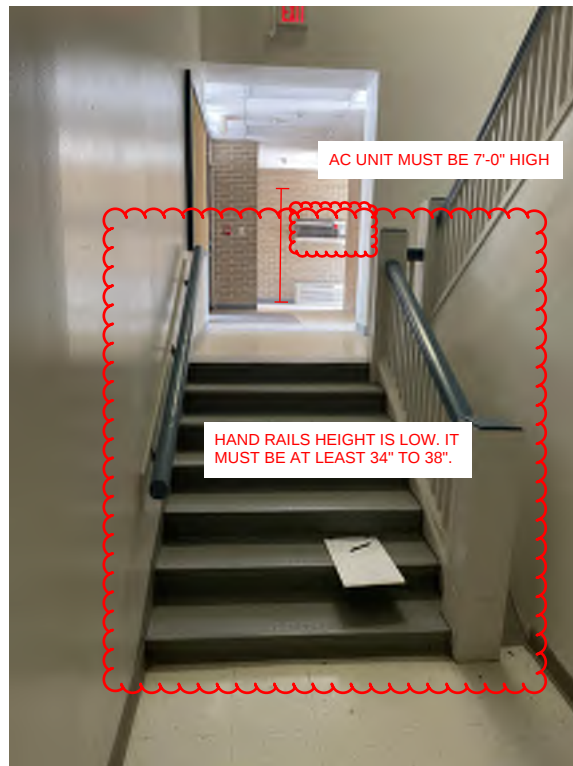
Figure 9: Stair handrails & AC unit not ADA complaint

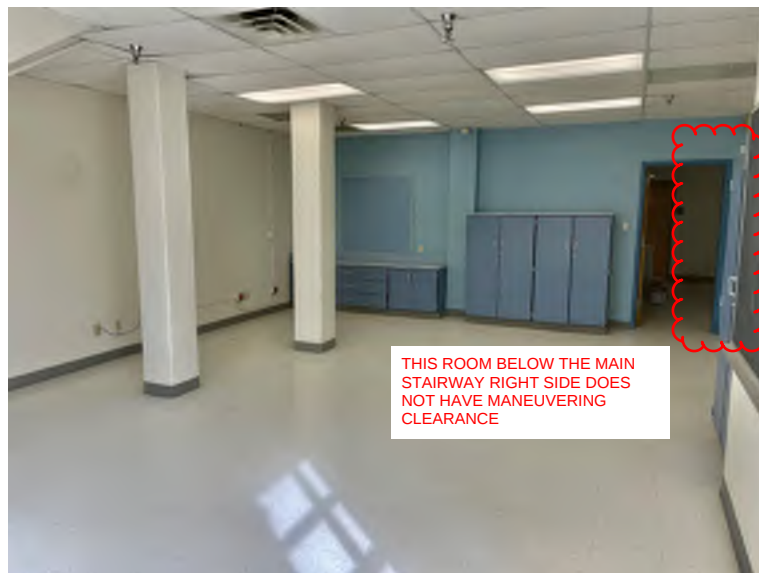
Figure 12: First Floor Basement interior doors

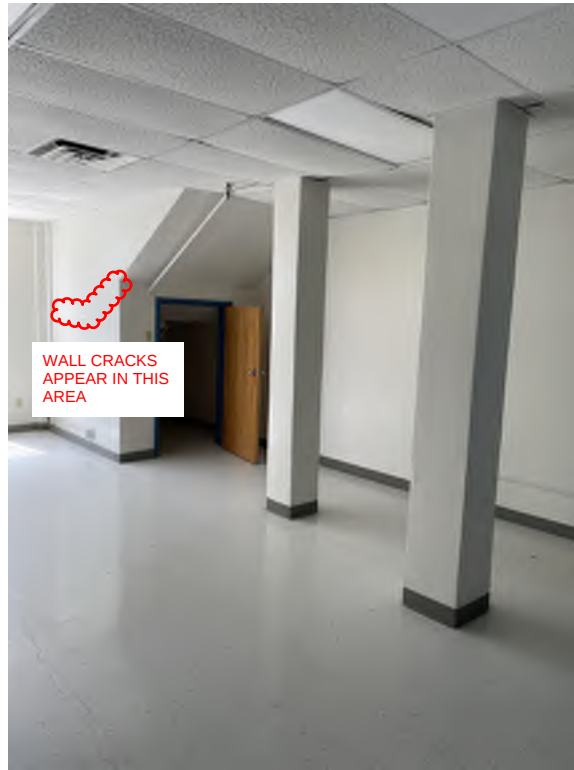
Figure 13: First Floor Basement Cracked Walls
