HAWKEYE **REAL ESTATE INSPECTION**

Daniel Wallace
301 Kuehler

PROPERTY INSPECTION REPORT FORM

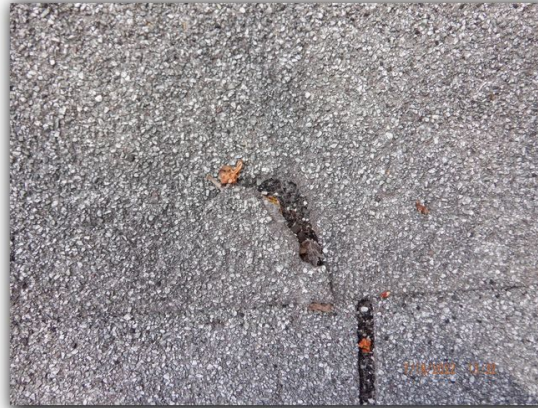
All exposed nail heads at the roof covering should be properly sealed to reduce risk of leaks.

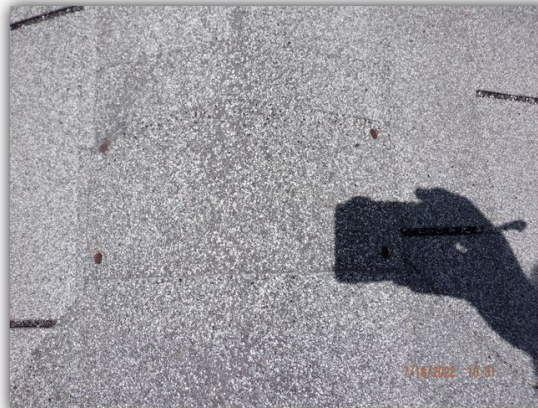
The starter run along the edge of the roofing does not appear to have been installed properly. Various shingles were observed to be loose and not properly fastened. These conditions should be further evaluated by a licensed roofing company and all repairs made as necessary.

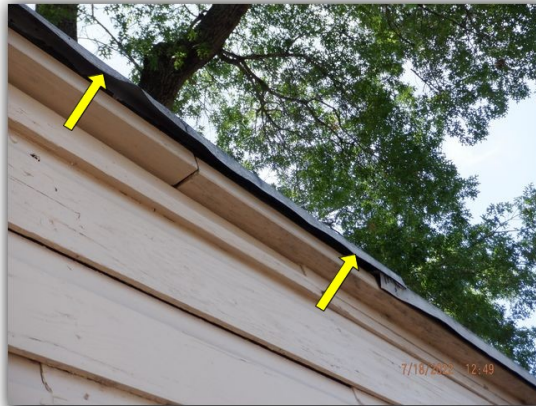
The gutters require cleaning to avoid spilling roof runoff around the building - a potential source of water entry or water damage. The gutters require cleaning to avoid spilling roof runoff around the building - a potential source of water entry or water damage and leaks in the gutters should be repaired. Various leaks in the gutters and damages should be repaired. Loose or damaged downspout's should be repaired promptly.

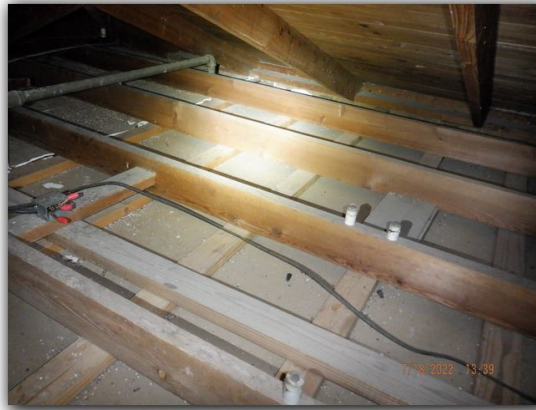
No soffit or roof covering passive vents were observed for the attic space. The level of ventilation should be improved. It is generally recommended that one square foot of free vent area be provided for every one hundred and fifty square feet of ceiling area. Proper ventilation will help to keep the house cooler during warm weather and extend the life of roofing materials. In colder climates, it will help reduce the potential for ice dams on the roof and condensation within the attic.

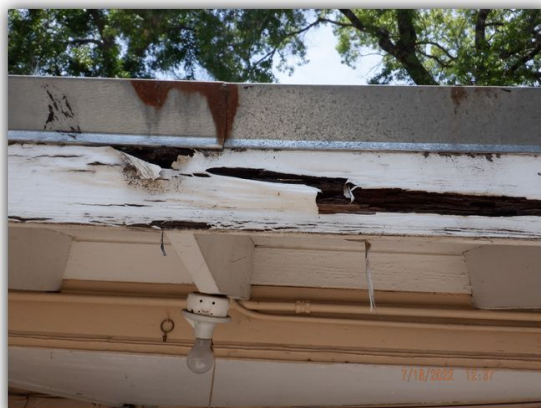
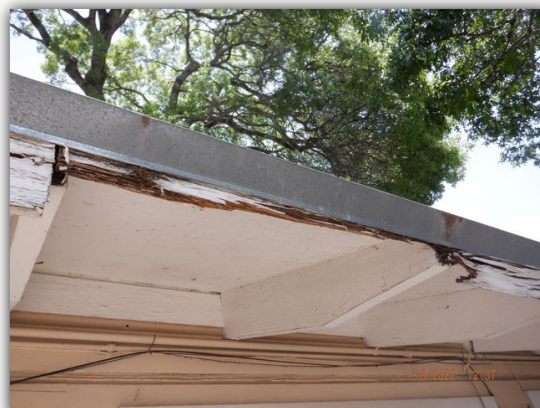
Wood rot and damage around various exterior walls, fascia, overhang and windows are in need of repair.

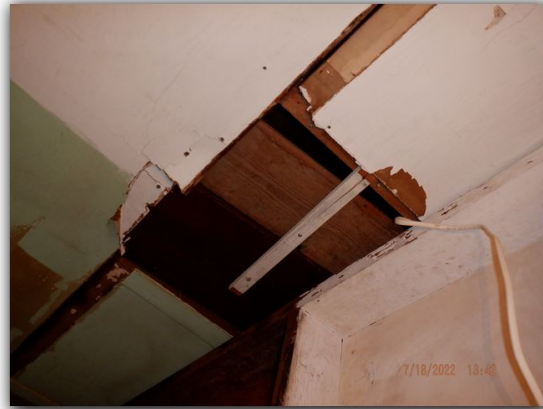
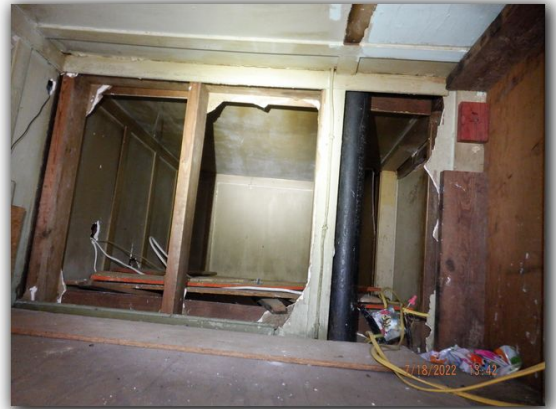
Damage to the interior finish was observed in the west closet area at wall and ceiling area and should be repaired.

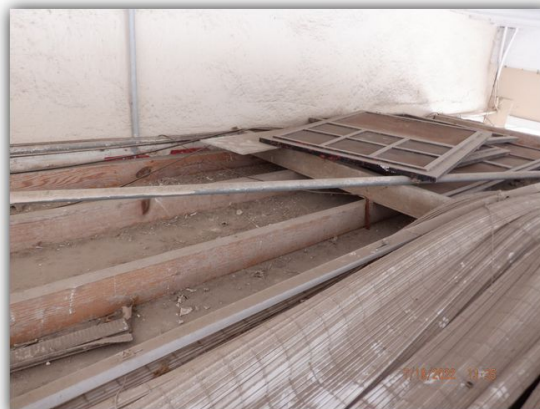
Finish covering and insulation missing above the front entry area at the exterior top side of the ceiling and in need of repair.

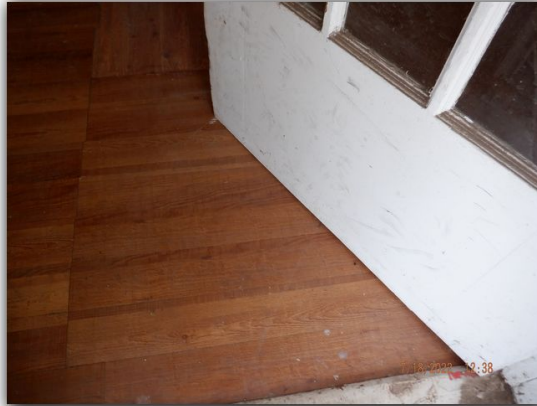
The front entry door rubs flooring should be adjusted as necessary to work properly.

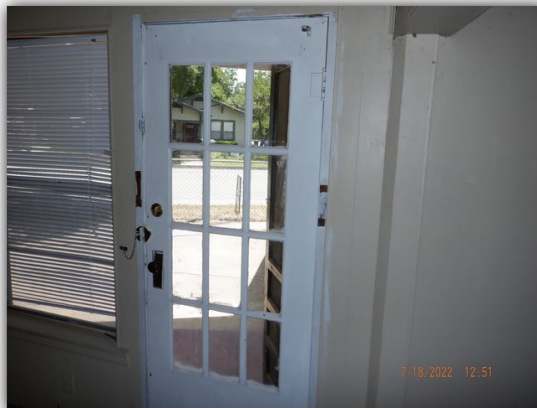
Safety glass etchings were not observed on the glass within the front and back doors. Safety glass is required for glass doors and is generally identified by an etching in the corner of the glass pane. Weather stripping is damaged/missing at the front back door and is in need of repair.

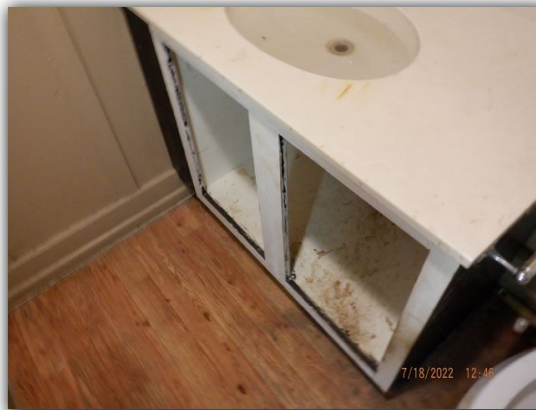
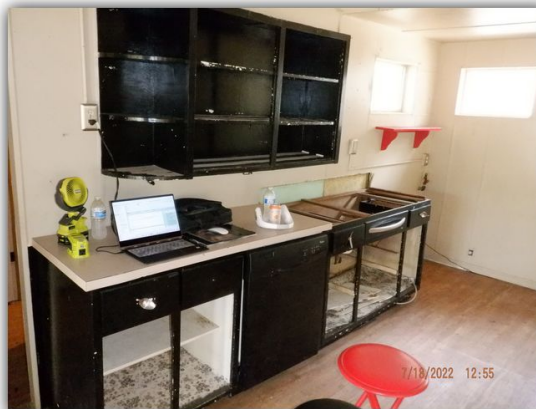
Cabinet doors missing at the kitchen and bathroom and in need of repair.

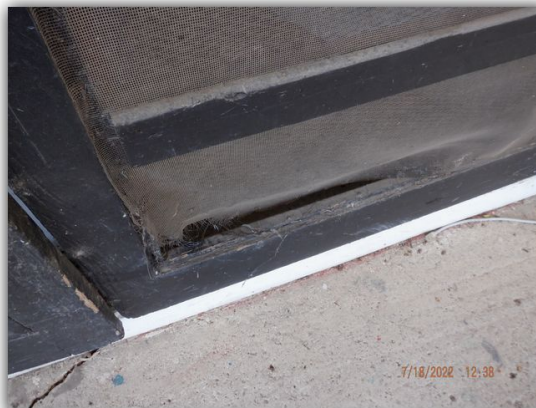
Front screen door in poor condition and in need of repair.

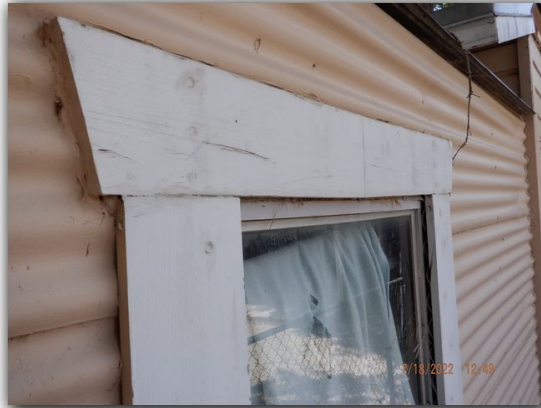
Various windows were inoperative. Nailed and or painted shut and Improvement can be undertaken to allow normal operation of the window.

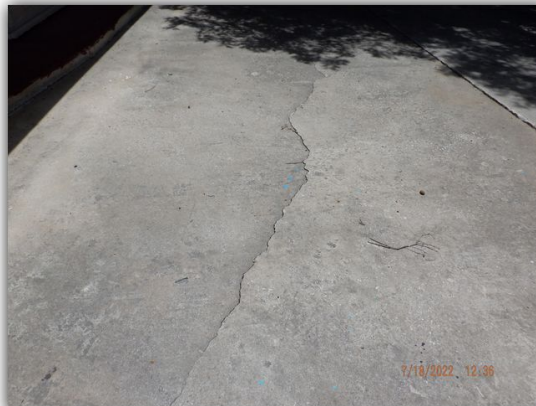
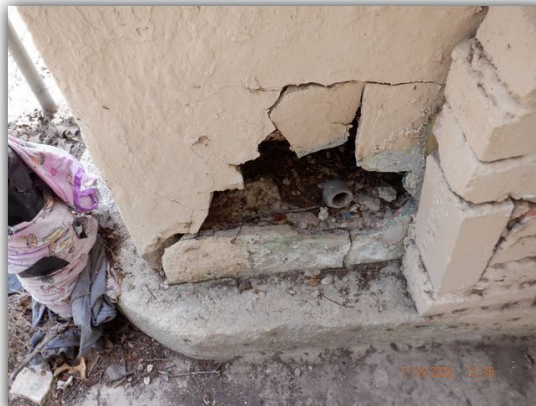
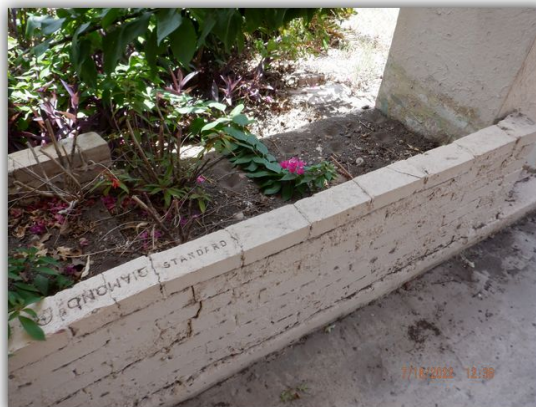
Damaged at the front column at driveway area and damaged brick at the front flower bed and are in need of repair.

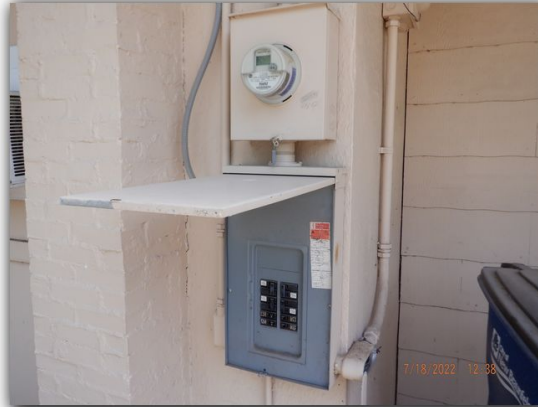
Main service panel is located at the exterior West wall. Breakers are not labeled at the main panel box and should be mark accordingly. When more than six breakers exist in the main service panel box, a main disconnect is required. A main disconnect is required at the main service panel box as per current standards of practice but was not required when the house was built. This condition should be further evaluated by a licensed electrician and all repairs made as necessary.

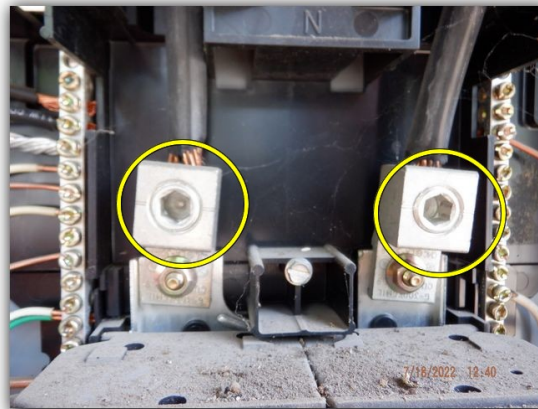
Main service wires missing the protective lug covers inside the main panel box but was not required when the house was built. This condition should be further evaluated by a licensed electrician and all repairs made as necessary as per current standards of practice.

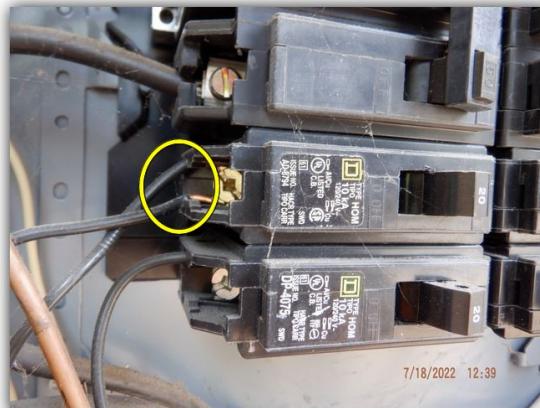
A circuit breaker within the main panel box are doubled up (referred to as "double taps") and should be separated. Each circuit should be served by a separate fuse or breaker as per current standards of practice. This condition should be further evaluated by a licensed electrician and all repairs made as necessary.

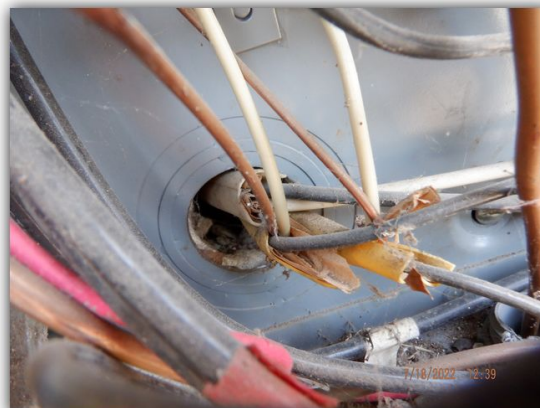
Wires should be properly protected with a grommet/bushing at for wires entering the panel box.

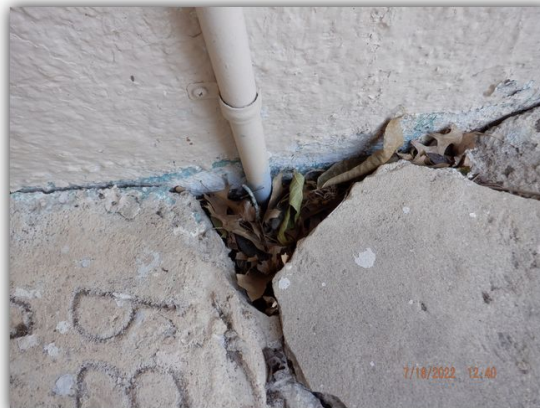
Ground electrode is not visible. This condition should be further evaluated and repaired as necessary.

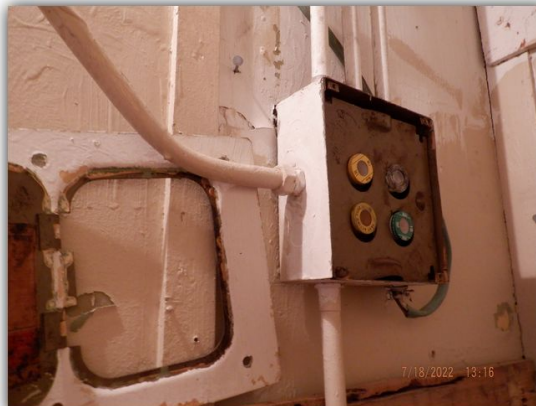
Loose cover at the sub panel box at utility closet.

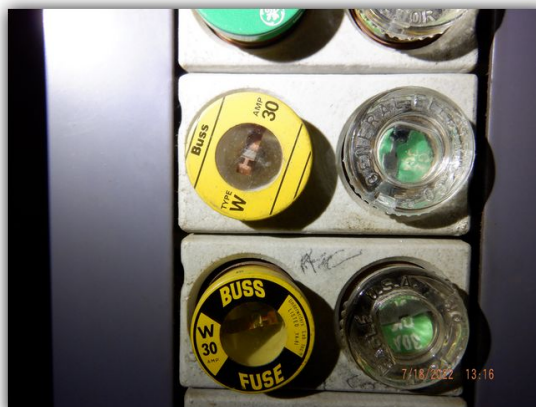
Oversized fuses within the sub distribution panel boxes should be replaced. The 30 amp breakers on 10 awg wires should be further evaluated by a licensed electrician and repairs made as needed.

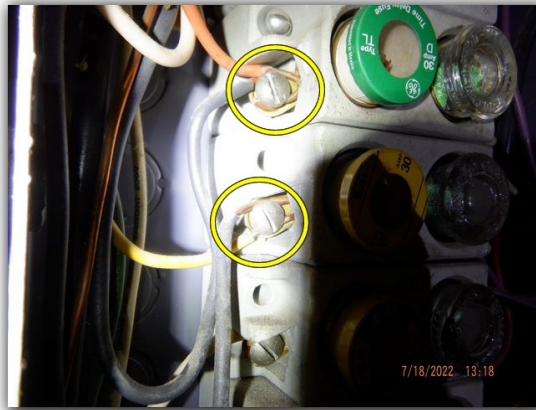
Several circuit fuses within the sub distribution panel box are doubled up (referred to as "double taps") and should be separated. Each circuit should be served by a separate fuse or breaker as per current standards of practice. This condition should be further evaluated by a licensed

electrician and all repairs made as necessary.

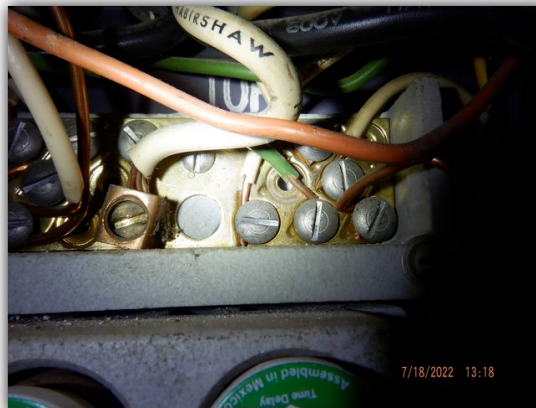
A ground wire and neutral wires at the sub panel are on the same bus bar and should be separated and repairs made as necessary as per current standards. This is typical of a 3 wire feeder system. Today's standards require 4 wire system where the grounds and neutrals are separated in the sub panel box.

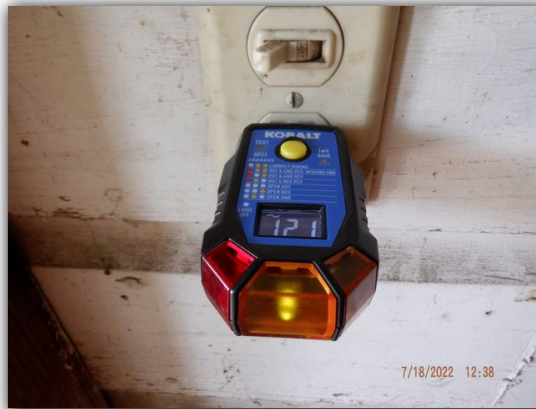
Various ungrounded 3-prong outlets were observed and should be improved. This condition should be further evaluated by a licensed electrician and all repairs made as necessary.

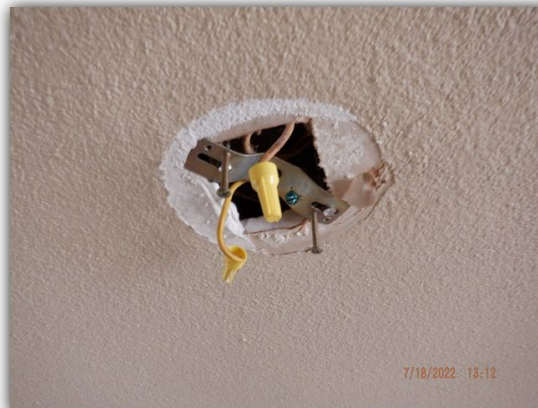
The light fixtures missing with exposed wiring at the dining and laundry area.

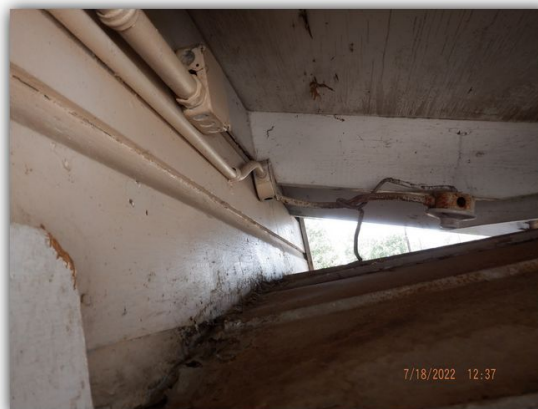
Wiring exposed on exterior finishes should be relocated or protected by a rigid conduit. The wiring does not appear to be for exterior moisture/weather rated wiring. These condition should be further evaluated by a licensed electrician and all repairs made as necessary.

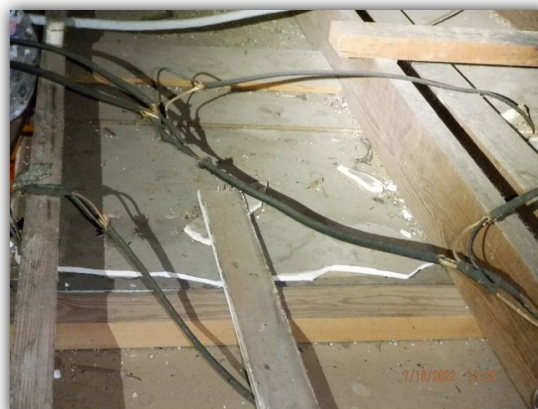
The house appears to consist of the old knob and tube wiring through out the electrical system, this condition can pose a safety hazard and should be further evaluated by a licensed electrician and all repairs or replacements made as necessary.

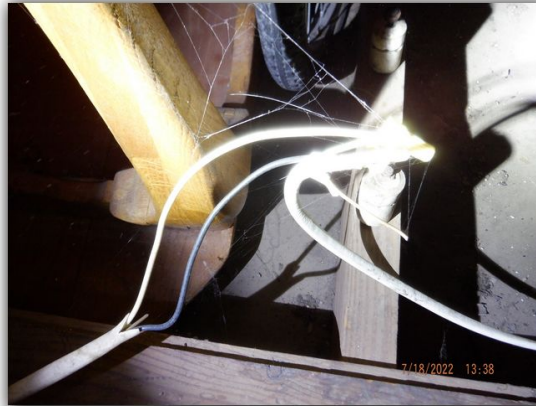
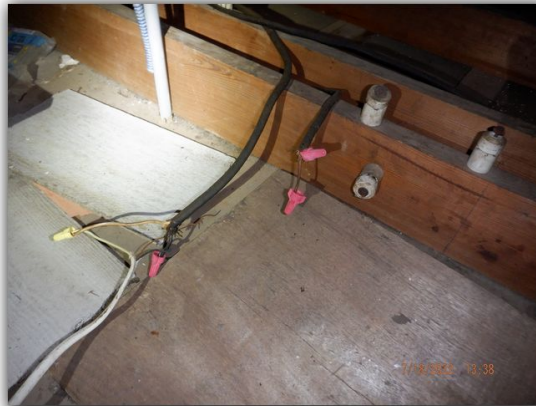
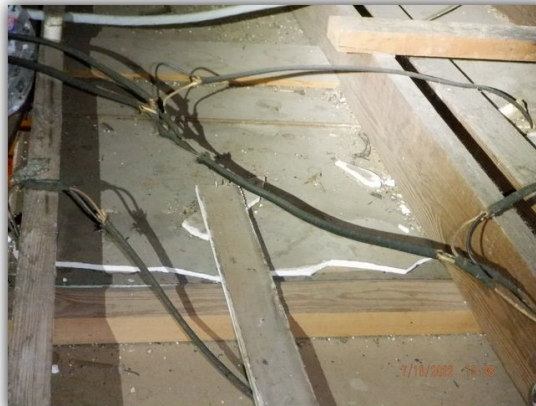
All spliced wires in the attic spaces should be enclosed in a junction box for safety purposes as per current standards of practice. Missing junction box cover in the attics should be properly covered as per current standards of practice.

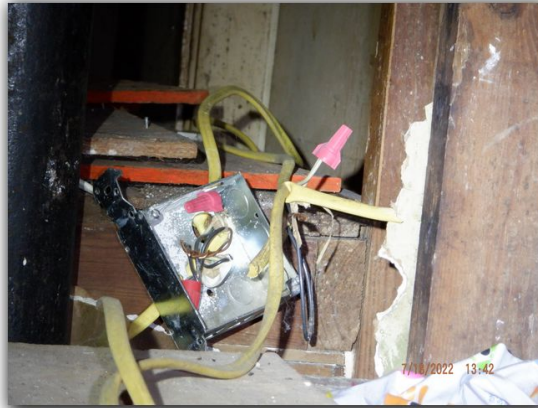
Wiring exposed on interior finishes should be relocated or protected by a rigid conduit. The installation of the distribution wiring is non-standard. It is suspected that installation was performed by an amateur, rather than a licensed electrician. This condition should be further evaluated by a licensed electrician and all repairs made as necessary.

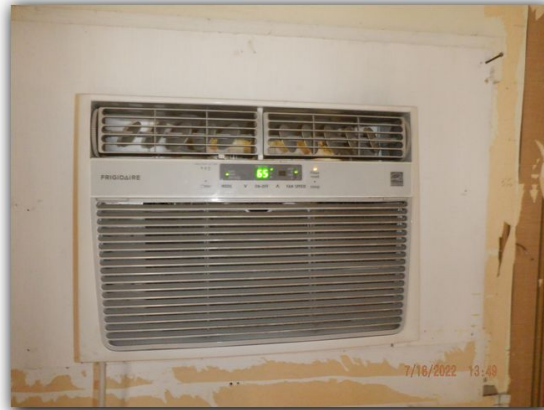
The air vent at the east interior wall did not function at the time of inspection and in need of repair. This condition should be further evaluated by a licensed a/c technician and all repairs made as necessary.

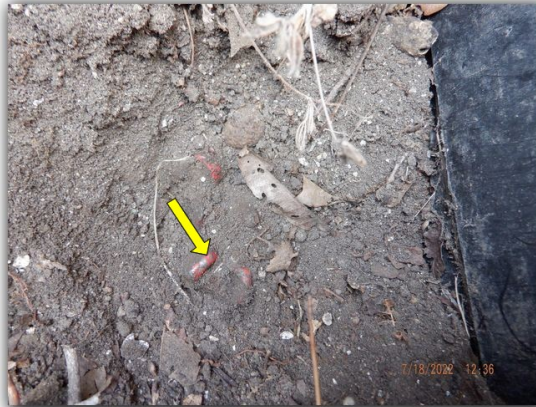
Location of main water supply valve: House side of the meter; The shut off valve in the front lawn for the house side of the meter is buried and needs to be cleared for proper access.

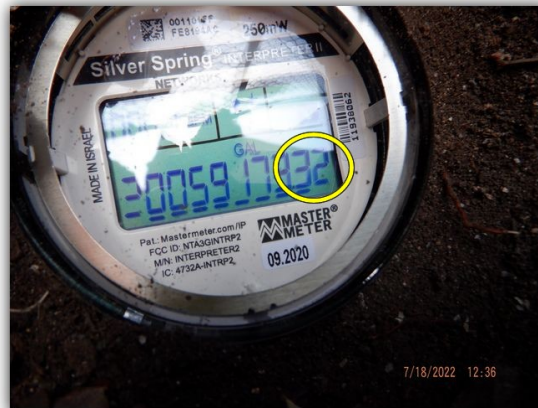
Water meter is located at the front curb. The peg/numbers were observed to be moving while water was turned off inside of the house which could indicate a possible leak in the main water lines. This condition should be further investigated by a qualified plumber and repairs made as necessary.

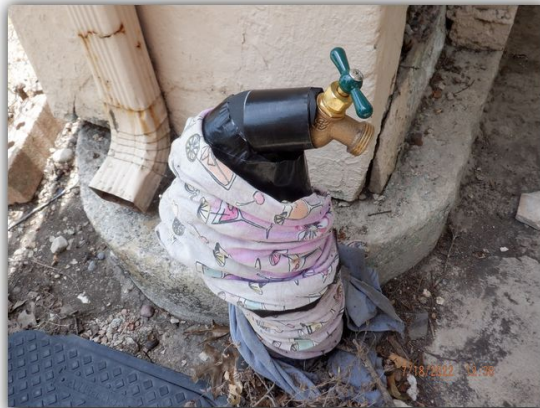
Rags are not considered an ideal way of insulating the exterior water lines and hose bibs. All exterior hose bibs and exposed water lines should be properly insulated to protect from freezing weather. Anti-siphon devices missing. It is recommended that an anti-siphon device be added to the hose bibs at the exterior of the house.

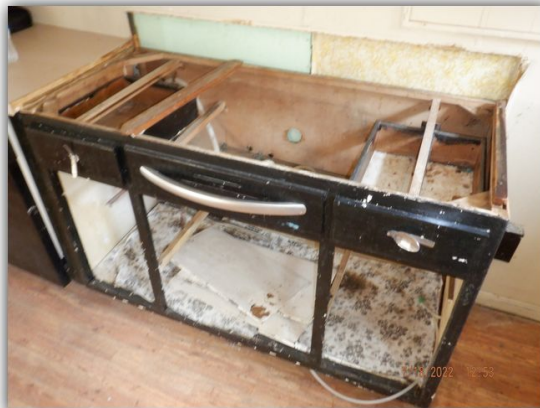
Kitchen sink missing at the time of inspection.

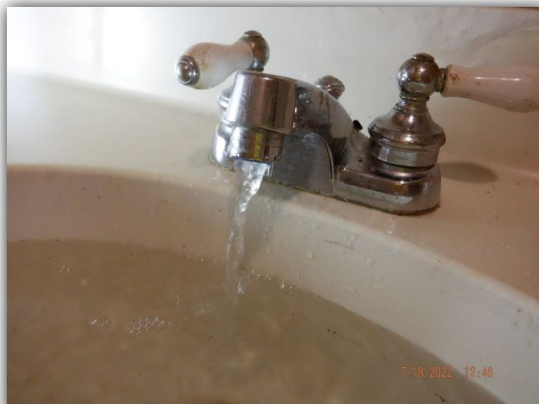
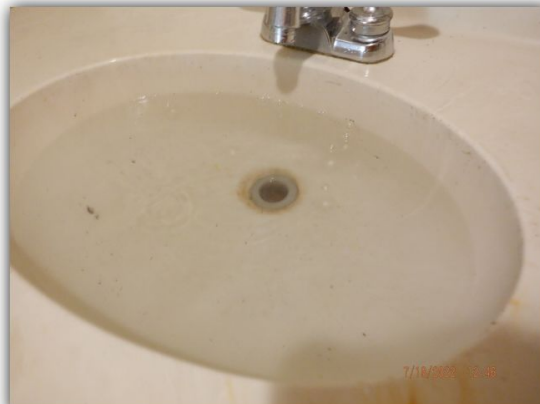
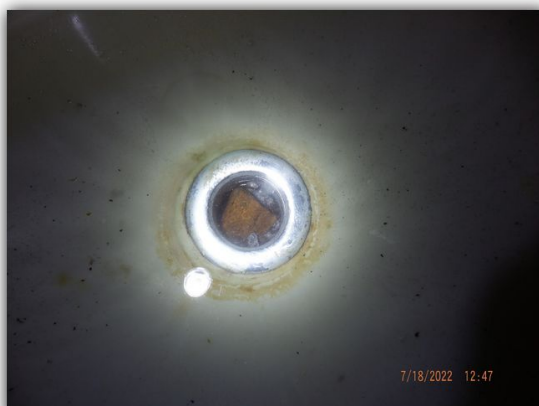
Low flow was observed at the hot and cold side faucets. The back bathroom sink was observed

to drain slowly, due to the obstruction that exist.. The drain stop for the sink is missing and should be replaced. These conditions should be further evaluated by a licensed plumber and all repairs made as necessary.

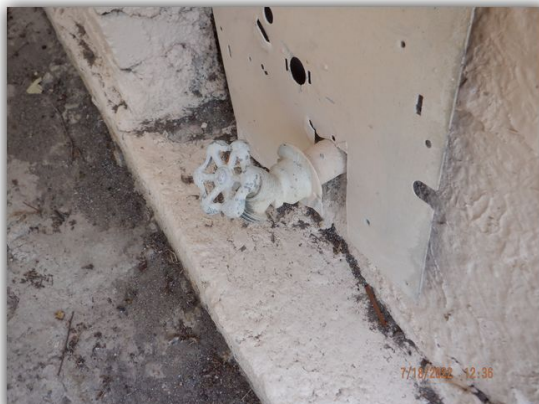
The exterior hose bibs are inoperative and should be repaired.

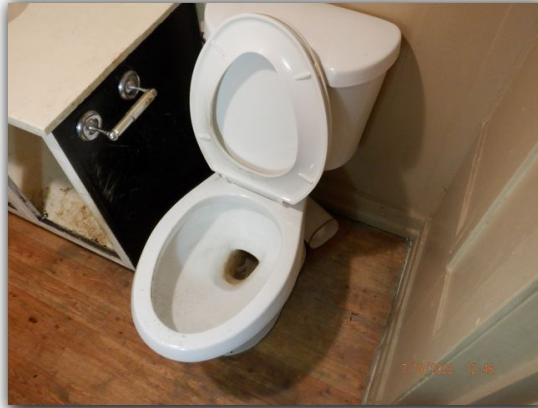
The toilet are loose at the flooring and should be properly re-secured and sealed and all repairs made as needed. This conditions should be further evaluated by a licensed plumber and all repairs made as necessary.

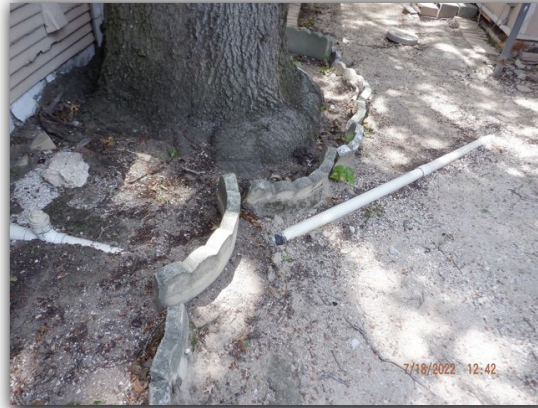
Various exposed pipes in the lawn should be properly buried to protect from freezing and lawn care maintenance.

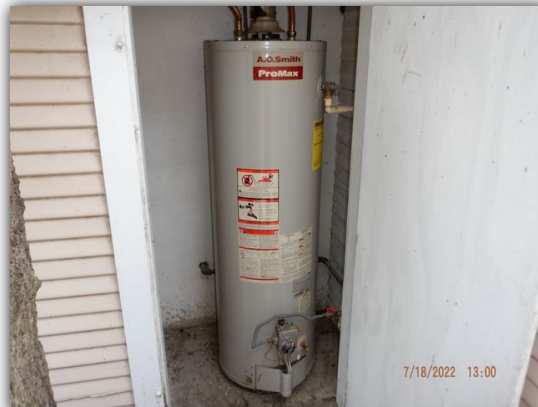
Name Brand: A.O. Smith

Mfg Date: 2008; The water heater is an older unit that may be approaching the end of its useful life. It would be wise to budget for a new unit. One cannot predict with certainty when replacement will become necessary.

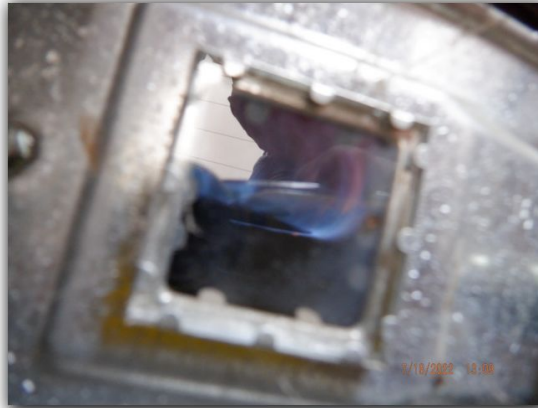
No safety pan and drainpipe was found for the water heater. It is recommended that the installation of a pan with a drain pipe to the exterior of the house be installed by a qualified professional. A moisture meter can also be used under the unit to detect for leaks.

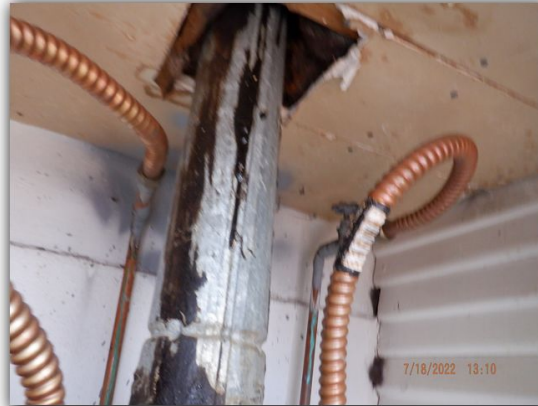
The vent pipe serving the water heater is of inappropriate material (single tube galvanized tubing).. These material are not well suited to this application and, for safety reasons, it should be replaced with proper rated vent pipe as per current standards of practice.

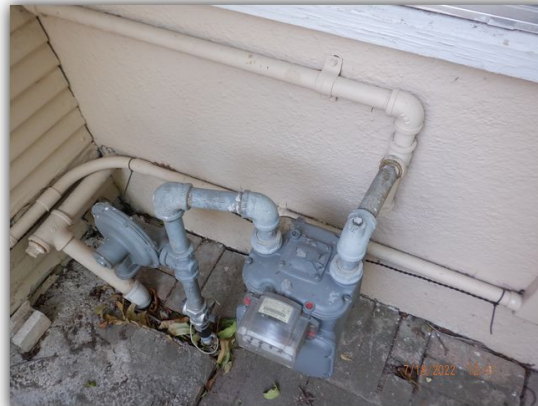
Location of gas meter: West exterior side of the house.

The gas meter does not appear to be bonded as per current standards but was not required when the house was built. This condition should be further evaluated by a licensed electrician and all repairs made as necessary.

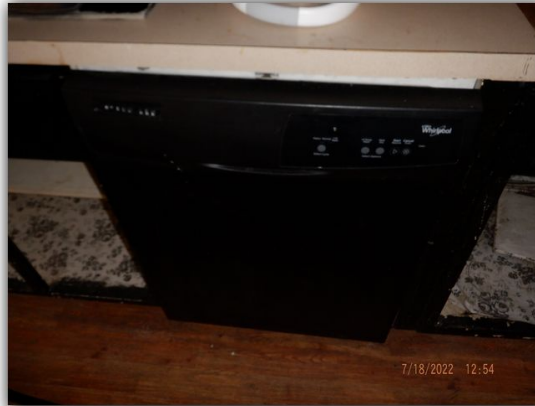
Name Brand: Whirlpool

The dishwasher is inoperative and should be repaired or replaced. Could not test due to no sink.

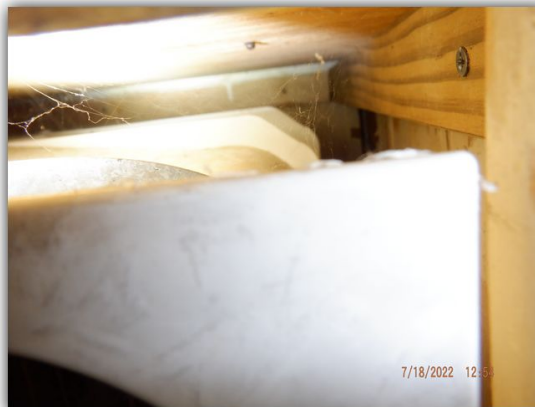
The heat and noise reduction insulation body wrap appears to be missing on the exterior/backside of the unit and should be placed as per manufacture.
