Dam Safety Inspection Report

Fischer Park No 1 Dam

TX07410

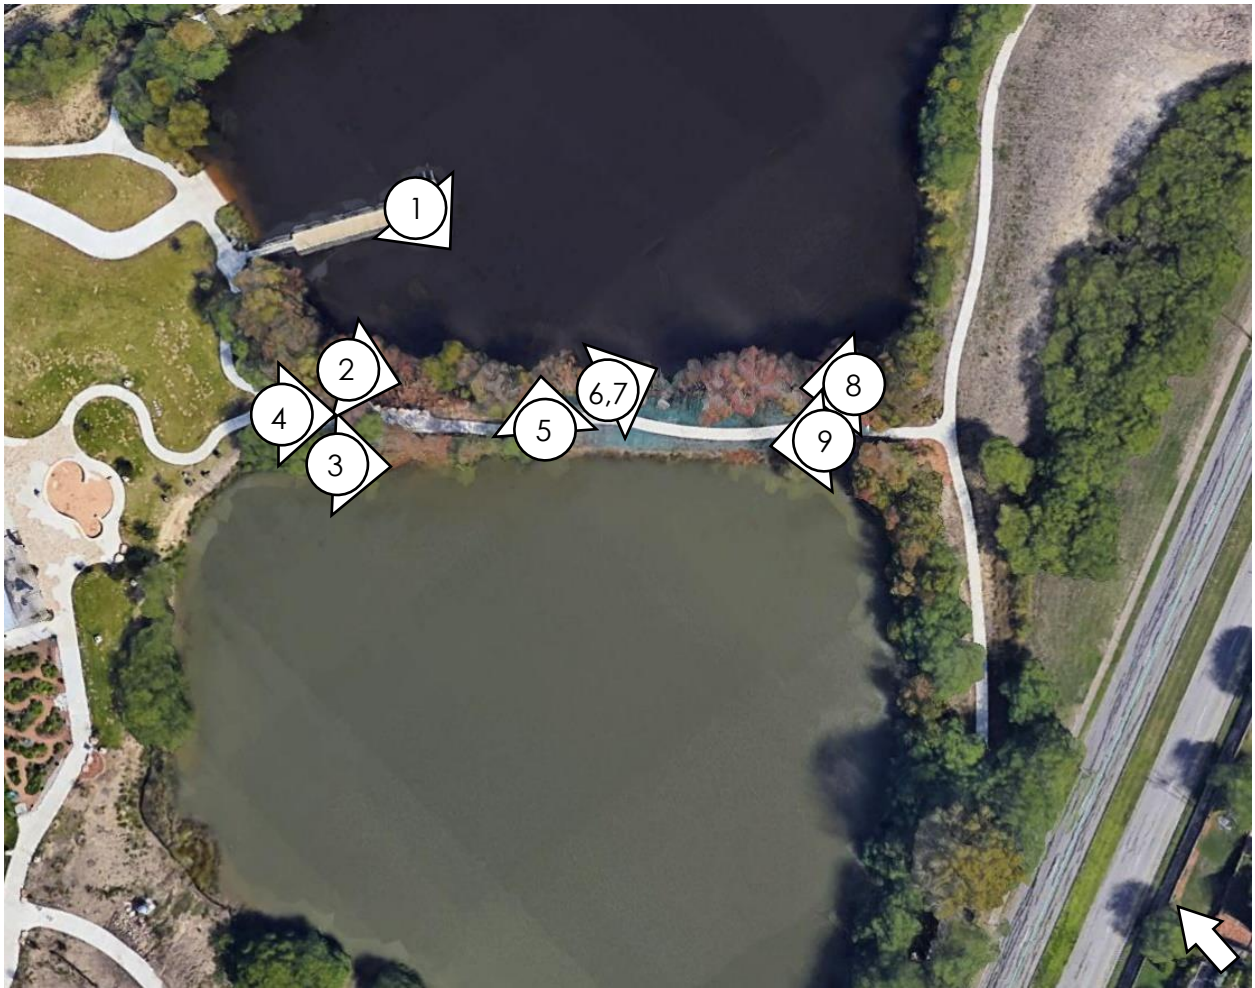
The earthen embankment has an overall length of approximately 350 feet (including the spillway) with a crest width of approximately 12-15 feet. The embankment was found to be in fair condition. Photos 1 through 4 show the crest and slopes of the embankment. The following observations were noted:

Photo 1: Embankment Overview (Looking Upstream)
