Traffic Study Summary

Date: June 17, 2021

Request: All-way stops at Avery Parkway and Avery Ranch Drive and at Avery Parkway

Recommendation: Extension of the existing school zone on Avery Parkway; installation of a

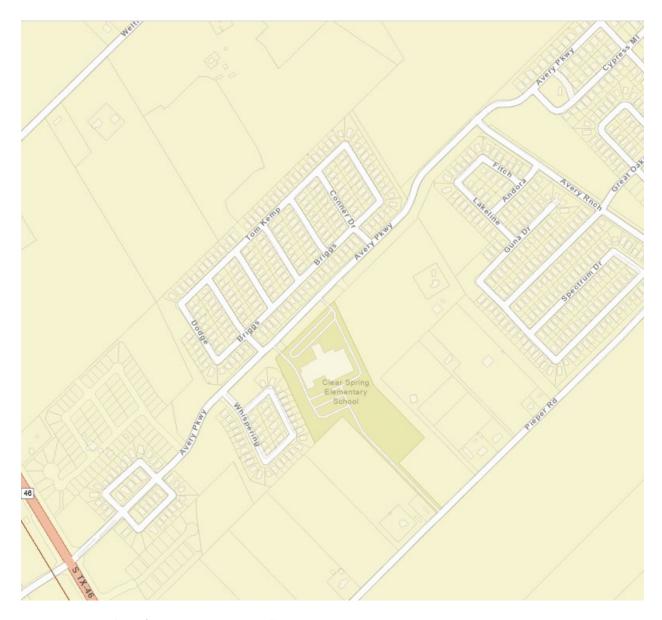
Figure 1. Avery Parkway from SH 46 to Cypress Mill

Clear Spring Elementary School is located on Avery Parkway within the Avery Ranch subdivision. There is an existing school zone with static school zone signs on Avery Parkway at the intersection with Wood Drake to approximately 500 feet north of Conner Drive.

A site investigation was completed in September 2020 to evaluate vehicle and pedestrian traffic during morning and afternoon school peak times on Avery Parkway between Whispering Way and Avery Ranch Drive(see Figure 1). School peak times are approximately 7 am to 7:30 am, and 3 pm to 3:30 pm. Pavement width of Avery Parkway is approximately 30 feet.

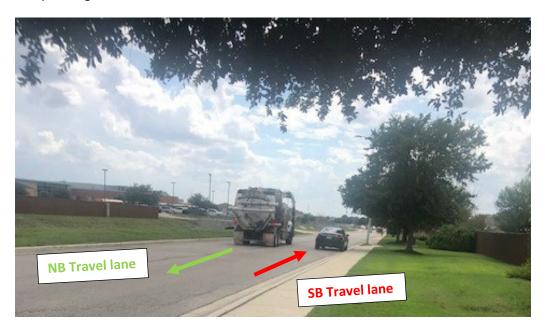
Figure 2. Parallel-parked parent during PM pick-up

Parents parallel park southwest-bound on Avery Parkway opposite the school, causing other vehicles to go into the middle of Avery Parkway in order to go around them (see Figure 2 below). However, Avery Parkway does not have vertical or horizontal curves in front of the school, so these vehicles do have adequate sight distance for these maneuvers.

Avery Parkway was evaluated for yellow center line pavement markings following the guidance in the TMUTCD and does not currently meet any warrants based on ADT or sight distance issues. However, vehicle maneuvers in the street may be an issue for oncoming traffic. Further evaluation is required to determine if parking restrictions are required in addition to the proposed centerline markings.

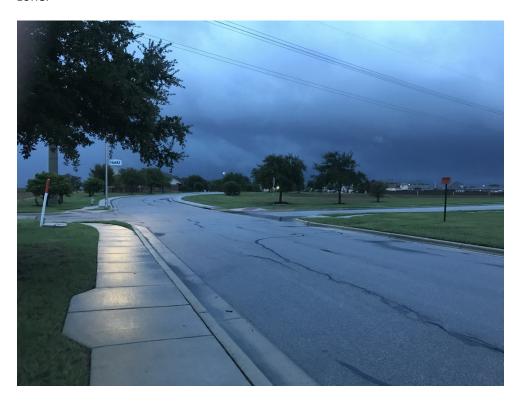
Figure 3. Avery Parkway looking northeast at Avery Ranch Drive

There is a horizontal curve on Avery Parkway northeast of Avery Ranch Drive as seen in Figure 3 below. The south side of Avery Parkway west of the intersection with Avery Ranch Drive does not have a sidewalk. Children cross Avery Parkway on foot and bicycles to get to the sidewalk on the north side of Avery Parkway on their route to school, and the opposite path in the afternoons on their way home

from school. The crossing location is currently not marked and outside of the existing posted school zone.

Based on the site investigation and engineering judgement, it is recommended that the existing school zone on Avery Parkway be extended on the northeast side to 200 feet northeast of Avery Ranch Drive with no changes to time frames. Also, crosswalk markings are recommended at this time on Conner Drive at the intersection with Avery Parkway, and on Avery Parkway at Avery Ranch Drive with a School Crossing Assembly with downward-pointing arrow (S1-1; SW16-7P) at both approaches of the crosswalk on Avery Parkway.

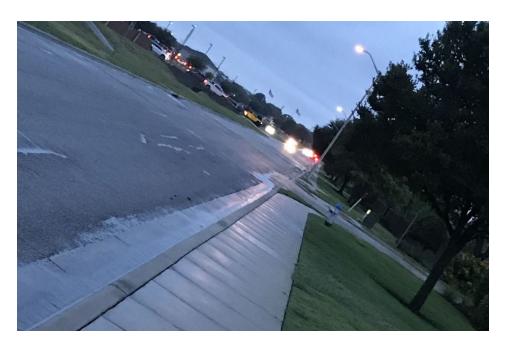
Figure 4. Avery Parkway at Conner Drive

Conner Drive is approximately 150 feet northeast of the northernmost school driveway. A sidewalk exists spanning the entire length of the north side of Avery Parkway, however the sidewalk on the south side of the street ends at the northernmost school driveway (Figures 2 and 4). Little to no traffic was observed turning onto or out of Conner Drive at Avery Parkway during both the morning and afternoon school peak times. This intersection is stop controlled on Conner Drive, and vehicles do not appear to have a problem approaching the intersection slowly or stopping at the stop sign. Based on the observations conducted, children do not have any issues crossing Conner Drive without a marked crosswalk.

volumes between the two roadways. None of the other non-volume all-way stop warrants from the TMUTCD were met and an all-way stop is not recommended for this intersection at this time. A crosswalk will be installed on Conner Drive at Avery Parkway because it is a part of the school route.

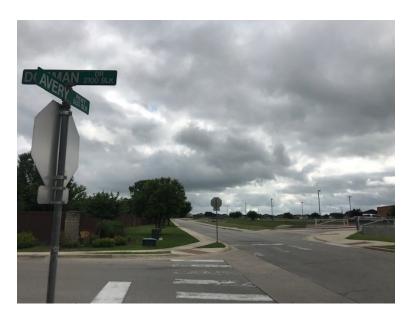
Figure 6. Marked Crosswalks at Avery Parkway and Dorman Drive

A marked crosswalk with police crossing guard during both morning and afternoon school peak times is present across Avery Parkway at Dorman Drive (Figure 6). The intersection of Avery Parkway and Dorman Drive is controlled by an all-way stop. All children are gathered and escorted by teachers at afternoon release in a single-file line to this crosswalk location before crossing the street all together in one group. During this time, all vehicles are stopped at the intersection by the police officer for approximately 5-10 minutes before resuming normal operation. In the mornings just as well as afternoons, children all appear to use only the existing crosswalk at Dorman Drive in order to cross Avery Parkway to get to the school.

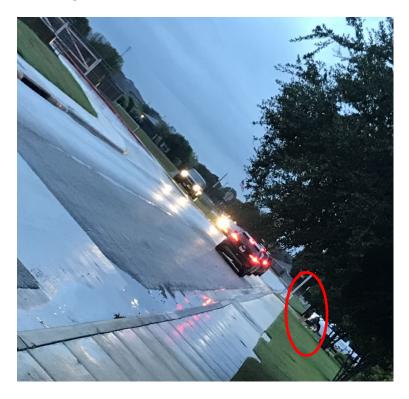
Figure 7. Children waiting for the bus at Avery Parkway and Dorman Drive

The northeastern corner of Dorman Drive at Avery Parkway also serves as a bus stop for another school, likely middle school. Children can be seen in Figure 7 waiting near the stop sign at this corner for morning bus pick-up. Avery Parkway carries majority of the pedestrian traffic, but Briggs Drive – parallel to and north of Avery Parkway – serves some pedestrian traffic too. Several children walk and bike to school in the mornings, however pedestrian activity is much heavier in the afternoons leaving school – some getting picked up along Avery Parkway to skip the parent vehicle pick-up line, and some walking and biking home.

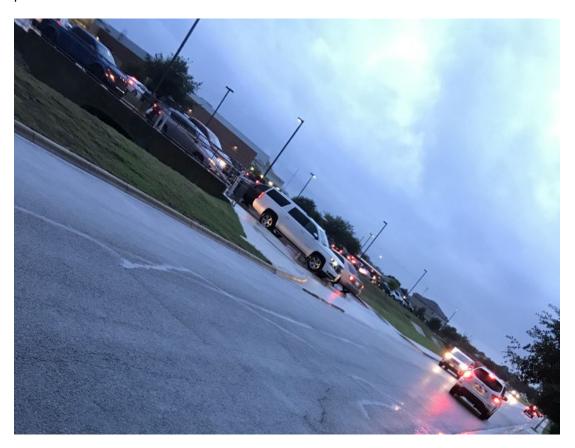
Figure 8. Two-lane utilization at northeast school driveway during morning drop-off

During the morning peak time, parents enter and exit the school parking lot for drop-off using the northeastern driveway while the buses use the southwestern driveway. In the afternoons, the driveway functions switch, where the parents use the southwestern driveway and the buses use only the northeastern driveway. The parent line is long as is usual and can be expected at an elementary school, but traffic does appear to function smoothly. Figure 8 shows the parent drop off line during the morning peak time.
