# Guadalupe Appraisal District

The Guadalupe Appraisal District Board of Directors (**BOD**) has adopted Resolution 2025-03 proposing the acquisition and renovation of the historic Mary B. Erskine Building located at **216 East College Street, Seguin, Texas**, as the future headquarters of the Appraisal District.

## FOR THE GUADALUPE COUNTY APPRAISAL DISTRICT

MAY 6, 2025

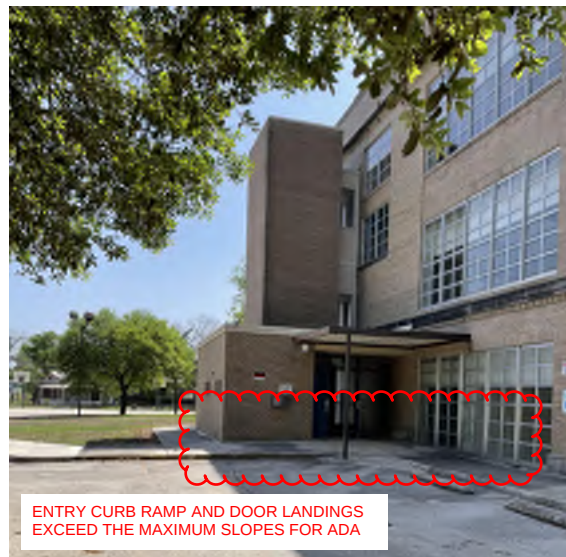
- The front entry curb ramp and door landings exceed the maximum slopes for ADA
- Many areas of the concrete sidewalks to the building are cracked, spalled and uneven
- Rework concrete front entry steps for compliant entry
- Additional parking will need to be constructed. Approximately 30 spaces may be retrofitted on the existing concrete paved basketball court. An additional 25 to 30 parking spaces will be needed to meet City of Seguin ordinances.
- Remove abandoned swing sets and other playground equipment.
- Improve site lighting for better security.
- New mechanical systems will require additional outdoor areas with concrete pads and better security fencing.
- Existing roof downspouts drain across public sidewalks which can cause slippery, unsafe conditions.
- Consider installing sidewalk trench drains to divert drainage to grassy areas.

*Figure 1: Entry sidewalk & curb ramp*
